ASBESTOS REFURBISHMENT SURVEY REPORT

St Kevins, Chapel, Administration Block,
Farmyard, Workshop and Ground Slabs

Our Ladys

Land Development Agency

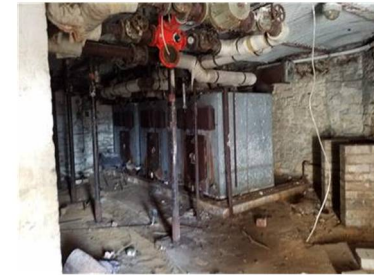
Rope seals to Boiler and Paper Gaskets

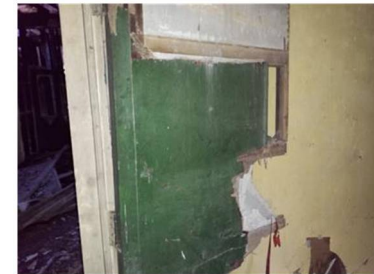
Fire Doors throughout building.

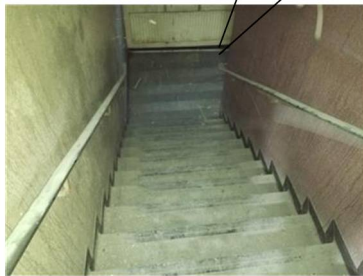
Vinyl Floor Tiles and Bitumen adhesive containing asbestos

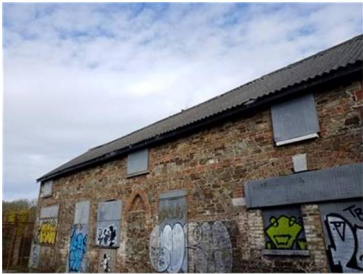
Farmyard Shed roof sheeting and broken debris on ground

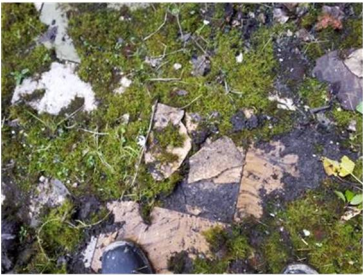
Vinyl floor tiles and bitumen adhesive

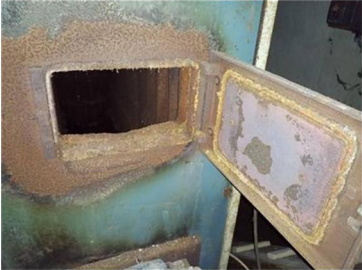
Rope Seals to Chapel Boiler
