**Architectural Heritage Impact Assessment  
(incorporating conservation survey)**

**St Kevin's Strategic Housing Development, Shanakiel, Cork City**

**December 2020**

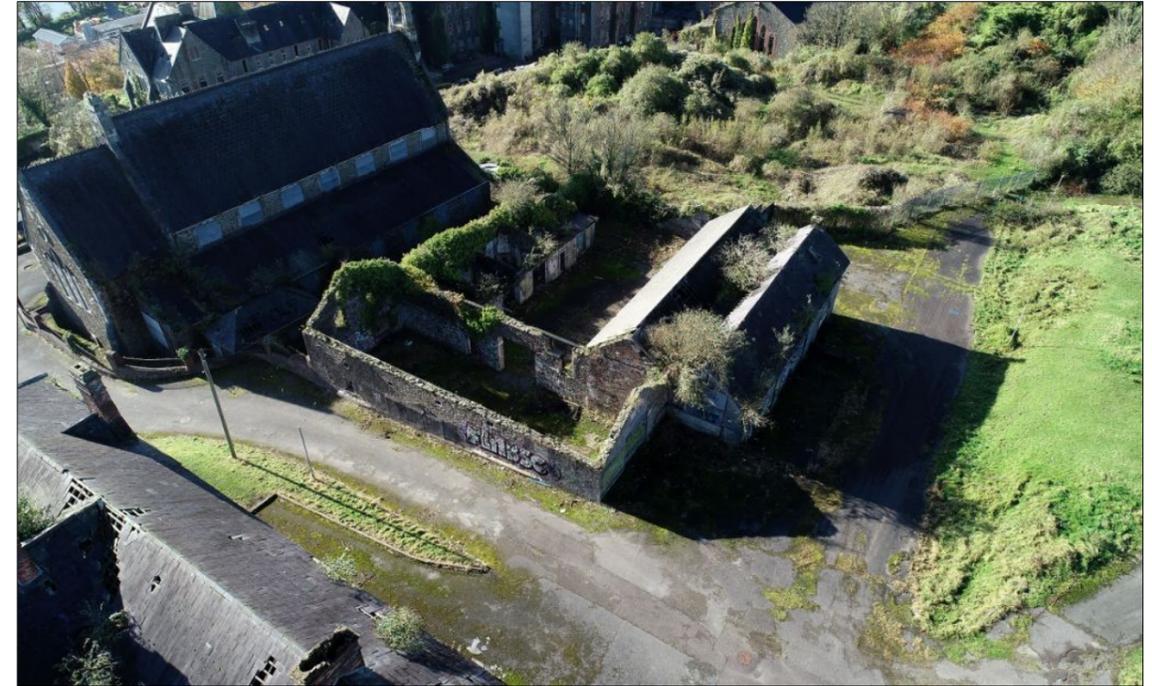
Figure 11: Recent aerial view of roofless

These buildings appear to have been formerly associated with the former Carrigmore House, that used to stand on where the former Catholic chapel is now. Roofless south and east ranges of horse-shoe arranged set of stone buildings while north range has altered openings and mature tree growth within internal roof valley suggesting extensive damage to building fabric. These buildings are devoid of authentic internal fabric and were significantly altered and adapted as workshops and storage for the hospital's maintenance staff and tradesmen. **Building complex of limited architectural interest but of some historical curiosity due to its former association with the long-demolished Carrigmore House.**

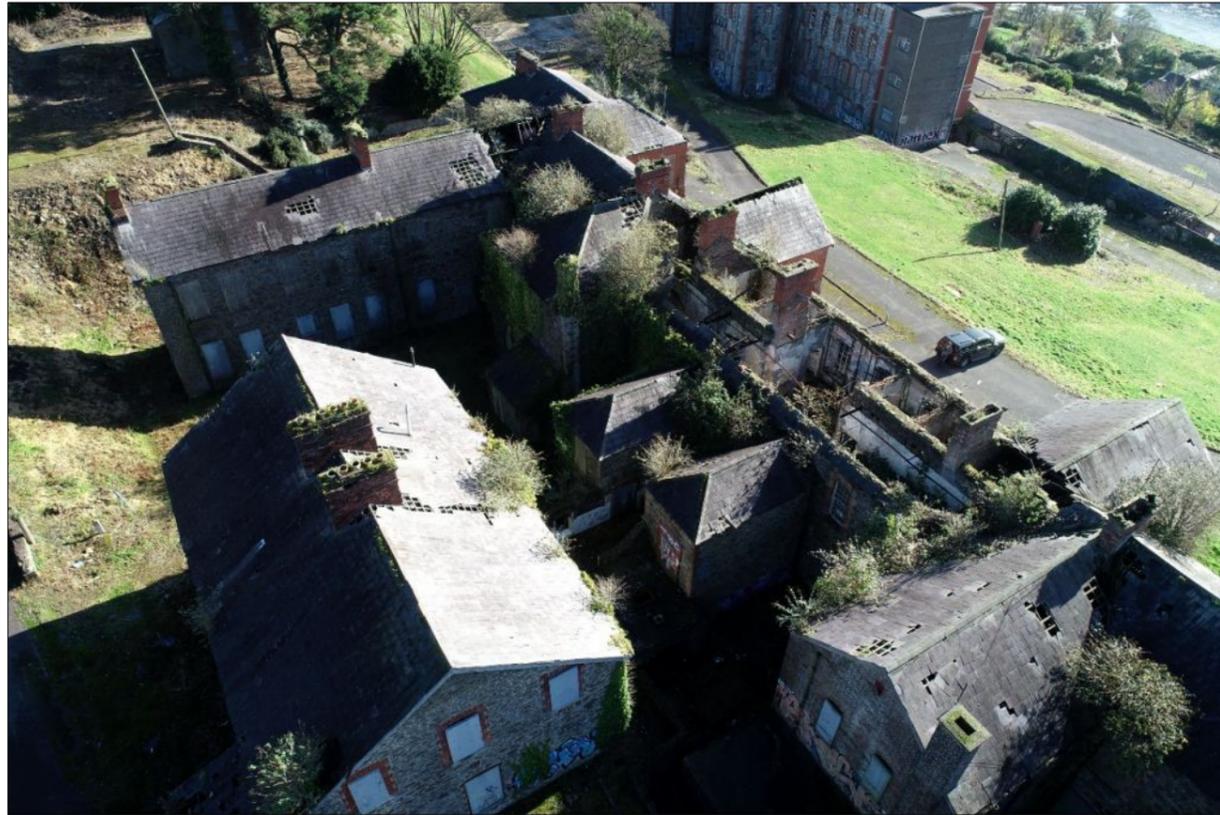
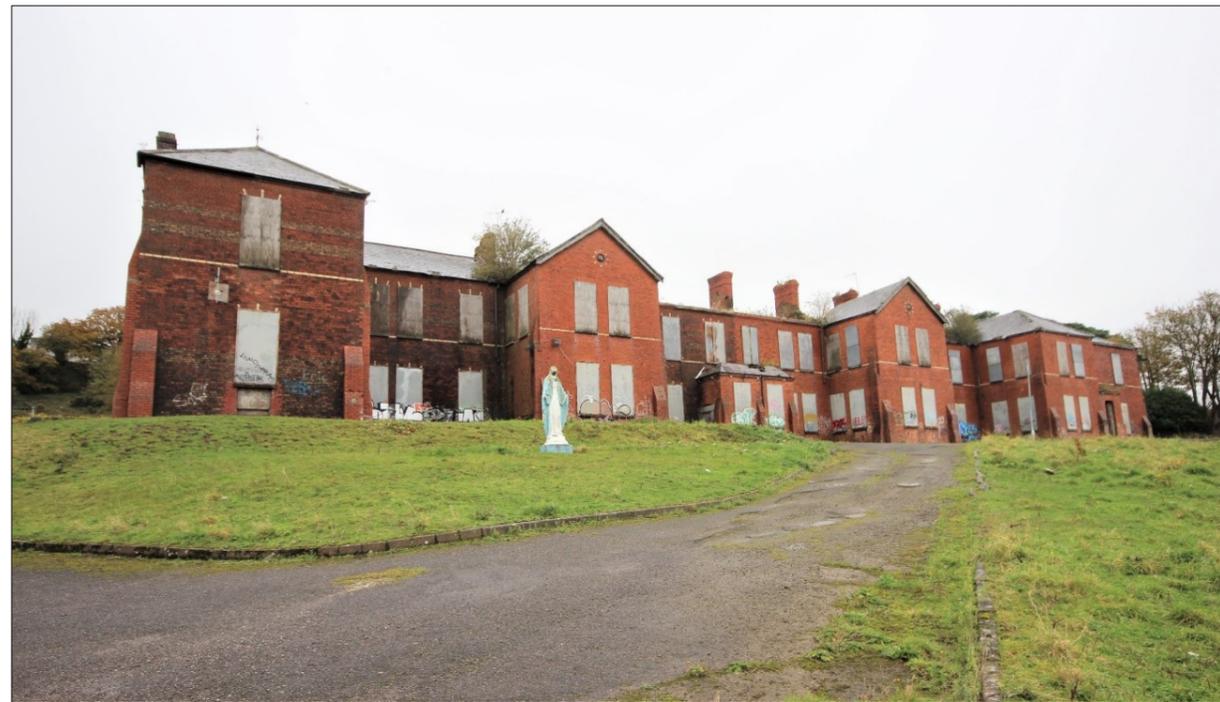
Figure 12: Recent aerial view of St Dympna's Hospital

Figure 13: View towards the front (south) elevation of St Dympna's Hospital

Building with complex of narrow two-storey brick projections to south and stone ranges to rear north elevation with roofless central block to front part of former hospital building. Extant sections of roof have extensive localised damage evident and building is tending towards general dereliction. Small number of unblocked windows contain multi-pane timber sliding sash frames. **Building complex of limited architectural or historical interest.**

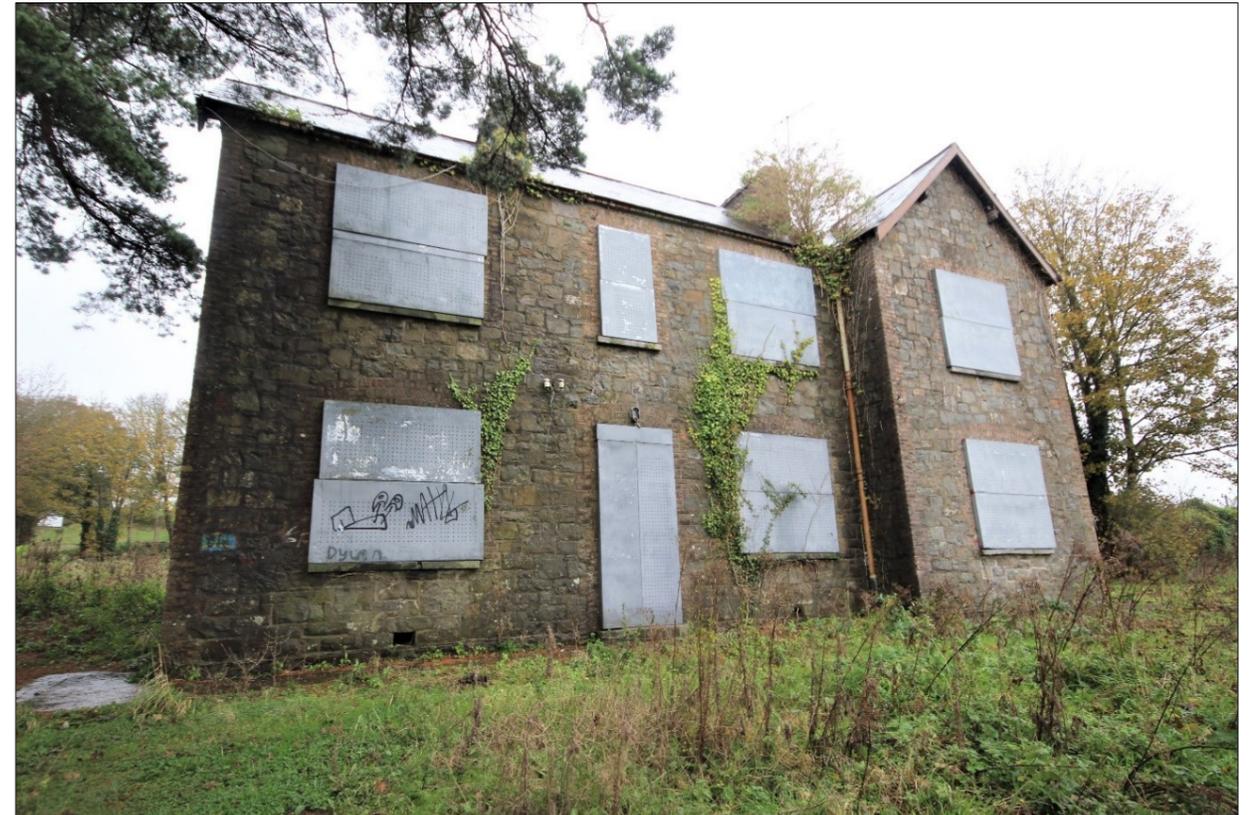
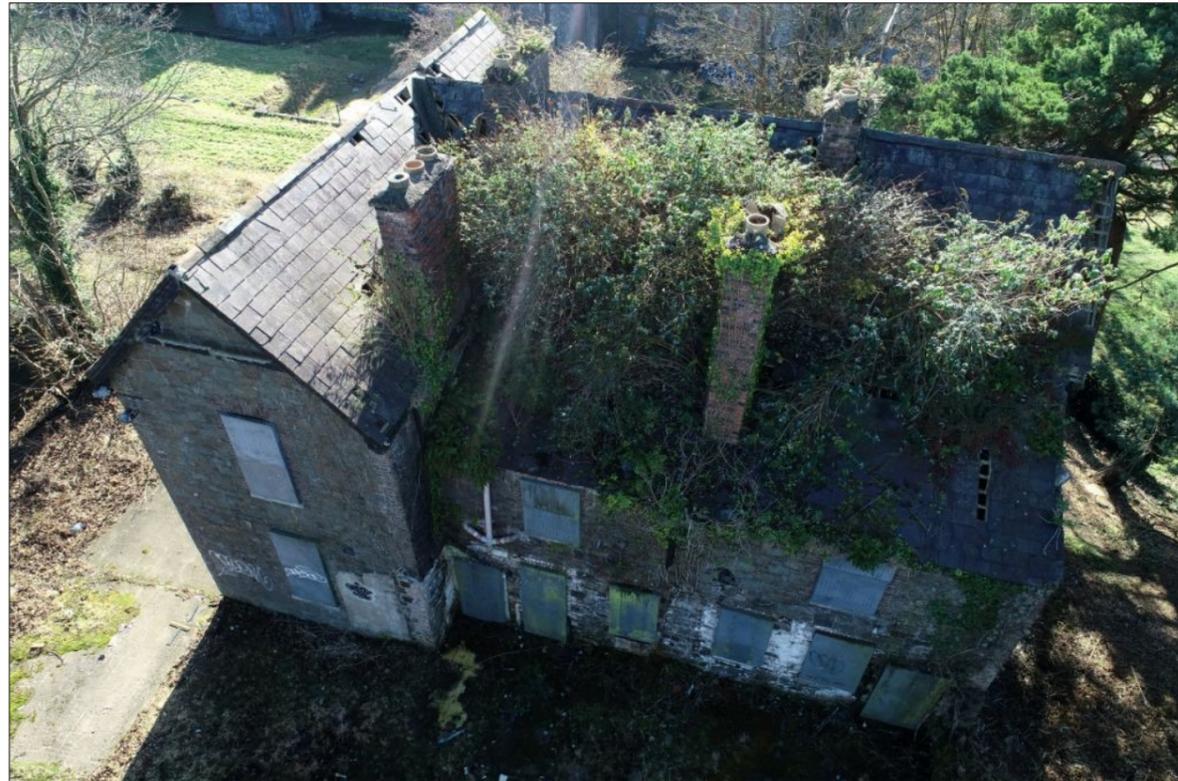
Figure 14: View towards the south elevation of the former Matron's House

Stone-built two-storey simply-detailed former matron's residence with extensive tree-growth to slated roof which has localised damage but appears to be in generally sound structural condition. **Building of limited architectural merit but some social significance.**

Figure 15: Recent aerial photograph of the former Matron's House – note the level of vegetation-growth on the roof

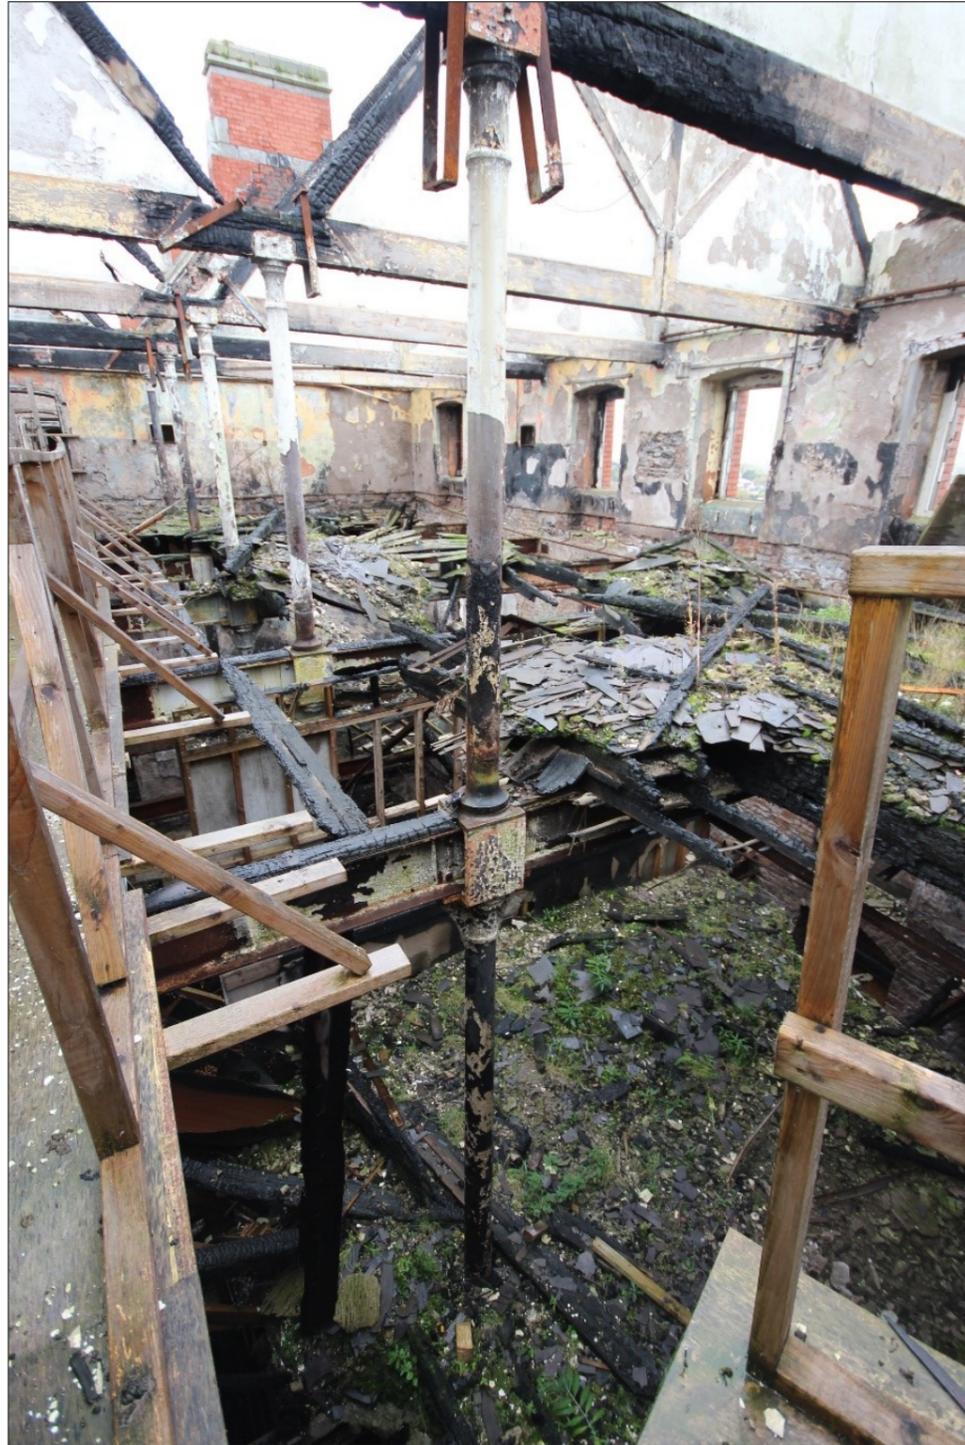
Notwithstanding the derelict and dangerous condition of the majority of the interior, **the building is of considerable architectural, historical and social significance to Cork City** and it is, along with the former Eglinton Asylum (now Atkins Hall), a **significant landmark** in the western portion of the city. The significance of the building is acknowledged by its inclusion the Record of Protected Structures for the city.

*Figure 23: Fire-damaged interior of the building*

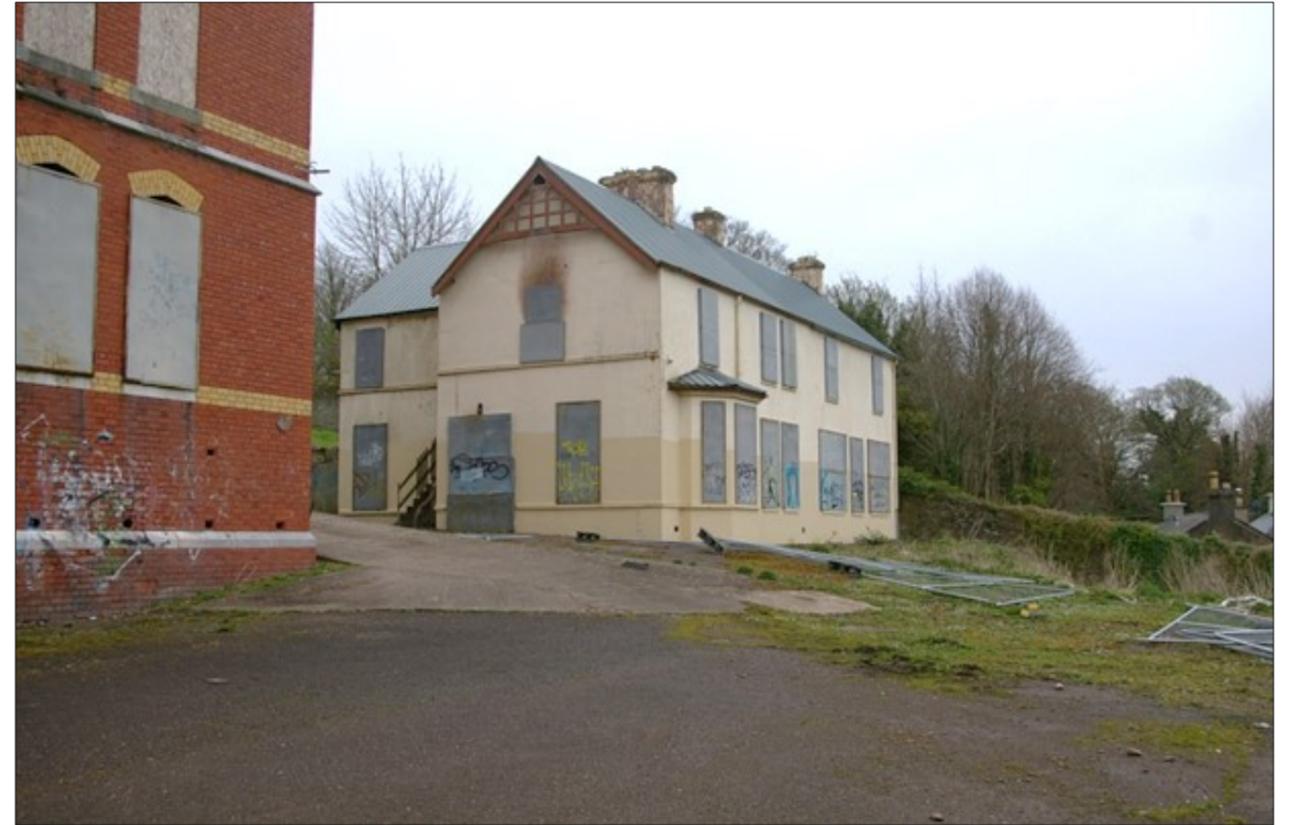
*Figure 24: Former doctors' residence located to the east of St. Kevin's*

Stone-built two-storey simply-detailed former doctors' residence with slated roof which has localised damage but appears to be in generally sound structural condition. Permission has been granted for the demolition of this building to facilitate the construction of a new rising and distribution water main at Shanakiel which will connect the Lee Road Waterworks to the Shanakiel Reservoirs (Cork City Council planning register reference 18/37965). **Building of limited architectural merit but some social significance.**

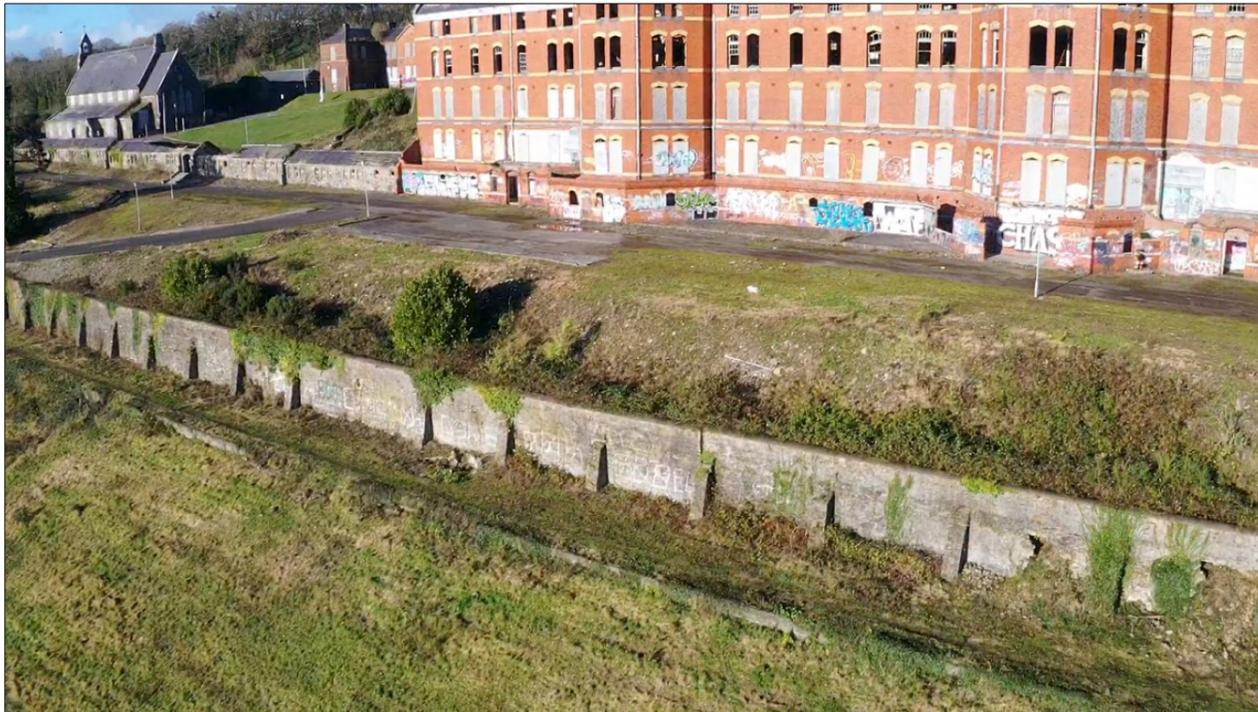
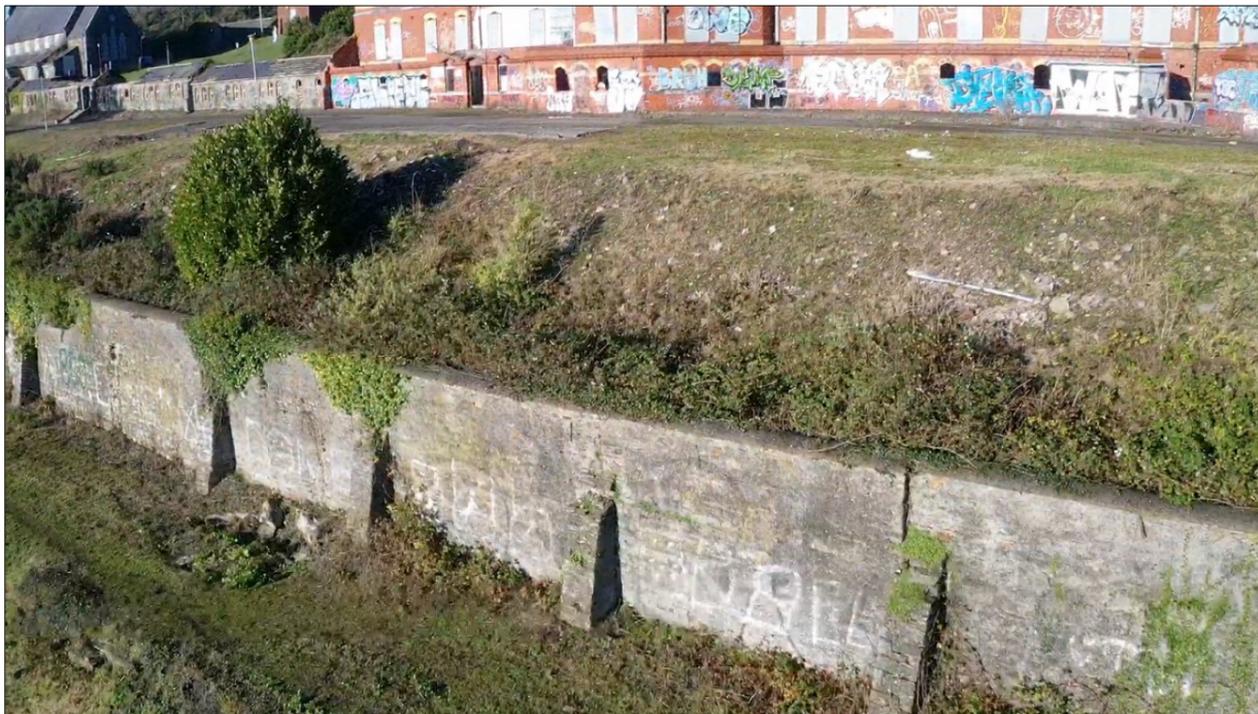
However, to the south of St Kevin's is a nineteenth-century masonry-built buttressed retaining wall; it measures approximately 160 metres in length. Up to the late twentieth century, the area to the south of this wall was used as vegetable gardens that supplied the hospital with fresh produce. Barrett Mahony Consulting Engineers have assessed the structural condition and capacity of this wall and have made recommendations

regarding its treatment in the proposed scheme. Their assessment states the “wall is in very poor condition which is unsurprising given its age and the fact that the site has been derelict and not maintained over the last few years.” Furthermore, the report states that the “stability of the wall it must be viewed as dangerous.”

*Figure 25: Recent aerial view of buttressed retaining wall to the south of St. Kevin's*

*Figure 26: Recent aerial close-up view of the buttressed retaining wall to the south of St. Kevin's*

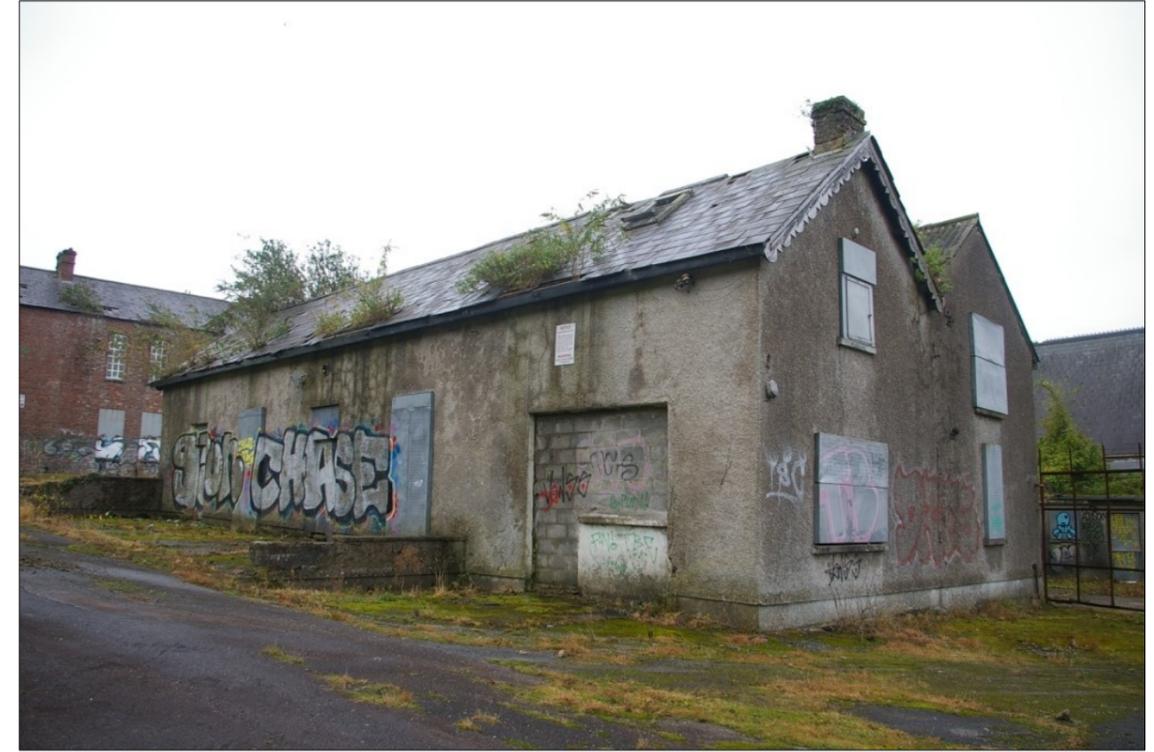
**Plate 7:** North elevation and west gable ends of double-pile range of outbuildings constructed in late nineteenth century, before 1893, to north of former chapel (roof of which is visible to background). Entire group of outbuildings here proposed to be removed.

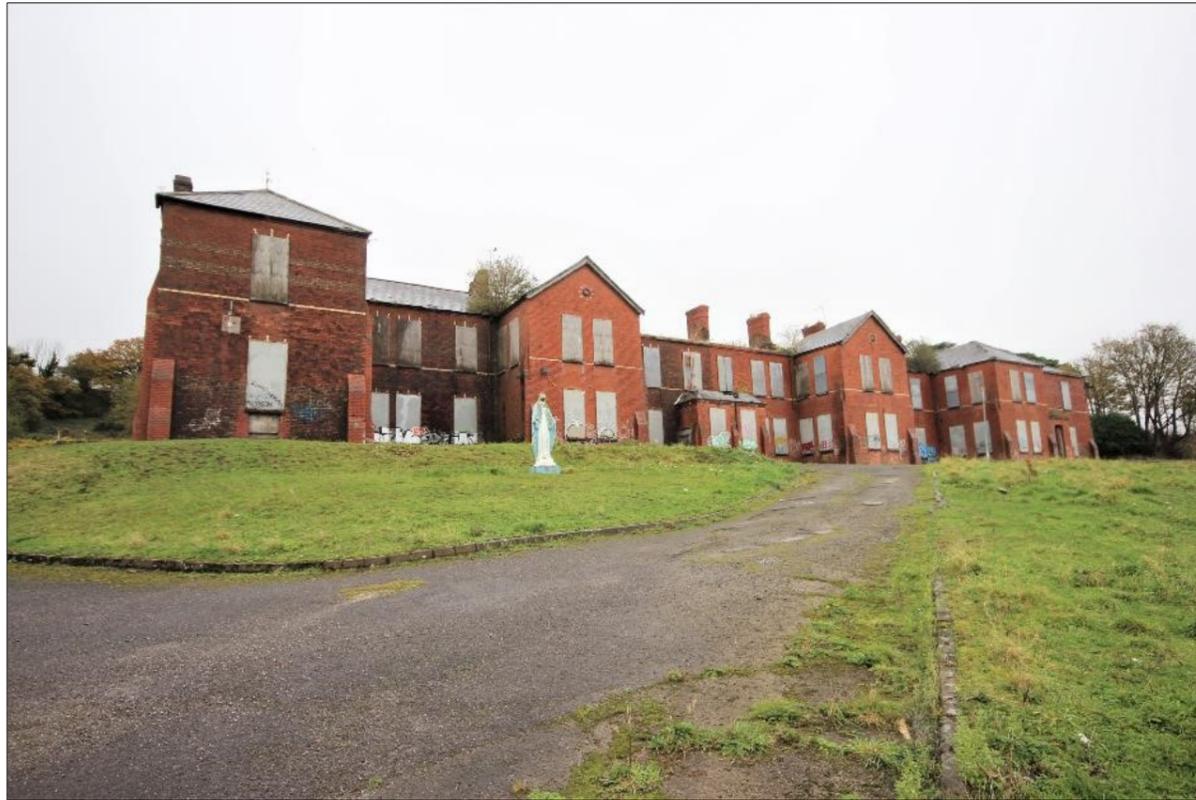
**Plate 17:** South façade of late nineteenth-century former St Dymphna's Hospital building proposed to be removed. Roof to central section removed since 2013

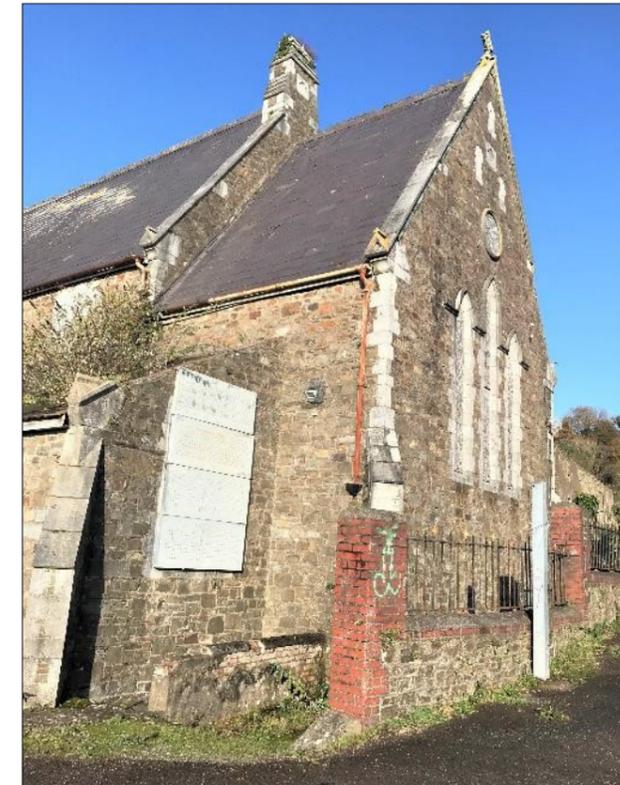
**Plate 28:** East end of former chapel from south-east. Proposed works will include reinstatement of stone capping to parapet walls of southern lean-to extension, currently missing as shown here.

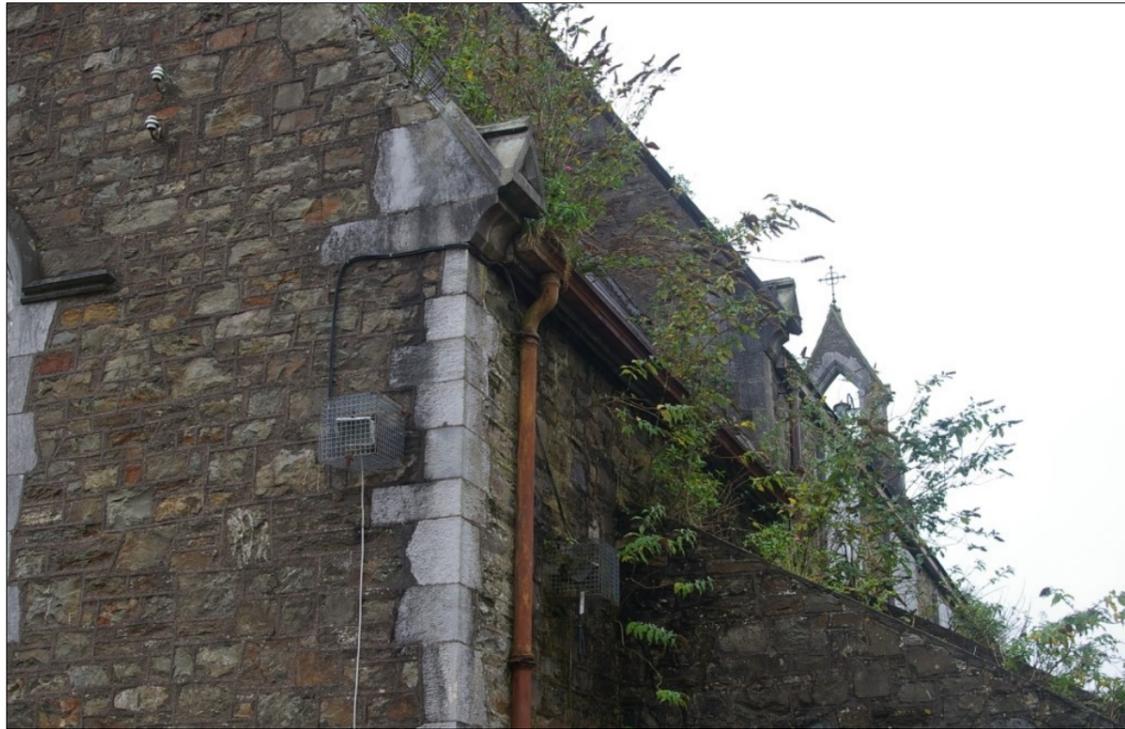
*Plate 29: Vegetation on north-eastern corner of former chapel.*

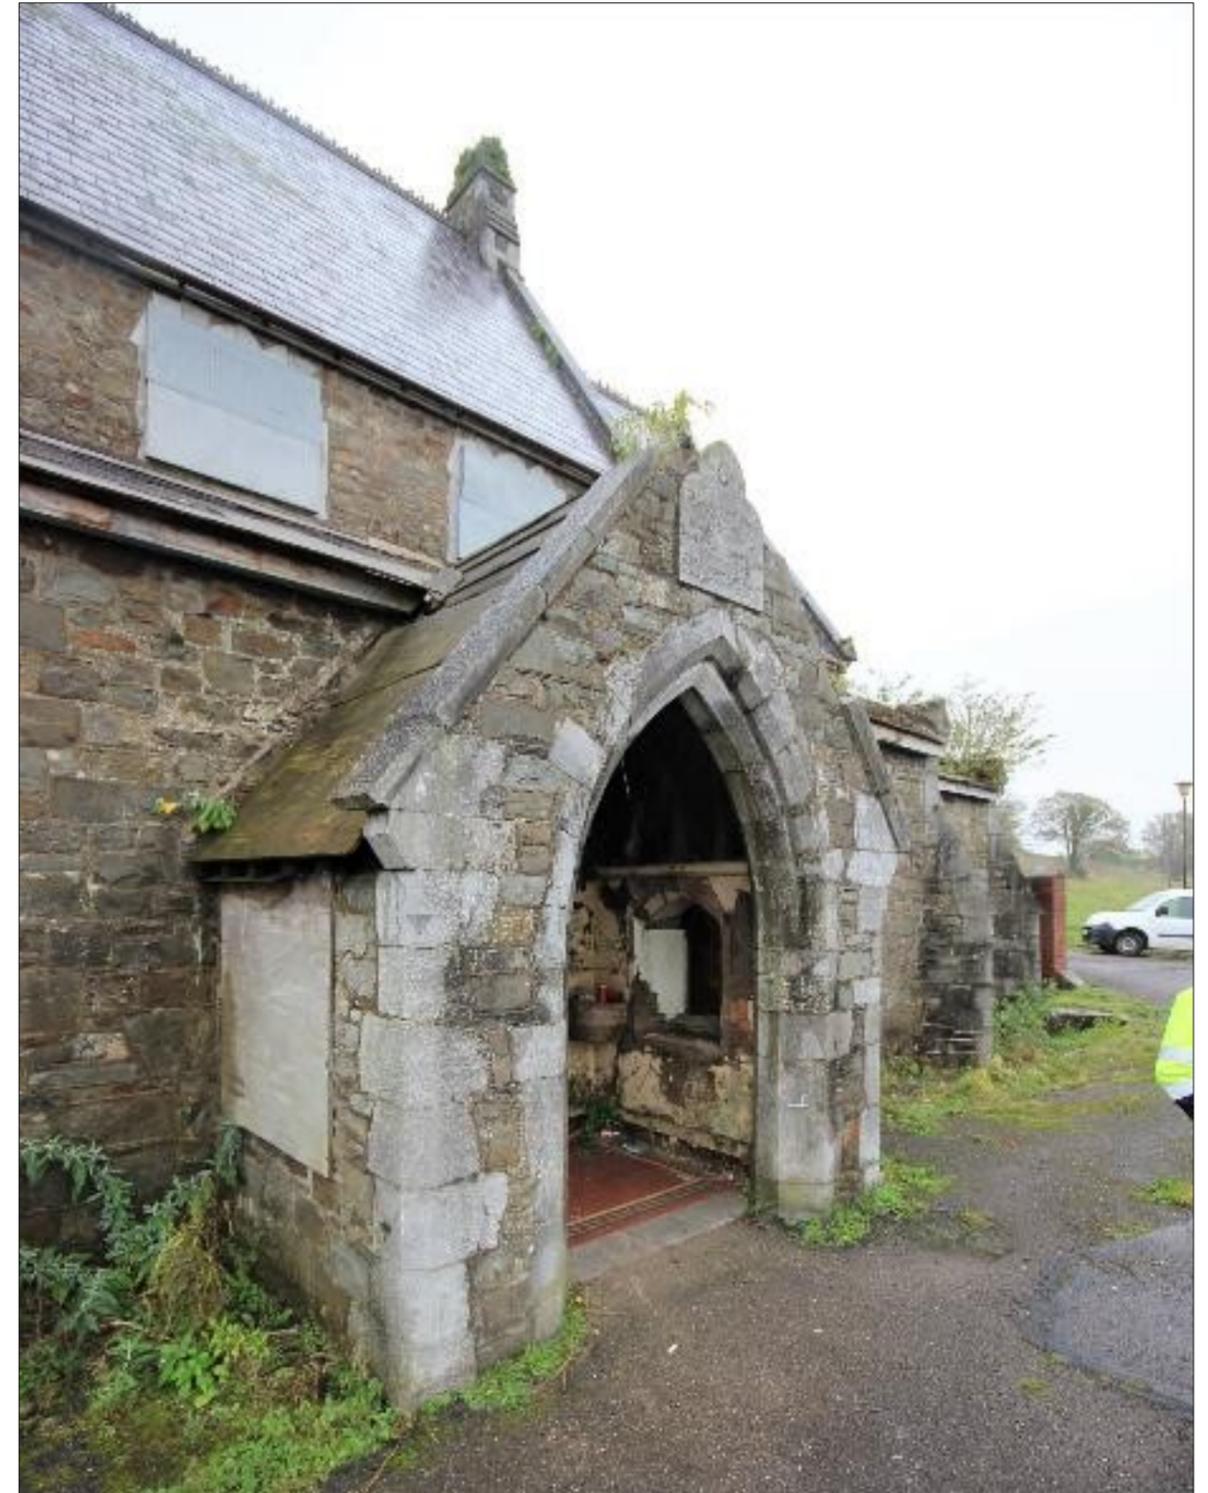
*Plate 31: South entrance porch to former chapel. Proposed works will include reinstatement of roof slates and capping stones to gable parapet*

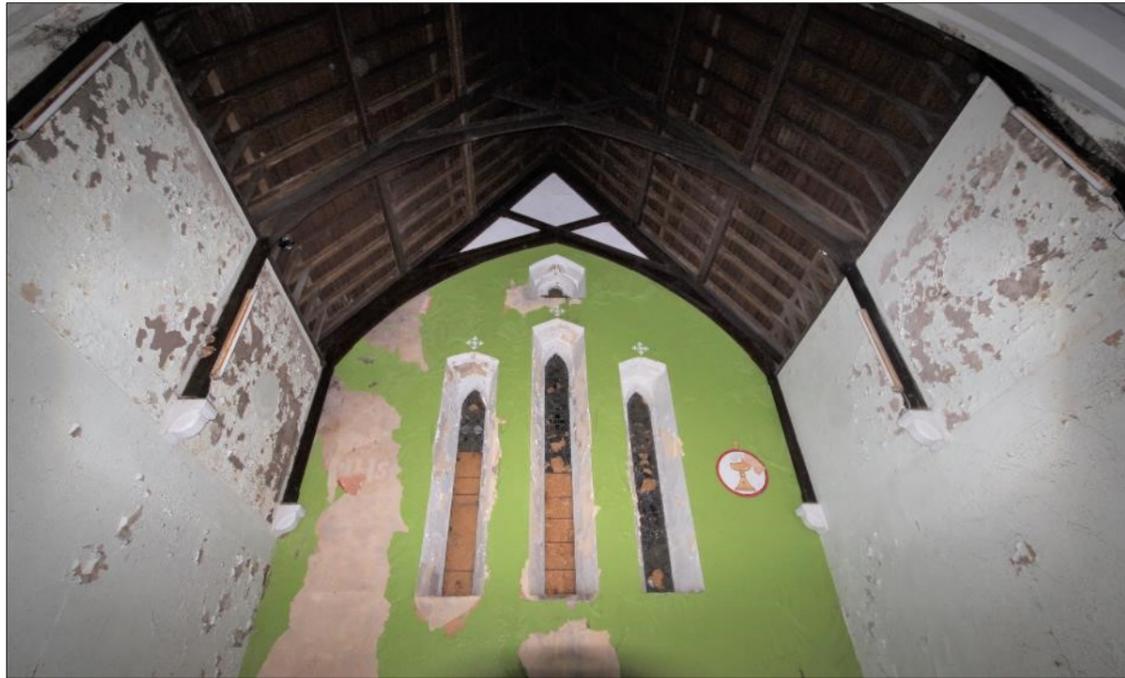
**Plate 36:** Detail of interior roof structure within chancel end of former chapel with evidence of localised timber decay and general damage to internal plaster wall surface as a result of limited ventilation combined with localised moisture ingress mostly from missing roof slates or defects to rainwater goods or leadwork.

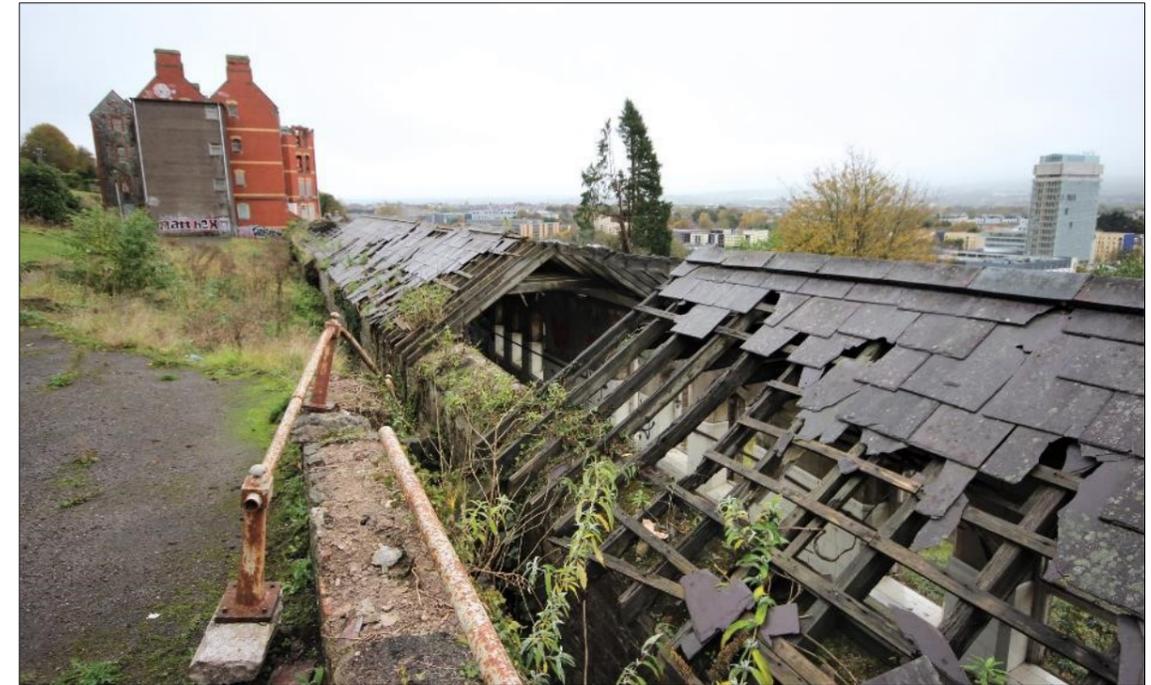
**Plate 38:** North elevation of extensively damaged roof of former communication corridor looking east towards former St Kevin's Hospital building. All but a central section of this corridor is proposed to be removed.

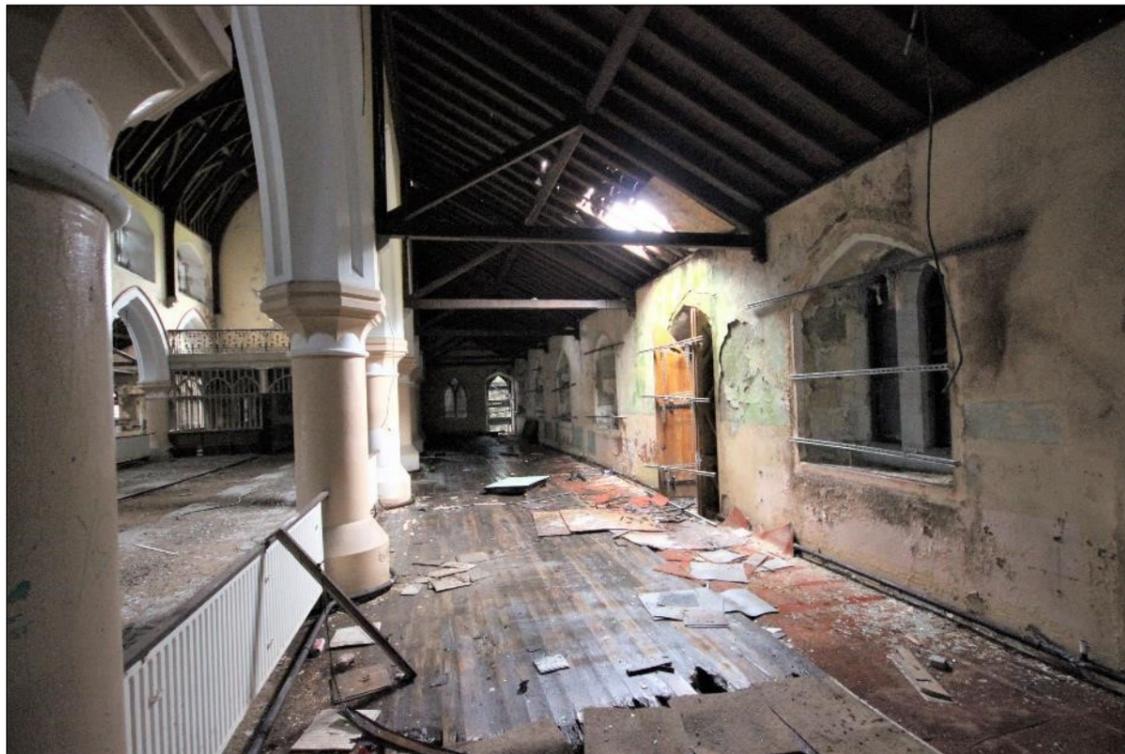
**Plate 37:** North aisle of former chapel looking towards west end with localised damage to timber sections of floor and to painted plaster wall surfaces, largely as a result of water ingress through missing roof slates and a general lack of ventilation, heating or regular inspection and maintenance for over 10 years.

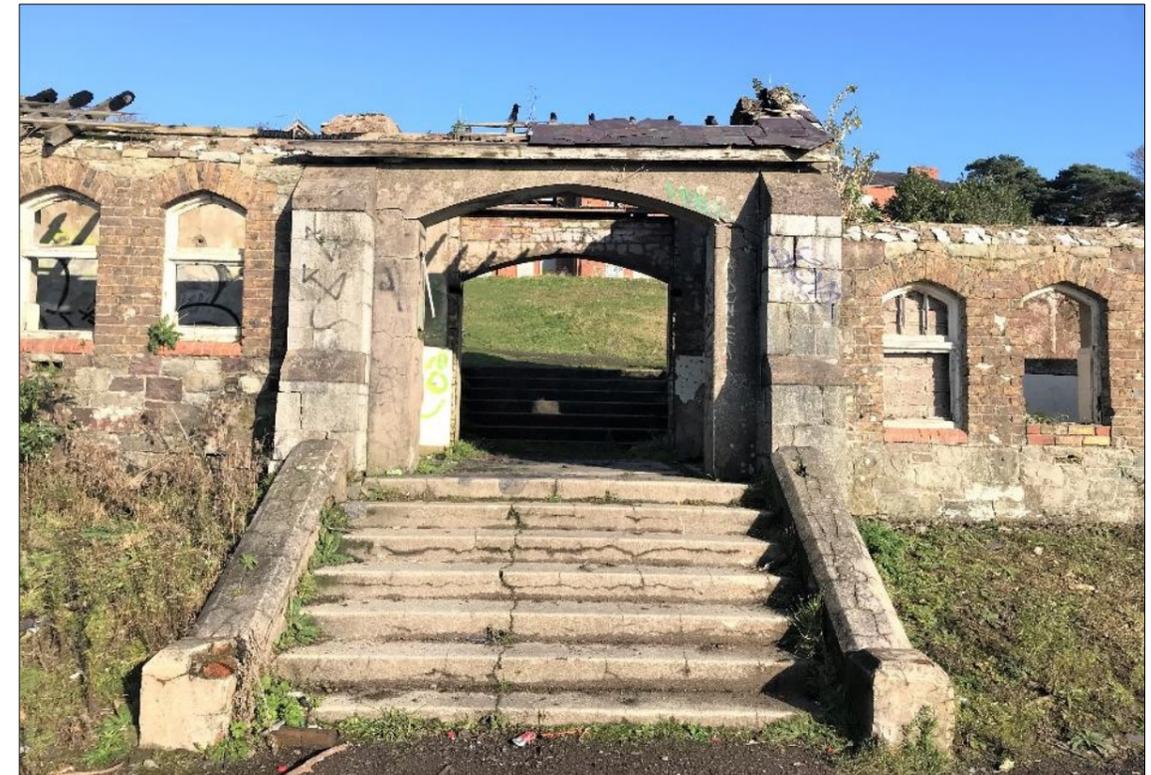
**Plate 39:** Section of corridor containing archway over existing steps proposed to be retained with removal of rest of late 1890s structure east and west of here

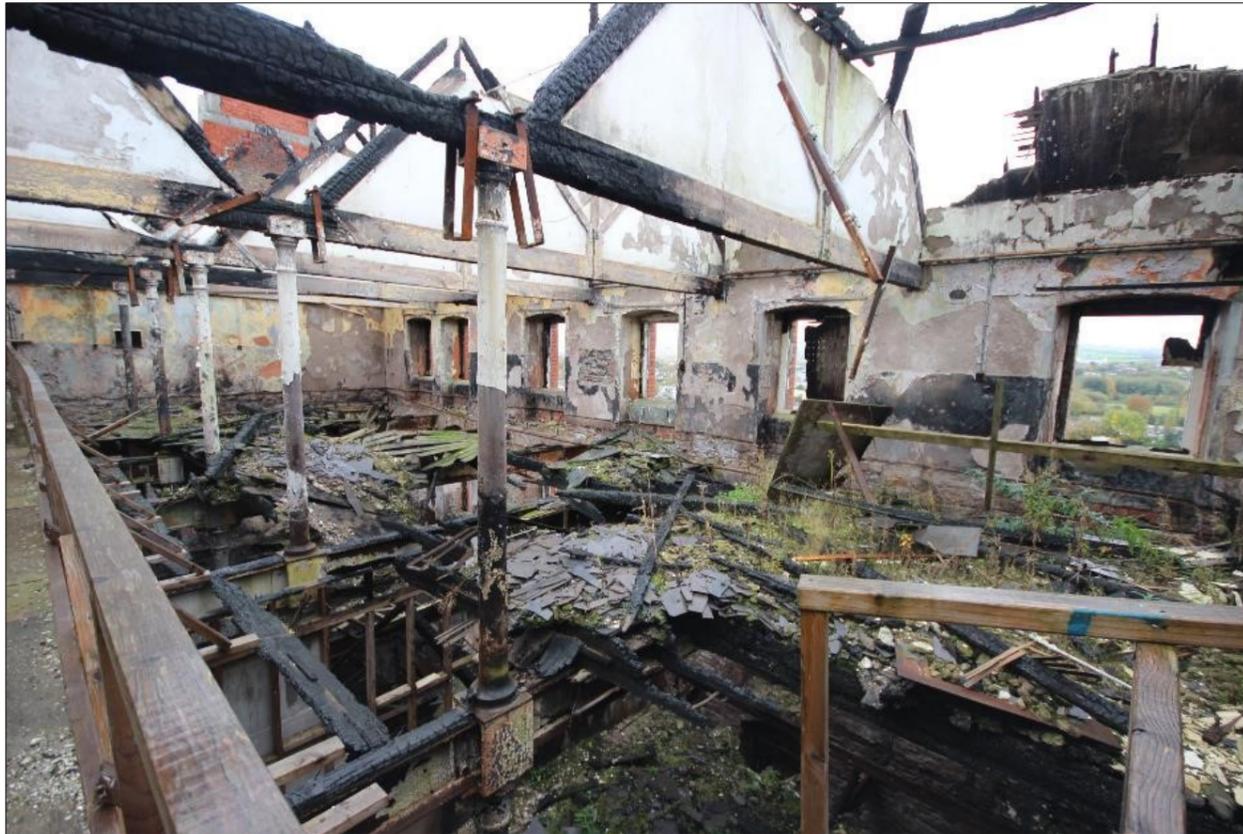
**Plate 52:** Third floor-level of former St Kevin's building following 2017 fire-damage which destroyed the roof, floors and window frames. The interior is proposed to be reconstructed here keeping any existing usable masonry partitions and supporting a new roof to follow the same design of the original structure.

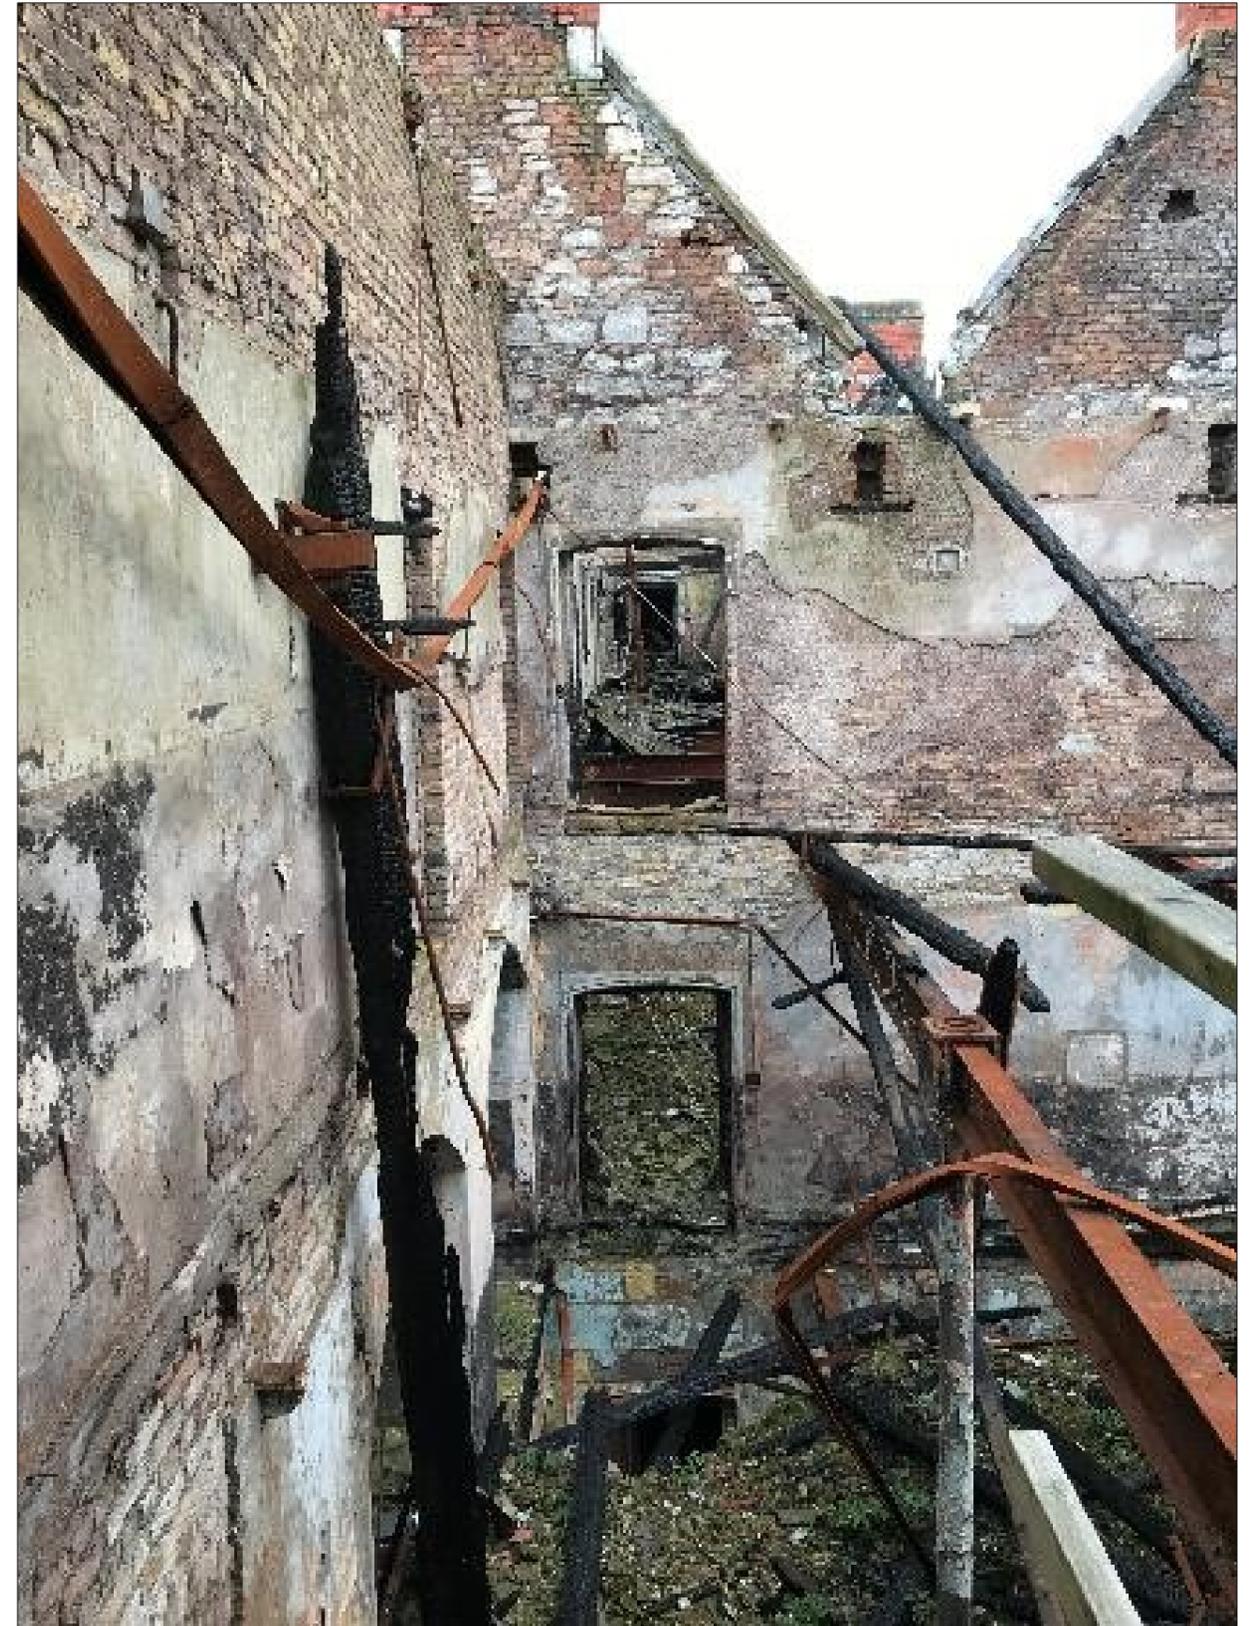
**Plate 53:** Interior of former St Kevin's hospital building showing extent of fire damage to timber floor and roof elements and remaining mixture of brick and stone masonry walls. Steel floor beams are likely to have been compromised by the heat of the 2017 fire with cast iron supports potentially re-usable within proposed development as appropriate.
