**Architectural Heritage Impact Assessment  
(incorporating conservation survey)**

**St Kevin's Strategic Housing Development, Shanakiel, Cork City**

**December 2020**

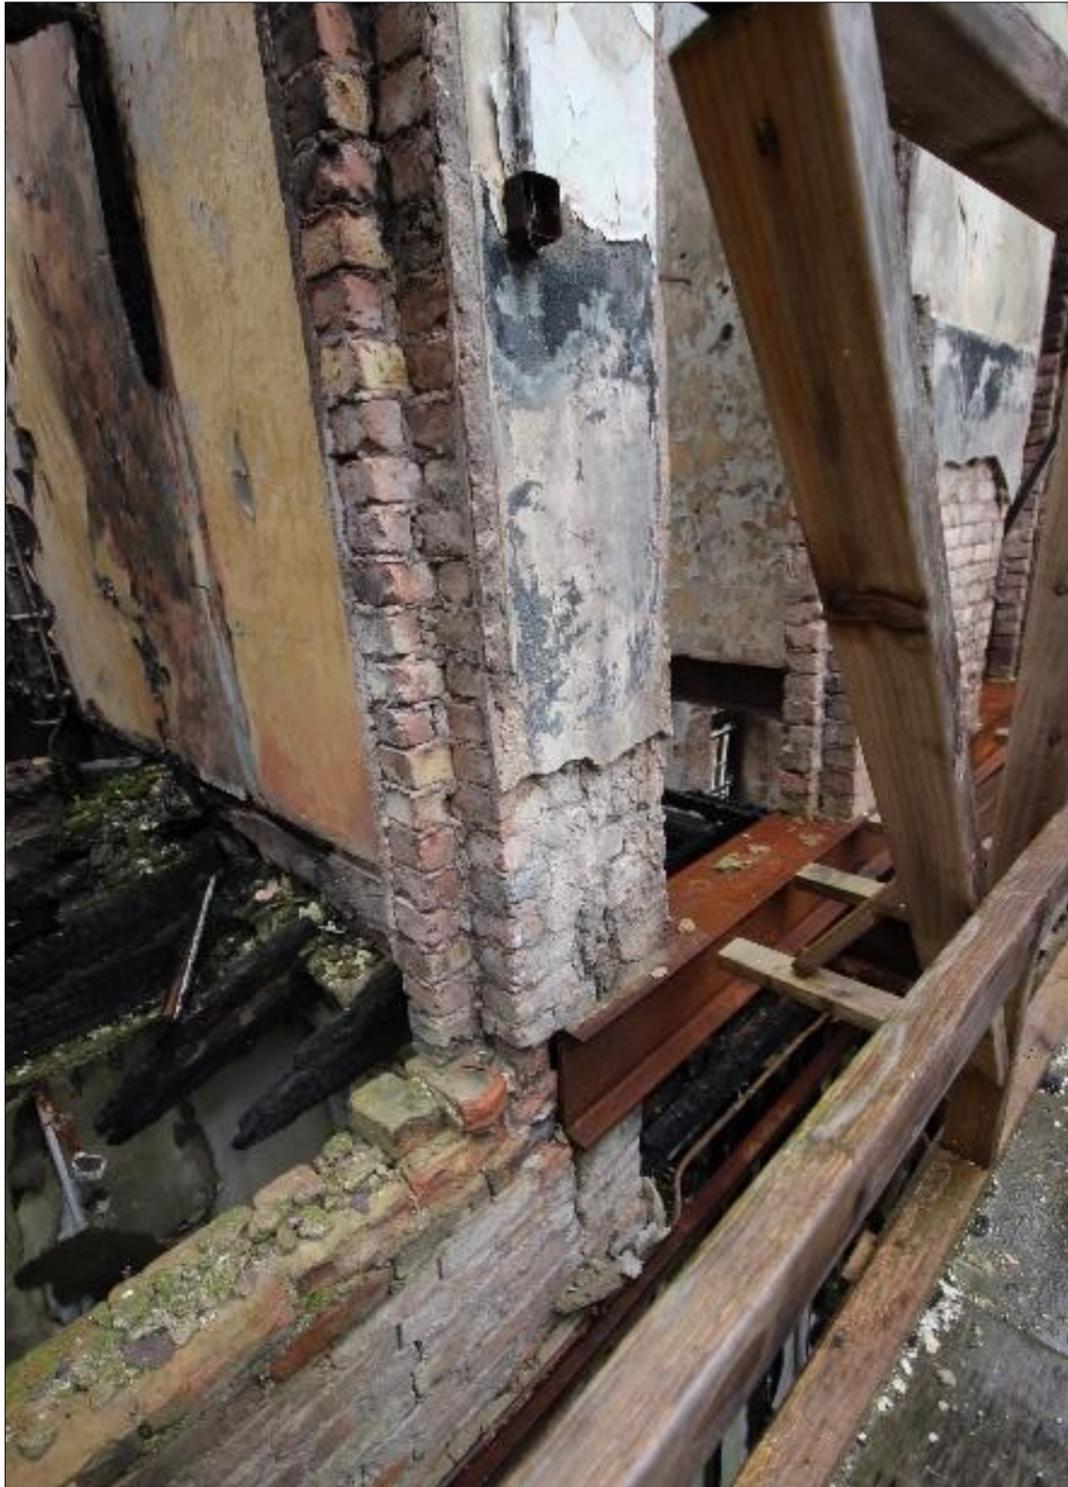
**Plate 54:** Localised steel support has been inserted in recent years to prevent imminent collapse of vulnerable elements of masonry. Proposed works will incorporate any surviving masonry walls within building into new internal layout where possible.

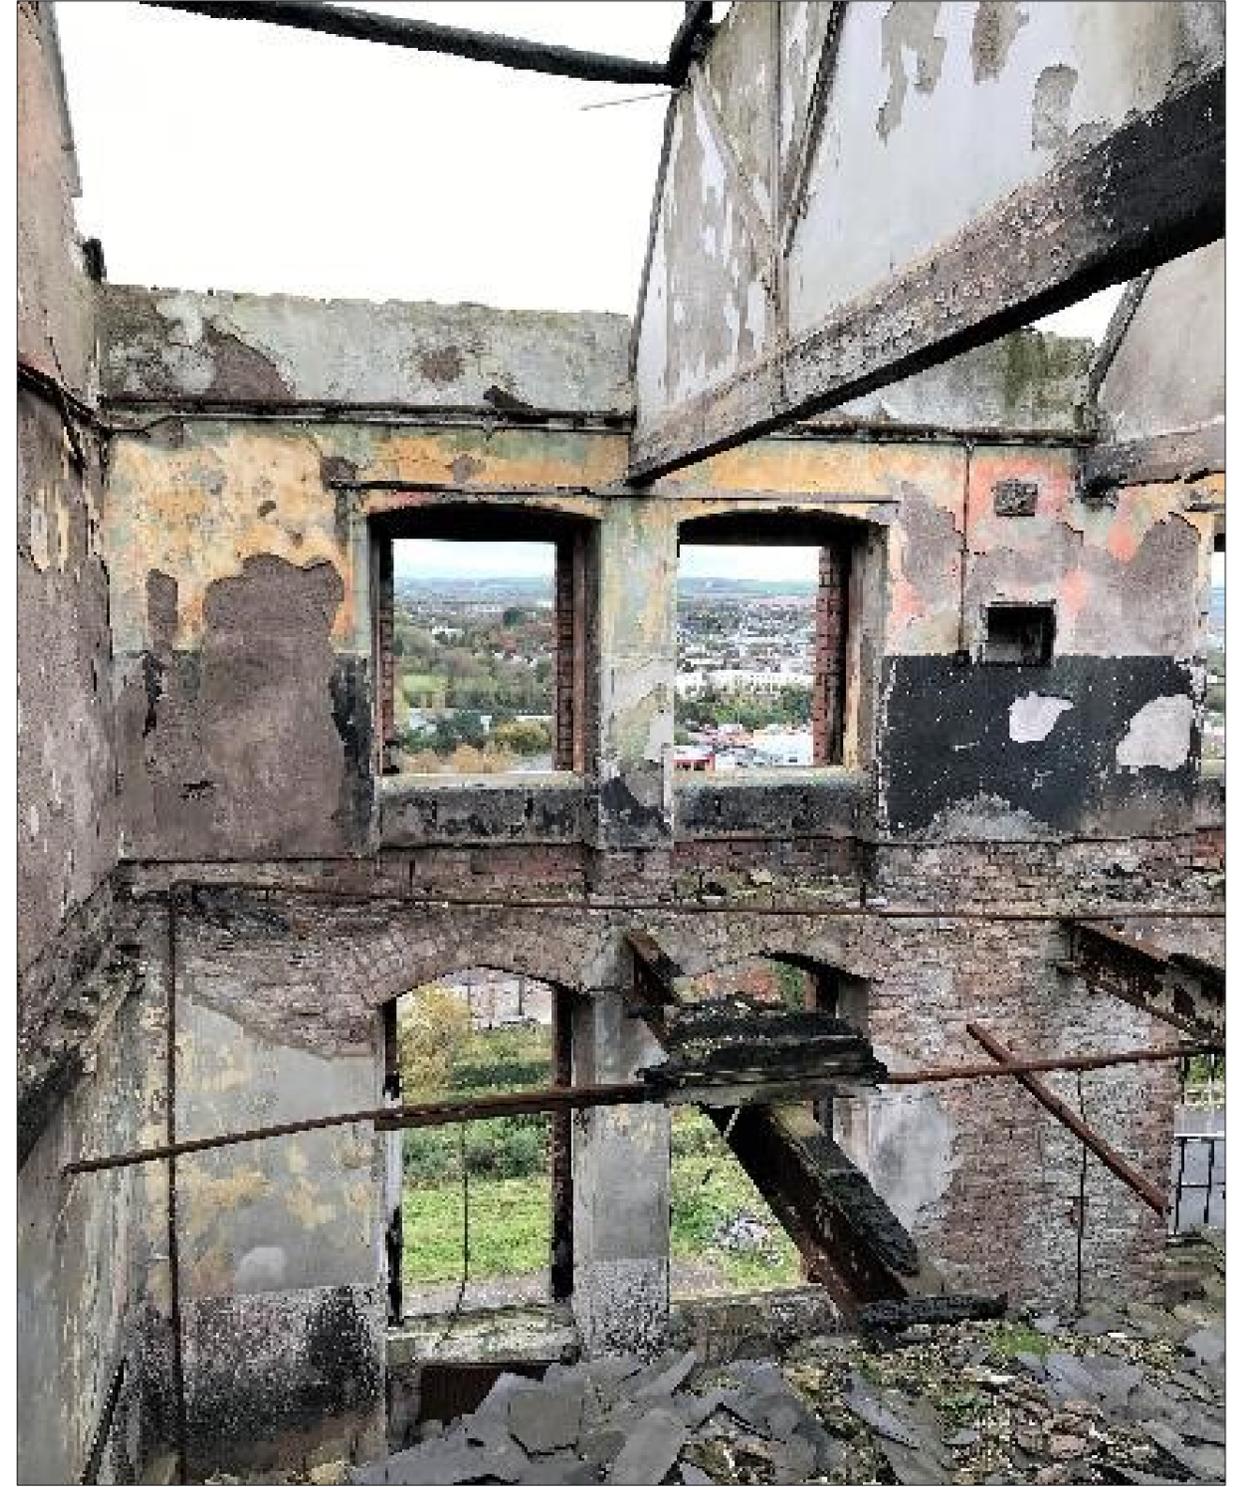
**Plate 55:** Relative lack of embedded timbers within existing building (note brick arched window heads and stone corbels for carrying floor joists) means that masonry walls are not compromised by decayed timber within their structure.

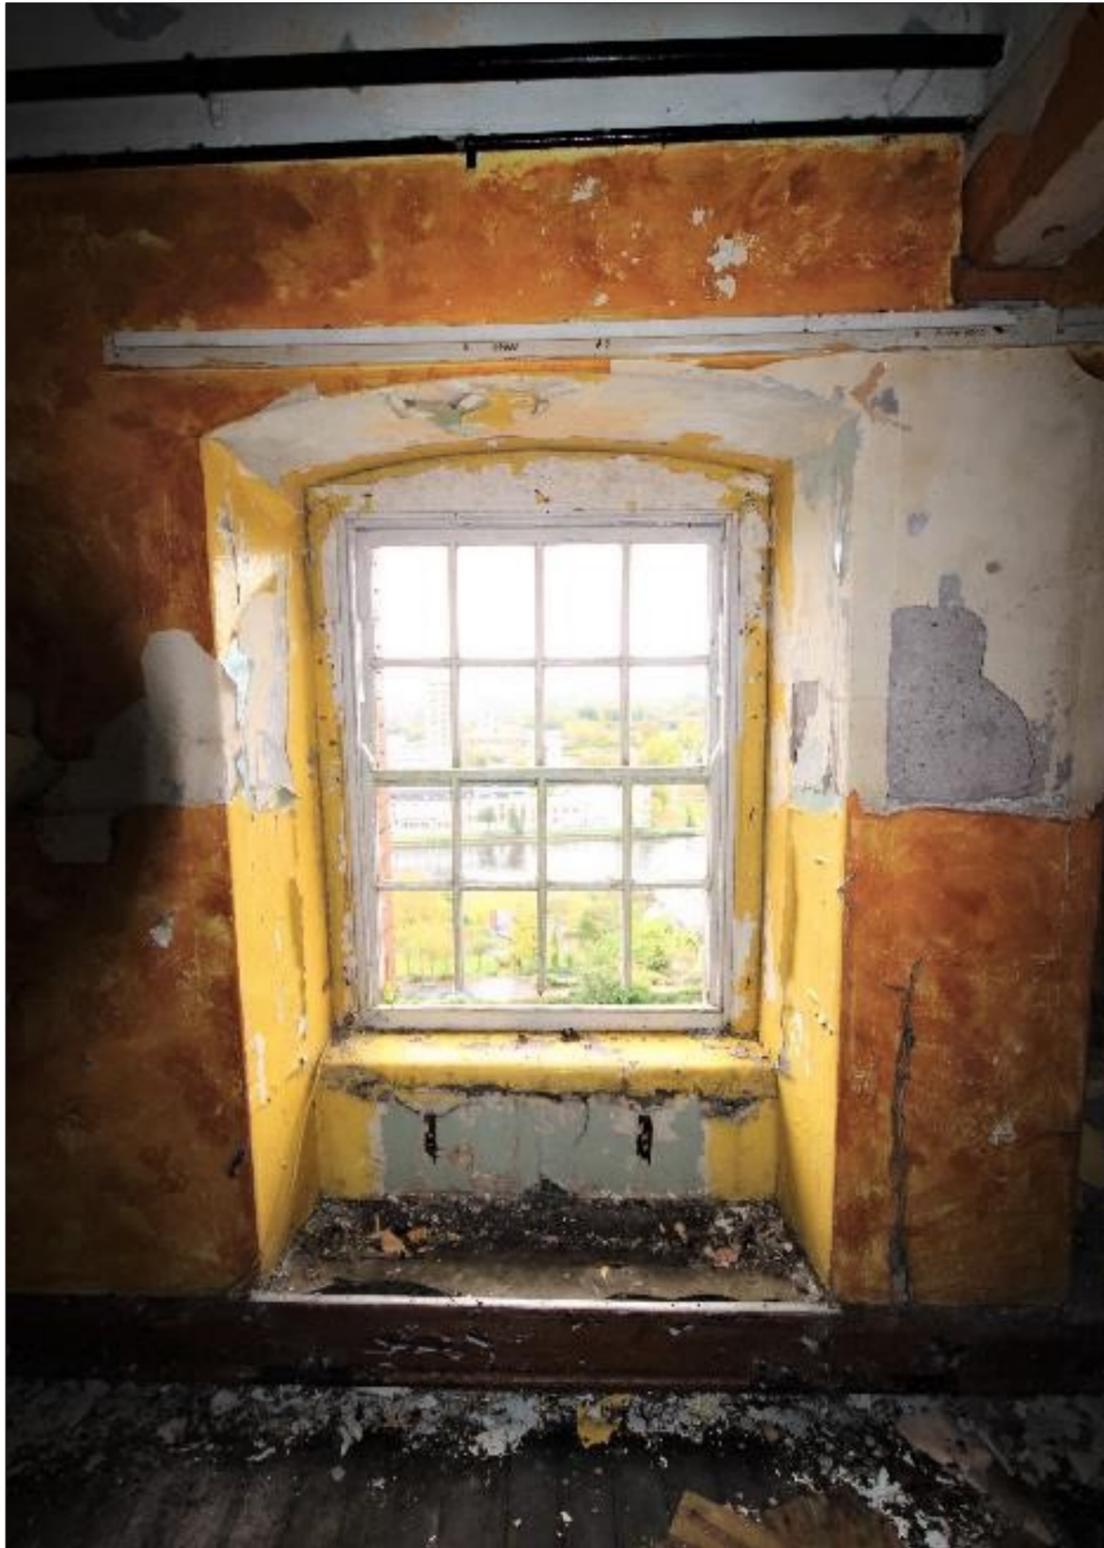
**Plate 56:** Surviving historic timber window within section of third floor-level inside former St Kevin's Hospital where fire damage did not extend in 2017. Bottom rail of this window has been lost but could be replicated and refitted by a, experienced conservation joiner.

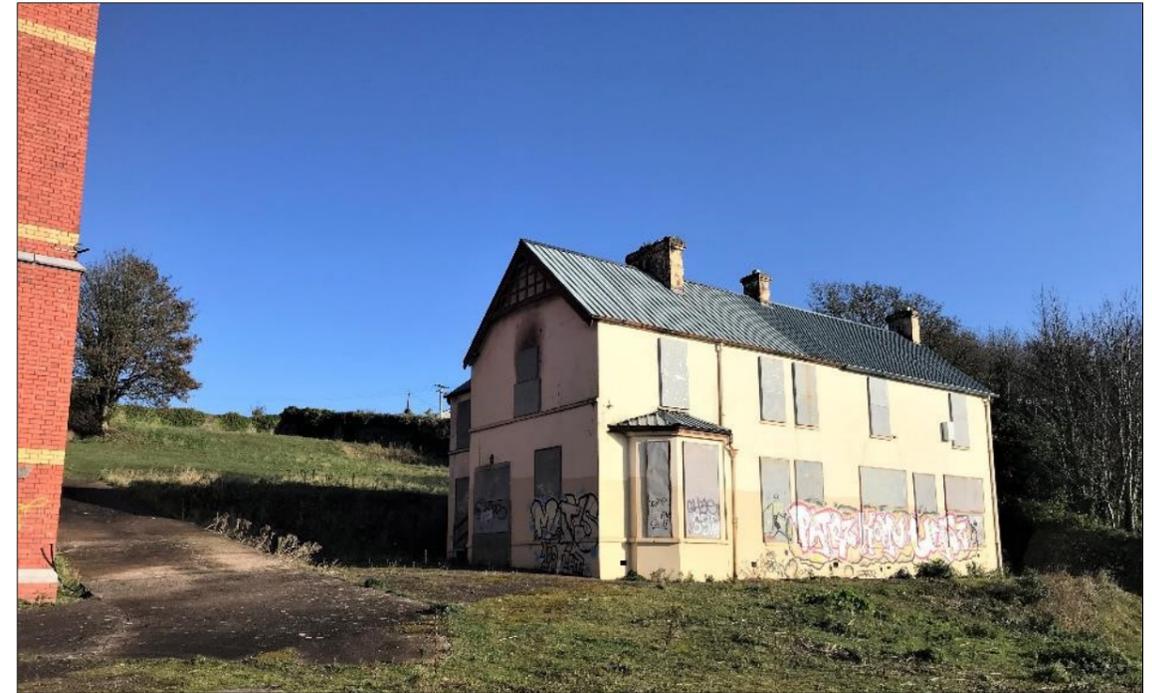
**Plate 57:** Fire-damaged former Doctors' residence associated with former St Kevin's Hospital. Removal of this structure has previously been granted planning permission by Cork City Council (ref. 18/37965).

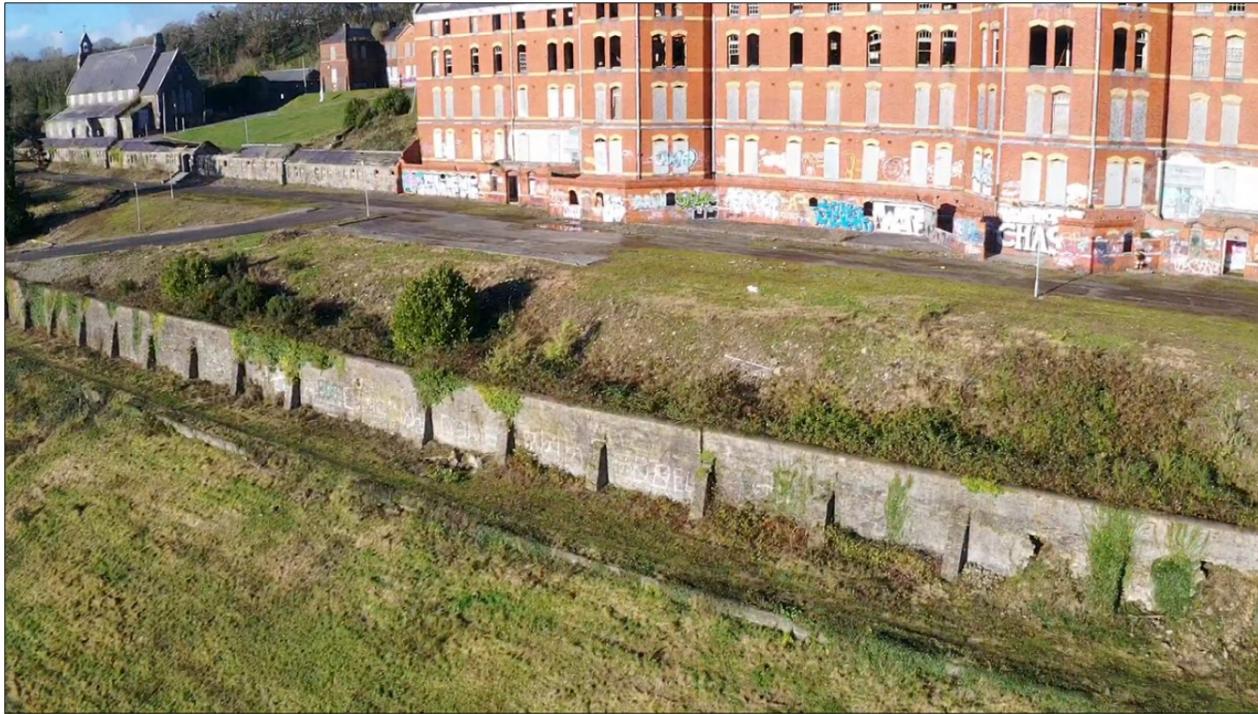
*Plate 59: Retaining wall to south of St. Kevin's Hospital – due to its dangerous structural condition*

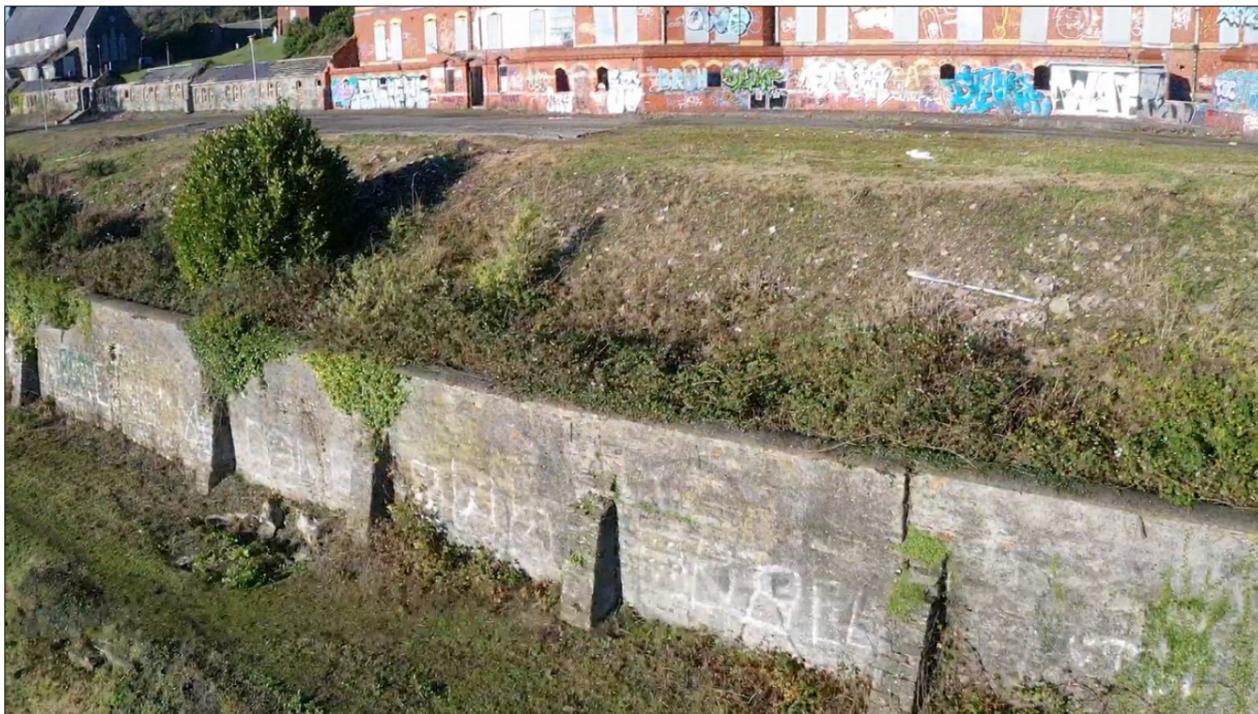
*Plate 60: Detail of central section of the buttressed retaining wall to south of St. Kevin' Hospital*

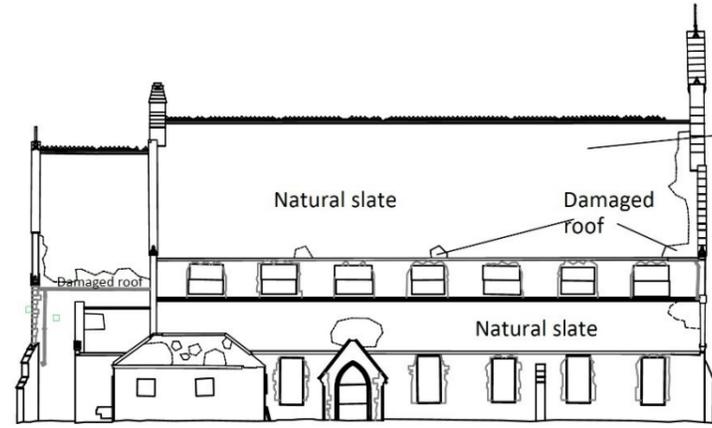
Northern elevation

Natural slate roof with crested terracotta ridge tiles, ashlar limestone coping and ashlar limestone bellcote. Sections of roof damaged and missing slates

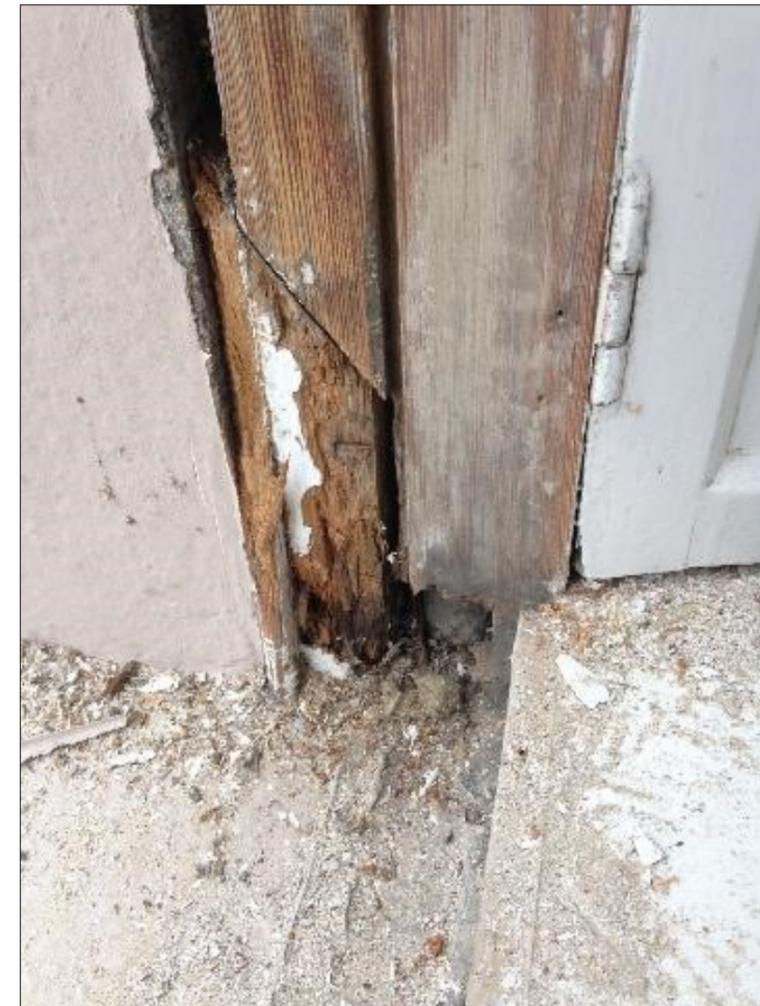
**Figure c):** Use of poor-quality modern softwood for repairs to historic pine window frames represents a poor standard of conservation where inferior-quality materials and techniques are being applied to superior-quality historic fabric. Only high-quality hardwood such as iroko should be used when matching modern repairs to historic first or second-generation Nordic softwood windows. Common repairs to lower parts of pulley-lining such as in the illustrated example should have saw-cut joints between original and inserted repair material sloping outward unlike the failed previous repair shown here

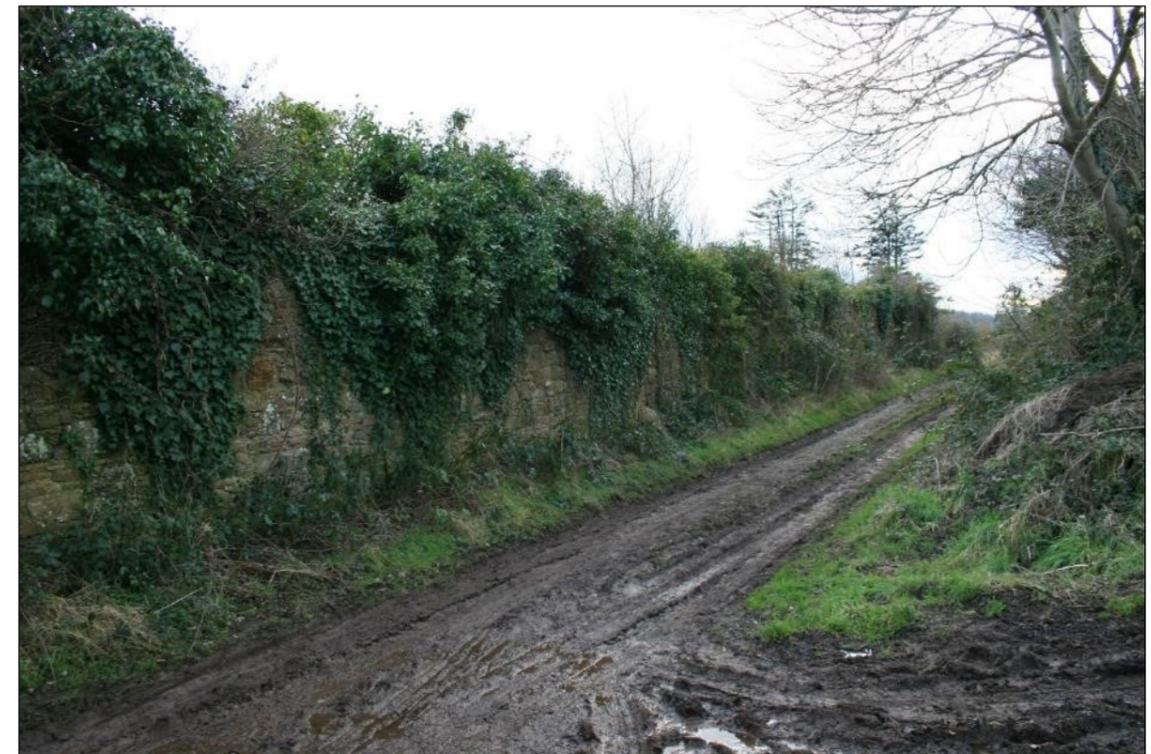
**Figure d):** *Overgrown historic masonry wall with heavy ivy growth and potentially trees rooted on structure. Growth needs to be trimmed back tight to masonry surface without touching stonework. Eventual removal of vegetation will require specialist masonry work which preparations must be made for before commencing*

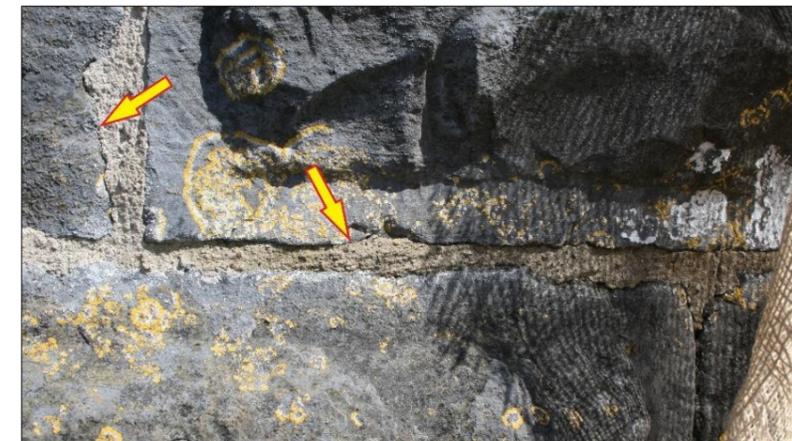
**Figure g):** Applying excessively wet pointing mortar in a shallow layer over an inadequately raked-out void, combined with insufficient damping of surrounding stone and a lack of subsequent protection leads to rapid drying of mortar with shrinkage cracks (arrowed) forming between mortar and stone.
