PROJECT: ST KEVIN'S STRATEGIC HOUSING DEVELOPMENT
AT THE FORMER ST. KEVIN'S HOSPITAL AND GROUNDS
SHANAKIEL
CORK

DOCUMENT TITLE: STRUCTURAL REPORT ON SOUTH RETAINING WALL
DOCUMENT NO: 19.305 – SR – 01

ST KEVIN'S STRATEGIC HOUSING DEVELOPMENT
AT THE FORMER ST. KEVIN'S HOSPITAL AND GROUNDS
SHANAKIEL
CORK
STRUCTURAL REPORT ON
SOUTH RETAINING WALL

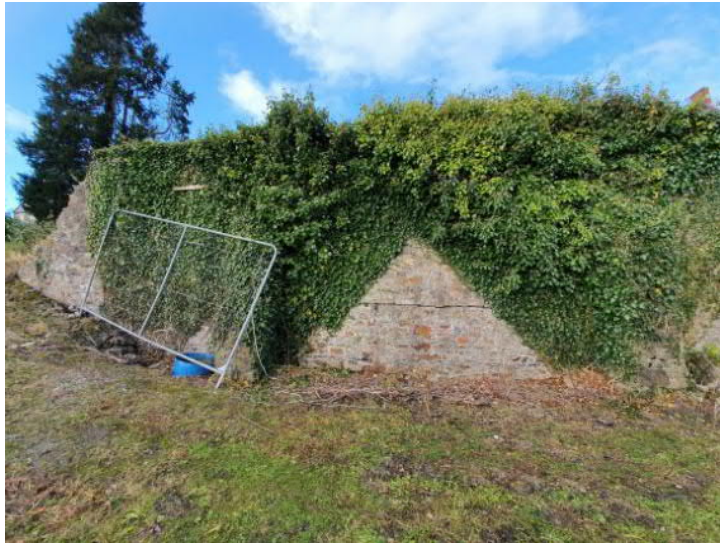
Photo 1- Buttress 1-2

Location	Photo Ref	Description of Defect
Buttresses 1-2	1	Significant horizontal crack approx. 1m from lower level. Small cracks emanating from this crack.
Buttresses 2-3	2	Significant horizontal crack approx. 1m from lower level. Open joints in buttress 3.
Buttresses 3-4	3	Overgrown with ivy. Some minor horizontal cracks..
Buttresses 4-5	4	Horizontal crack visible where not overgrown.
Buttresses 5-6	5	Buttresses need to be repointed. Minor diagonal crack.
Buttresses 6-7	6	Open joints in buttresses & Buddleia growth in buttress 6.
Buttresses 7-8	7	Open joints in buttresses. Minor Horizontal cracks
Buttresses 8-9	8	Significant horizontal crack approx. 1.5m from lower level. Open joints in buttress.
Buttresses 9-10	9	Collapsed section at top of buttress 9. Significant horizontal cracking.
Buttresses 10-11	10	Significant horizontal crack approx. 1.5m from lower level.
Buttresses 11-12	11	Buttress 12 has largely been removed- wall significantly weakened. Horizontal cracking.

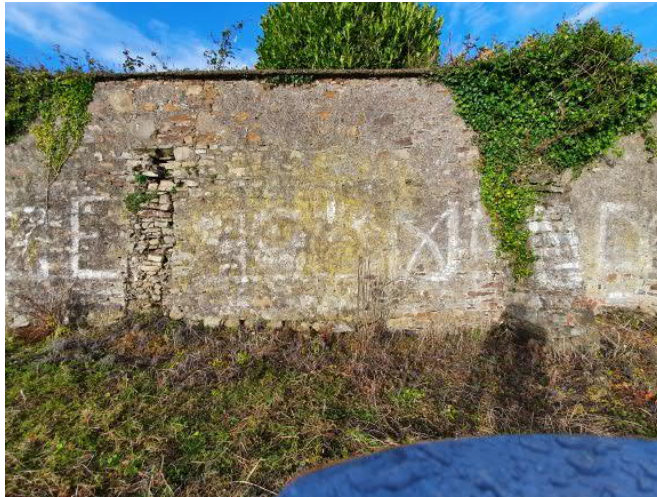
Photo 12- Buttress 12-13

Buttresses 12-13	12	As above - Buttress 12 has largely been removed- wall significantly weakened.
Buttresses 13-14	13	Vertical & horizontal cracking.
Buttresses 14-15	14	Top section of buttress 15 has fallen away.
Buttresses 15-16	15	Significant horizontal cracking approx. 1.5m from lower level.
Buttresses 16-17	16	Open joints in buttress 16
Buttresses 17-18	17	Top section of buttress 17 has fallen away.
Buttresses 18-19	18	Major failure of wall between buttresses with body of wall fallen away and earth behind wall exposed and coming through to lower level. Horizontal cracking on remaining section of wall.

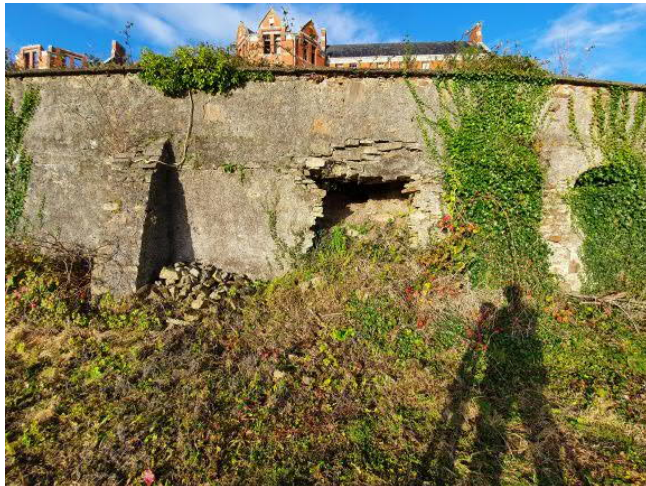
Photo 18- Buttress 18-19

There are several significant horizontal cracks evident between buttresses consistent with failure of the bed joints due to flexural stresses caused by overturning moments or possibly local shear failure due to horizontal forces. Particularly concerning is the areas between buttresses 18 to 20 where complete collapse of a section of the wall panel between buttresses has occurred and the retained earth has fallen through onto the lower level.

Given the inherent deficiencies in the wall and the history of sectional collapse it is the recommendation of this report that the wall should be demolished. There is, however, enough space to bank back the earth from the lower level at a safe slope of 1 vertical to 3 horizontal which is generally available. This removes the requirement for a retaining wall and provides a much more sustainable approach to the landscaping. It is the recommendation of this report, therefore, that the wall is demolished and the retained side is banked back at a safe angle so that no new retaining structure is required.

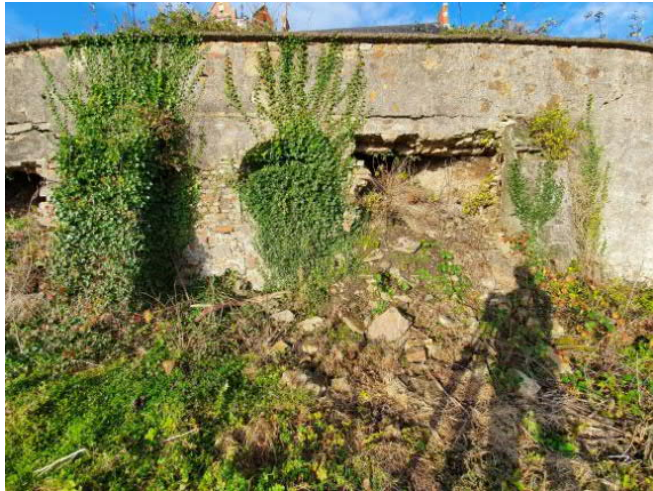
Photo 19- Buttress 19-20

Buttresses 19-20	19	Similar but more extensive failure of wall between buttresses with body of wall fallen away and earth behind wall exposed and coming through to lower level. Old formed opening in wall to left of collapsed section.
Buttresses 20	20	Diagonal crack near buttress 20. No other significant defects.
Buttresses 21	21	opes in wall to left hand side of buttress 21
Buttresses 21-22	22	Largely overgrown with ivy. No significant defects evident.
Buttresses 22-23	23	Two cavities visible where stone has fallen away.
Buttresses 23-24	24	Section of top of wall has fallen away over buttress 24
Buttresses 24-25	25	Same comment as for photo 24
Buttresses 25-26	26	Wall completely overgrown with ivy and mature tree adjacent to this section of wall.
