St. Kevin's Asylum, Cork - Ground Investigation

Report No.: 20-0105

Date: July 2020

Status: Final for Issue

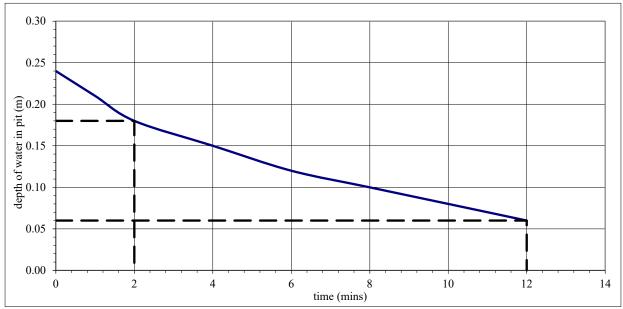
In infiltration tests carried out in trial pits IF01, IF02 and IF05, the rate of infiltration was calculated ranging from 0.071 - 0.690m/hr. The rates of infiltration coupled with the soil descriptions imply that the subsoil may be considered suitable media for an infiltration drainage system. In IF04 the pit was unable to be filled due to the water draining away too fast. This would indicate that the stratum is highly permeable.

depth to	depth of	time	volume of	Area of walls and		
time	water	water in pit	elapsed	water lost	base at 50% drop	q	q
(mins)	(m)	(m)	(mins)	(m ³)	(m^2)	(m/min)	(m/h)
2	0.52	0.18	10	0.04	0.50	7.1E-03	0.424
12	0.64	0.06	10	0.04	0.50	7.1E-U3	0.424

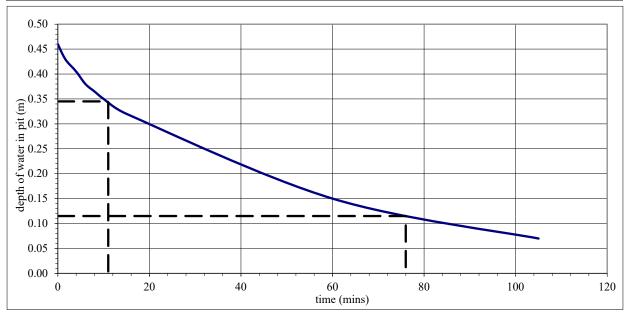
depth to	depth of	time	volume of	Area of walls and		
time	water	water in pit	elapsed	water lost	base at 50% drop	q	q
(mins)	(m)	(m)	(mins)	(m ³)	(m^2)	(m/min)	(m/h)
11	0.66	0.345	65	0.06	0.76	1.2E-03	0.071
76	0.89	0.115	03	0.06	0.76	1.2E-03	0.071

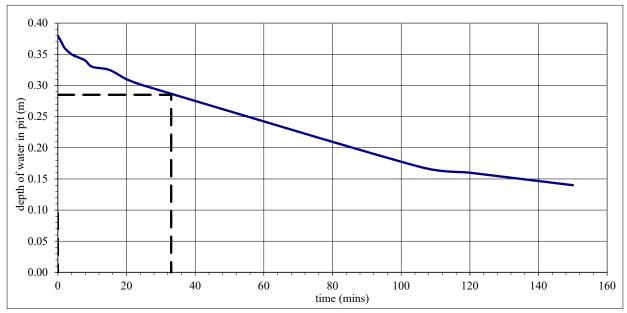
In IF03, the absence of the outflow from the pits precluded calculation of infiltration coefficients. The low-permeability soils are therefore considered to be poor infiltration media and would be deemed unsuitable for the implementation of infiltration drainage systems.

depth to	depth of	time	volume of	Area of walls and		
time	water	water in pit	elapsed	water lost	base at 50% drop	q	q
(mins)	(m)	(m)	(mins)	(m^3)	(m^2)	(m/min)	(m/h)
33	0.37	0.285					
	0.56	0.095

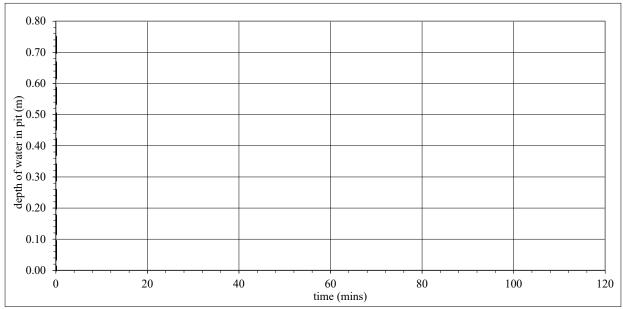
depth to	depth of	time	volume of	Area of walls and	_	
time	water	water in pit	elapsed	water lost	base at 50% drop	q	q
(mins)	(m)	(m)	(mins)	(m^3)	(m^2)	(m/min)	(m/h)
	0.25	0.75					
	0.75	0.25

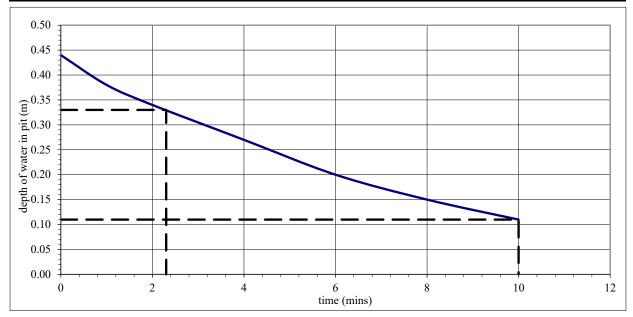
L								
I		depth to	depth of	time	volume of	Area of walls and		
	time	water	water in pit	elapsed	water lost	base at 50% drop	q	q
	(mins)	(m)	(m)	(mins)	(m ³)	(m^2)	(m/min)	(m/h)
	2.3	0.87	0.33	7.7	0.07	0.78	1.2E-02	0.690
ſ	10	1.09	0.11	7.7	0.07	0.76	1.ZE-UZ	0.090

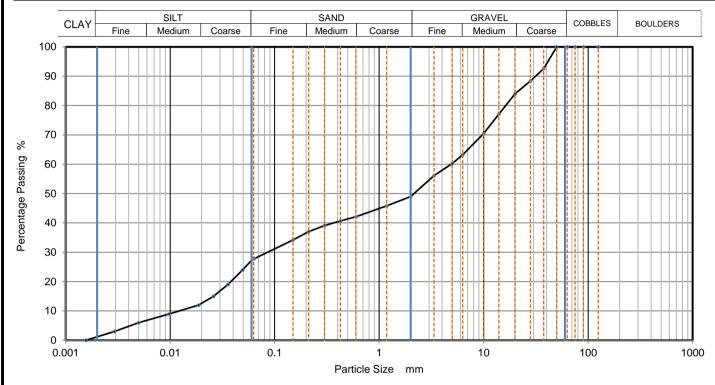
CAUSEWAY	DADT	PARTICLE SIZE DISTRIBUTION -			Job Ref	20-0105
——— GEOTECH	PANI				Borehole/Pit No.	вно6
Site Name	St. Kevin's Asylum, Co	it. Kevin's Asylum, Cork			Sample No.	2
Soil Description	Brown sandy gravelly SILT.			Depth, m	1.20	
Specimen Reference	6 Specimen 1.2 m			Sample Type	В	
Test Method	BS1377:Part 2:1990, clau	uses 9.2 and 9.5			KeyLAB ID	Caus2020031124

Siev	ving	Sedime	entation
Particle Size mm	% Passing	Particle Size mm	% Passing
125	100	0.06300	28
90	100	0.04939	24
75	100	0.03581	19
63	100	0.02594	15
50	100	0.01866	12
37.5	93	0.00980	9
28	88	0.00498	6
20	84	0.00292	3
14	77	0.00156	0
10	71		
6.3	63		
5	60		
3.35	56		
2	49		
1.18	46		
0.6	42	Particle density	(assumed)
0.425	41	2.65	Mg/m3
0.3	39		
0.212	37		
0.15	34		
0.063	28

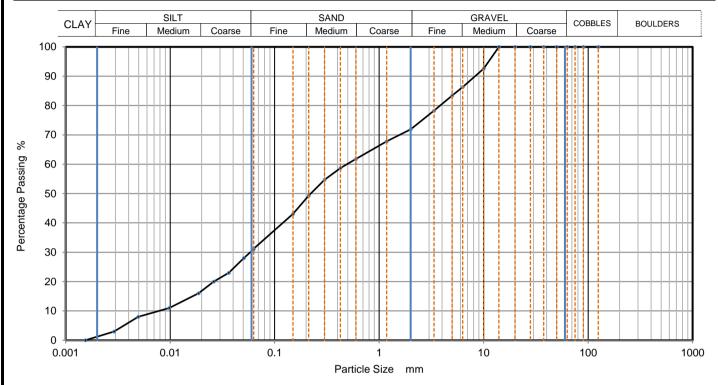
CAUSEWAY	DART	PARTICLE SIZE DISTRIBUTION -			Job Ref	20-0105
—— деотесн	PARII				Borehole/Pit No.	вно6
Site Name	St. Kevin's Asylum, Co	it. Kevin's Asylum, Cork			Sample No.	3
Soil Description	Brown sandy gravelly SILT.			Depth, m	2.00	
Specimen Reference	6	6 Specimen 2 m			Sample Type	В
Test Method	BS1377:Part 2:1990, clau	ses 9.2 and 9.5			KeyLAB ID	Caus2020031125

Sie	ving	Sedime	entation
Particle Size mm	% Passing	Particle Size mm	% Passing
125	100	0.06300	31
90	100	0.05066	28
75	100	0.03647	23
63	100	0.02609	20
50	100	0.01866	16
37.5	100	0.00980	11
28	100	0.00495	8
20	100	0.00291	3
14	100	0.00154	0
10	93		
6.3	86		
5	83		
3.35	78		
2	72		
1.18	68		
0.6	62	Particle density	(assumed)
0.425	59	2.65	Mg/m3
0.3	55		
0.212	49		
0.15	43		
0.063	31

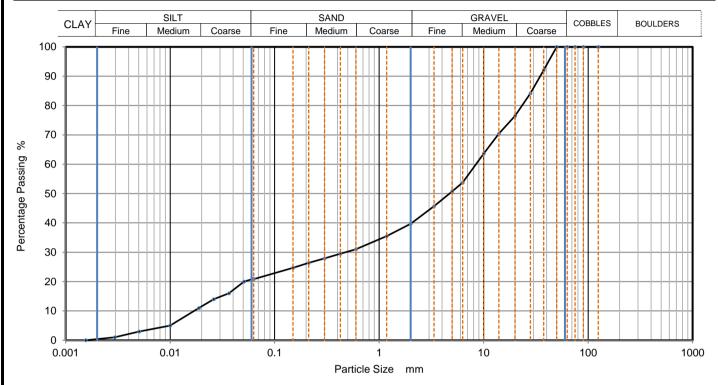
CAUSEWAY PARTICI F SIZE			ISTRIBUTION		Job Ref	20-0105
—— GEOTECH	PANI	PARTICLE SIZE DISTRIBUTION -			Borehole/Pit No.	внов
Site Name	St. Kevin's Asylum, Co	t. Kevin's Asylum, Cork			Sample No.	2
Soil Description	Brown sandy gravelly silty CLAY.			Depth, m	1.20	
Specimen Reference	6 Specimen 1.2 m			Sample Type	В	
Test Method	BS1377:Part 2:1990, cla	uses 9.2 and 9.5		·	KeyLAB ID	Caus2020031126

Sie	ving	Sedime	entation
Particle Size mm	% Passing	Particle Size mm	% Passing
125	100	0.06300	21
90	100	0.05084	20
75	100	0.03660	16
63	100	0.02618	14
50	100	0.01883	11
37.5	92	0.00999	5
28	84	0.00505	3
20	77	0.00294	1
14	70	0.00156	0
10	64		
6.3	54		
5	51		
3.35	46		
2	40		
1.18	36		
0.6	31	Particle density	(assumed)
0.425	30	2.65	Mg/m3
0.3	28		
0.212	26		
0.15	25		
0.063	21

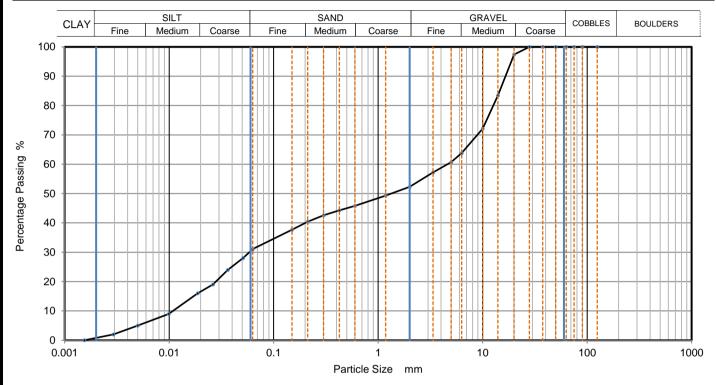
CAUSEWAY	PARTICLE SIZE DISTRIBUTION -		Job Ref	20-0105
—— GEOTECH			Borehole/Pit No.	внов
Site Name	St. Kevin's Asylum, Cork		Sample No.	3
Soil Description	Brown sandy gravelly silty CLAY.		Depth, m	2.00
Specimen Reference	6 Specimen 2 m Depth		Sample Type	В
Test Method	BS1377:Part 2:1990, clauses 9.2 and 9.5		KeyLAB ID	Caus2020031127

Sieving		Sedimentation		
Particle Size mm	% Passing	Particle Size mm	% Passing	
125	100	0.06300	31	
90	100	0.05097	28	
75	100	0.03647	24	
63	100	0.02624	19	
50	100	0.01877	16	
37.5	100	0.00991	9	
28	100	0.00501	5	
20	97	0.00292	2	
14	83	0.00154	0	
10	72			
6.3	64			
5	61			
3.35	57			
2	52			
1.18	49			
0.6	46	Particle density	(assumed)	
0.425	44	2.65	Mg/m3	
0.3	43			
0.212	40			
0.15	38			
0.063	31

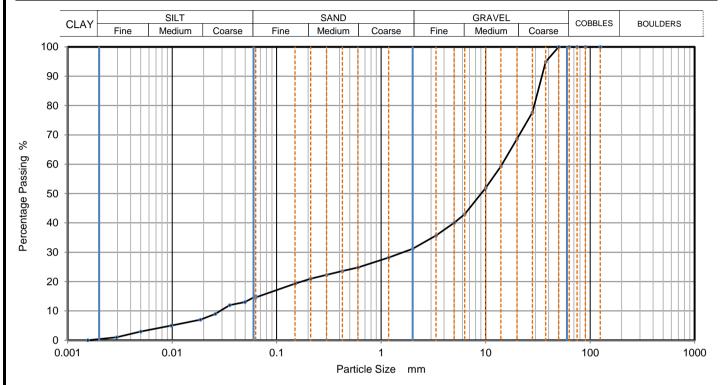
CAUSEWAY	PARTICLE SIZE DISTRIBUTION -		Job Ref	20-0105
—— GEOTECH			Borehole/Pit No.	вн09
Site Name	St. Kevin's Asylum, Cork		Sample No.	2
Soil Description	Brown sandy gravelly silty CLAY.		Depth, m	1.20
Specimen Reference	6 Specimen 1.2 m		Sample Type	В
Test Method	BS1377:Part 2:1990, clauses 9.2 and 9.5		KeyLAB ID	Caus2020031128

Sieving		Sedime	entation
Particle Size mm	% Passing	Particle Size mm	% Passing
125	100	0.06300	15
90	100	0.04958	13
75	100	0.03551	12
63	100	0.02588	9
50	100	0.01862	7
37.5	95	0.00978	5
28	78	0.00499	3
20	69	0.00293	1
14	59	0.00156	0
10	52		
6.3	43		
5	40		
3.35	36		
2	31		
1.18	28		
0.6	25	Particle density	(assumed)
0.425	24	2.65	Mg/m3
0.3	22		
0.212	21		
0.15	19		
0.063	15

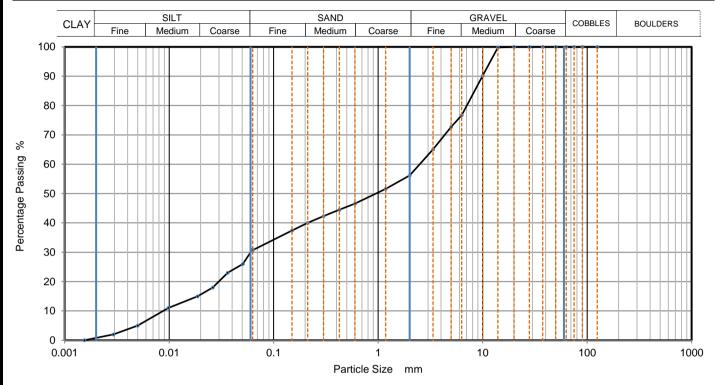
CAUSEWAY	PARTICLE SIZE DISTRIBUTION -			Job Ref	20-0105	
——— GEOTECH	PANI	PARTICLE SIZE DISTRIBUTION			Borehole/Pit No.	BH10
Site Name	St. Kevin's Asylum, Co	St. Kevin's Asylum, Cork			Sample No.	3
Soil Description	Brown sandy gravelly silty CLAY.			Depth, m	2.00	
Specimen Reference	6 Specimen 2 m			Sample Type	В	
Test Method	BS1377:Part 2:1990, clauses 9.2 and 9.5			KeyLAB ID	Caus2020031129

Sieving		Sedimentation		
Particle Size mm	% Passing	Particle Size mm	% Passing	
125	100	0.06300	31	
90	100	0.05066	26	
75	100	0.03626	23	
63	100	0.02609	18	
50	100	0.01866	15	
37.5	100	0.00980	11	
28	100	0.00501	5	
20	100	0.00292	2	
14	100	0.00154	0	
10	90			
6.3	77			
5	73			
3.35	65			
2	56			
1.18	52			
0.6	47	Particle density	(assumed)	
0.425	45	2.65	Mg/m3	
0.3	42			
0.212	40			
0.15	37			
0.063	31

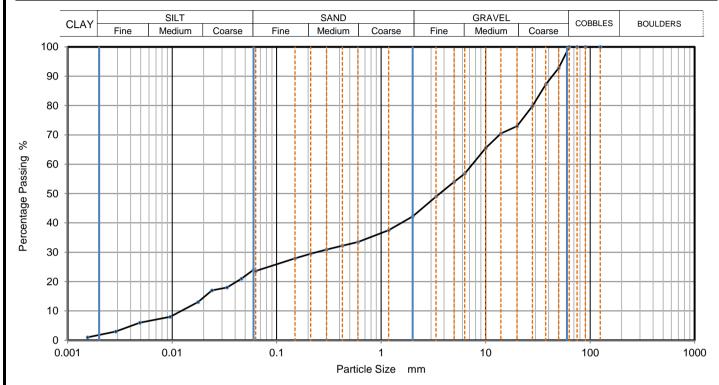
CAUSEWAY	PARTICLE SIZE DISTRIBUTION -			Job Ref	20-0105	
—— GEOTECH	PANII	PARTICLE SIZE DISTRIBUTION			Borehole/Pit No.	TP01
Site Name	St. Kevin's Asylum, Co	St. Kevin's Asylum, Cork			Sample No.	3
Soil Description	Brown sandy gravelly silty CLAY.			Depth, m	0.40	
Specimen Reference	2 Specimen 0.4 m			Sample Type	В	
Test Method	BS1377:Part 2:1990, clauses 9.2 and 9.5			KeyLAB ID	Caus2020031130

Sieving		Sedim	entation
Particle Size mm	% Passing	Particle Size mm	% Passing
125	100	0.05994	24
90	100	0.04596	21
75	100	0.03345	18
63	100	0.02398	17
50	93	0.01764	13
37.5	87	0.00956	8
28	80	0.00489	6
20	73	0.00288	3
14	71	0.00155	1
10	66		
6.3	57		
5	54		
3.35	49		
2	42		
1.18	38		
0.6	34	Particle density	(assumed)
0.425	32	2.65	Mg/m3
0.3	31		
0.212	30	7	
0.15	28	1	
0.063	24	7

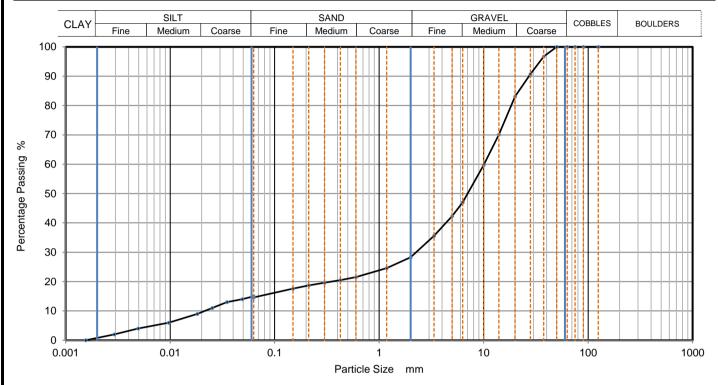
CAUSEWAY PARTICLE SIZE DISTRIBUTION -			Job Ref	20-0105		
—— GEOTECH	PARTICLE SIZE DISTRIBUTION			Borehole/Pit No.	TP03	
Site Name	St. Kevin's Asylum, Co	St. Kevin's Asylum, Cork			Sample No.	3
Soil Description	Brown slightly sandy silty subangular fine to coarse GRAVEL.			Depth, m	0.50	
Specimen Reference	2 Specimen 0.5 m			Sample Type	В	
Test Method	3S1377:Part 2:1990, clauses 9.2 and 9.5				KeyLAB ID	Caus2020031131

Sie	ving	Sedimentation			
Particle Size mm	% Passing	Particle Size mm	% Passing		
125	100	0.06300	15		
90	100	0.04894	14		
75	100	0.03506	13		
63	100	0.02526	11		
50	100	0.01819	9		
37.5	97	0.00967	6		
28	91	0.00494	4		
20	83	0.00291	2		
14	70	0.00156	0		
10	60				
6.3	47				
5	42				
3.35	36				
2	28				
1.18	25				
0.6	22	Particle density	(assumed)		
0.425	21	2.65	Mg/m3		
0.3	20				
0.212	19				
0.15	18				
0.063	15

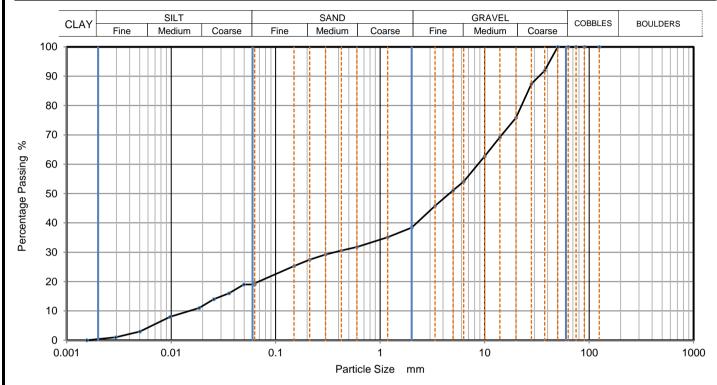
CAUSEWAY PARTICLE SIZE DISTRIBUTION -			Job Ref	20-0105		
—— GEOTECH	GEOTECH PARTICLE SIZE DISTRIBUTION			Borehole/Pit No.	TP05	
Site Name	St. Kevin's Asylum, Co	St. Kevin's Asylum, Cork			Sample No.	3
Soil Description	Brown sandy silty subangular fine to coarse GRAVEL.			Depth, m	1.50	
Specimen Reference	2 Specimen 1.5 m			Sample Type	В	
Test Method	3S1377:Part 2:1990, clauses 9.2 and 9.5			·	KeyLAB ID	Caus2020031132

Sie	ving	Sedimentation			
Particle Size mm	% Passing	Particle Size mm	% Passing		
125	100	0.06300	19		
90	100	0.04958	19		
75	100	0.03573	16		
63	100	0.02557	14		
50	100	0.01851	11		
37.5	92	0.00978	8		
28	87	0.00502	3		
20	76	0.00294	1		
14	69	0.00156	0		
10	63				
6.3	54				
5	51				
3.35	46				
2	38				
1.18	35				
0.6	32	Particle density	(assumed)		
0.425	31	2.65	Mg/m3		
0.3	29		_		
0.212	28				
0.15	25				
0.063	19

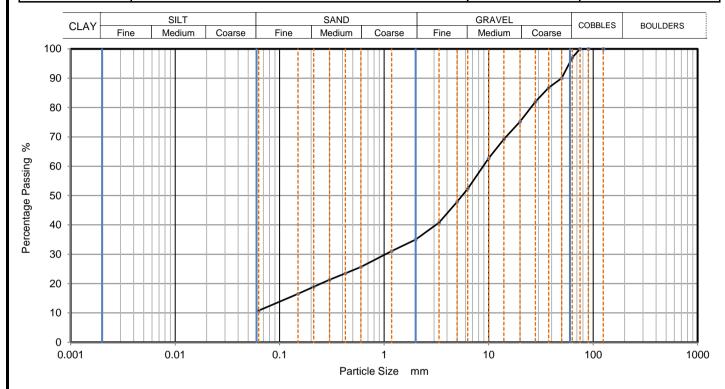
CAUSEWAY PARTICLE SIZE DISTRIBUTION			Job Ref	20-0105		
—— GEOTECH	GEOTECH PARTICLE SIZE DISTRIBUTION			Borehole/Pit No.	ТРО6	
Site Name	St. Kevin's Asylum, Cor	St. Kevin's Asylum, Cork			Sample No.	3
Soil Description	Brown sandy slightly silty subangular fine to coarse GRAVEL.			Depth, m	0.40	
Specimen Reference	2 Specimen 0.4 m			Sample Type	В	
Test Method	BS1377:Part 2:1990, clause 9.2			KeyLAB ID	Caus2020031133

Siev	ving	Sedime	ntation
Particle Size mm	% Passing	Particle Size mm	% Passing
125	100		
90	100		
75	100		
63	97		
50	90		
37.5	87		
28	82		
20	75		
14	69		
10	63		
6.3	52		
5	48		
3.35	41		
2	35		
1.18	31		
0.6	26		
0.425	24	1	
0.3	21		
0.212	19		
0.15	17		
0.063	11

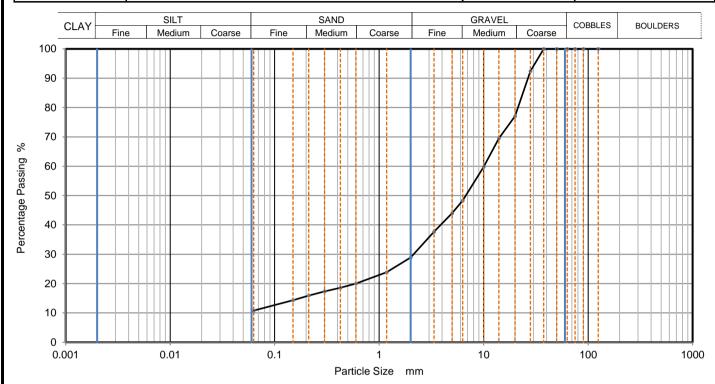
CAUSEWAY	DARTI	DARTICLE SIZE DISTRIBUTION		Job Ref	20-0105	
—— GEOTECH	PARTICLE SIZE DISTRIBUTION			Borehole/Pit No.	TP07	
Site Name	St. Kevin's Asylum, Cor	t. Kevin's Asylum, Cork			Sample No.	3
Soil Description	Brown sandy slightly silty subangular fine to coarse GRAVEL.			Depth, m	0.65	
Specimen Reference	2 Specimen 0.65 m		Sample Type	В		
Test Method	BS1377:Part 2:1990, clause 9.2			KeyLAB ID	Caus2020031134

Siev	/ing	Sedime	ntation
Particle Size mm	% Passing	Particle Size mm	% Passing
125	100		
90	100		
75	100		
63	100		
50	100		
37.5	100		
28	92		
20	77		
14	70		
10	60		
6.3	48		
5	44		
3.35	38		
2	29		
1.18	24		
0.6	20		
0.425	19		
0.3	17		
0.212	16		
0.15	14		
0.063	11

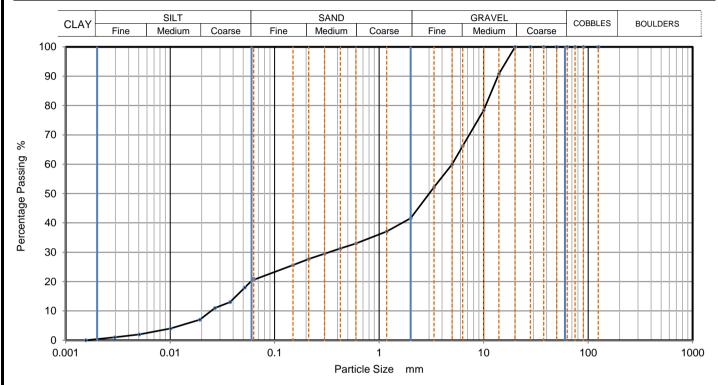
CAUSEWAY	DARTICI E CIZE DICTRIBUTIONI		Job Ref	20-0105		
—— GEOTECH	PARTICLE SIZE DISTRIBUTION			Borehole/Pit No.	TP11	
Site Name	St. Kevin's Asylum, Co	St. Kevin's Asylum, Cork			Sample No.	3
Soil Description	Brown sandy gravelly SILT.		Depth, m	1.50		
Specimen Reference	6 Specimen 1.5 m		Sample Type	В		
Test Method	BS1377:Part 2:1990, clauses 9.2 and 9.5			KeyLAB ID	Caus2020031135

Sieving		Sedime	entation
Particle Size mm	% Passing	Particle Size mm	% Passing
125	100	0.06300	21
90	100	0.05176	18
75	100	0.03745	13
63	100	0.02677	11
50	100	0.01924	7
37.5	100	0.01009	4
28	100	0.00507	2
20	100	0.00294	1
14	91	0.00156	0
10	78		
6.3	66		
5	60		
3.35	52		
2	42		
1.18	37		
0.6	33	Particle density	(assumed)
0.425	31	2.65	Mg/m3
0.3	30		
0.212	28		
0.15	26		
0.063	21

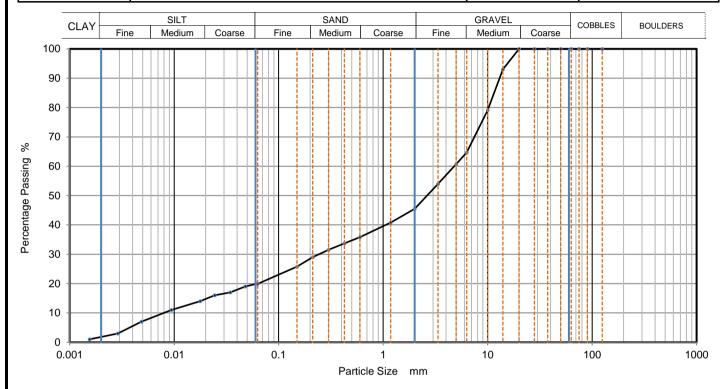
CAUSEWAY	PARTICLE SIZE DISTRIBUTION		Job Ref	20-0105		
—— GEOTECH	PARTICLE SIZE DISTRIBUTION			Borehole/Pit No.	TP12	
Site Name	St. Kevin's Asylum, Co	it. Kevin's Asylum, Cork			Sample No.	3
Soil Description	Brown sandy gravelly silty CLAY.			Depth, m	1.00	
Specimen Reference	2 Specimen 1 m			Sample Type	В	
Test Method BS1377:Part 2:1990, clauses 9.2 and 9.5			KeyLAB ID	Caus2020031136

Sievi	ng	Sedim	entation
Particle Size mm	% Passing	Particle Size mm	% Passing
125	100	0.06300	20
90	100	0.04797	19
75	100	0.03438	17
63	100	0.02447	16
50	100	0.01775	14
37.5	100	0.00939	11
28	100	0.00486	7
20	100	0.00288	3
14	93	0.00155	1
10	79		
6.3	65		
5	61		
3.35	54		
2	46		
1.18	41		
0.6	36	Particle density	(assumed)
0.425	34	2.65	Mg/m3
0.3	32		
0.212	29	1	
0.15	26	1	
0.063	20	7

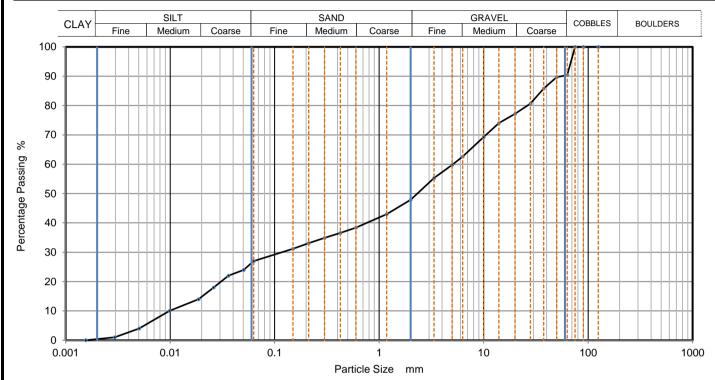
CAUSEWAY	DARTICI E CIZE DISTRIBUTIONI		Job Ref	20-0105		
——— GEOTECH	PANII	PARTICLE SIZE DISTRIBUTION -		Borehole/Pit No.	TP16	
Site Name	St. Kevin's Asylum, Cor	St. Kevin's Asylum, Cork			Sample No.	3
Soil Description	Brown sandy gravelly silty CLAY.			Depth, m	1.00	
Specimen Reference	2 Specimen 1 m Depth			Sample Type	В	
Test Method	BS1377:Part 2:1990, clauses 9.2 and 9.5				KeyLAB ID	Caus2020031137

Siev	/ing	Sedimo	entation
Particle Size mm	% Passing	Particle Size mm	% Passing
125	100	0.06300	27
90	100	0.05053	24
75	100	0.03616	22
63	90	0.02603	18
50	90	0.01872	14
37.5	86	0.00983	10
28	81	0.00505	4
20	77	0.00294	1
14	74	0.00156	0
10	69		
6.3	63		
5	60		
3.35	55		
2	48		
1.18	43		
0.6	38	Particle density	(assumed)
0.425	37	2.65	Mg/m3
0.3	35		
0.212	33		
0.15	31		
0.063	27

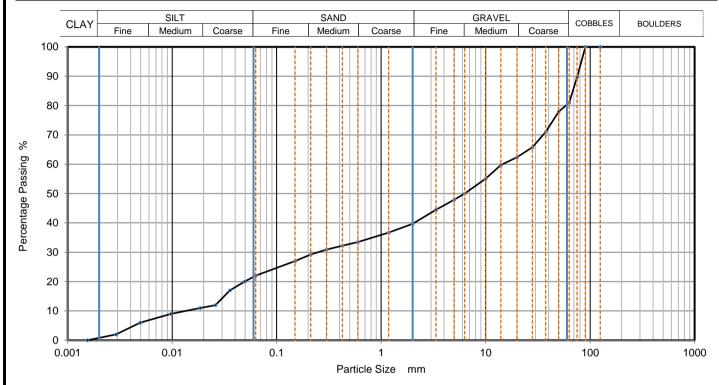
CAUSEWAY	DADT	CLE SIZE DIST	FDIRLITION		Job Ref	20-0105
——— GEOTECH	PANI		Borehole/Pit No.	TP17		
Site Name	St. Kevin's Asylum, Co	rk		Sample No.	3	
Soil Description	Brown sandy gravelly silt	y CLAY.		Depth, m	1.00	
Specimen Reference	2	Specimen Depth	1	Sample Type	В	
Test Method	BS1377:Part 2:1990, clau	uses 9.2 and 9.5		·	KeyLAB ID	Caus2020031138

Siev	/ing	Sedime	entation
Particle Size mm	% Passing	Particle Size mm	% Passing
125	100	0.06300	22
90	100	0.04940	20
75	90	0.03560	17
63	81	0.02594	12
50	78	0.01856	11
37.5	71	0.00969	9
28	66	0.00493	6
20	62	0.00291	2
14	60	0.00154	0
10	55		
6.3	50		
5	48		
3.35	45		
2	40		
1.18	37		
0.6	34	Particle density	(assumed)
0.425	32	2.65	Mg/m3
0.3	31		
0.212	29		
0.15	27		
0.063	22

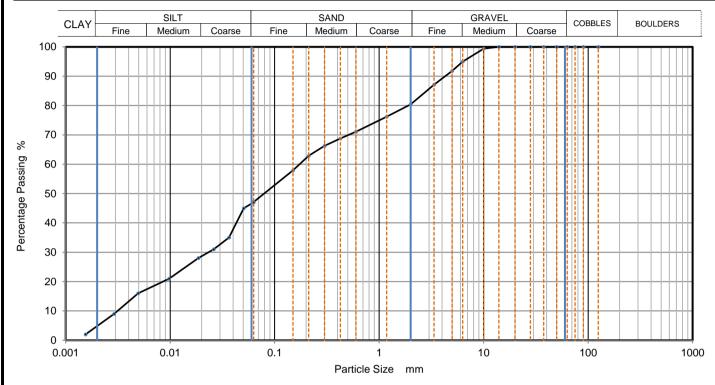
CAUSEWAY	DADT	CLE SIZE DIST	FDIRLITION		Job Ref	20-0105		
—— GEOTECH	PANI		Borehole/Pit No.	TP18				
Site Name	St. Kevin's Asylum, Co	rk		Sample No.	3			
Soil Description	Brown sandy gravelly silt	y CLAY.		Depth, m	1.00			
Specimen Reference	6	Specimen Depth	1	Sample Type	В			
Test Method	BS1377:Part 2:1990, clau	uses 9.2 and 9.5		·	KeyLAB ID	Caus2020031139

Sie	ving	Sedime	entation
Particle Size mm	% Passing	Particle Size mm	% Passing
125	100	0.06300	47
90	100	0.05053	45
75	100	0.03660	35
63	100	0.02618	31
50	100	0.01862	28
37.5	100	0.00978	21
28	100	0.00494	16
20	100	0.00290	9
14	100	0.00155	2
10	99		
6.3	95		
5	92		
3.35	87		
2	80		
1.18	76		
0.6	71	Particle density	(assumed)
0.425	69	2.65	Mg/m3
0.3	66		
0.212	63		
0.15	58		
0.063	47

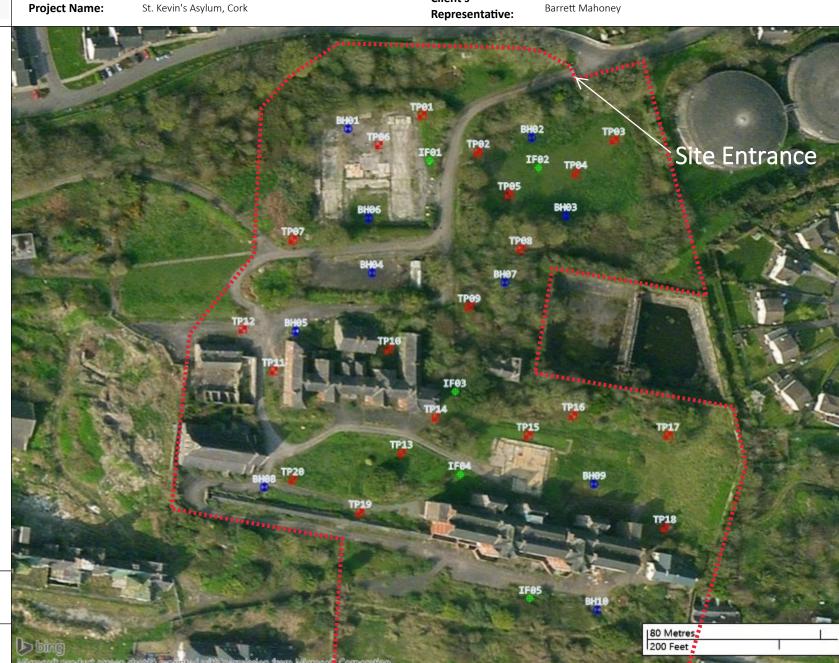
Exploratory Hole Location Plan

Locations By Type - Soakaway

Locations By Type - TP
