ASBESTOS REFURBISHMENT SURVEY REPORT

St Kevins, Chapel, Administration Block,
Farmyard, Workshop and Ground Slabs

Our Ladys

Land Development Agency

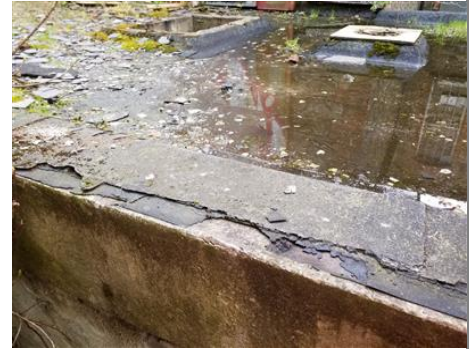
Location Details 375050 No Asbestos Found

Building/Area : Administration Block
Room/Section : Rear Oil Tank
Location : Roof
Description : Felts
Sample No. : AMB20200319007
Confirmation : Sample Taken
Access : Full Access
Normal Use :
Recommendations :

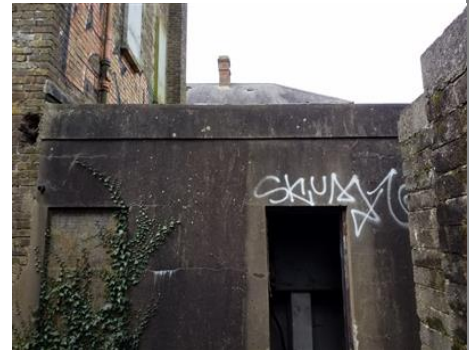
Location Details 375051 No Asbestos Found

Building/Area : Administration Block
Room/Section : Rear Boiler
Location : Roof
Description : Felts
Sample No. :
Confirmation : Sample Taken
Access : Full Access
Normal Use :
Recommendations :

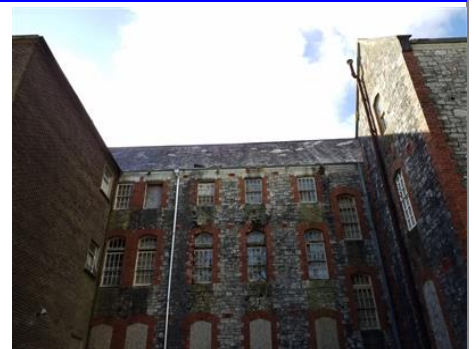
Location Details 372658 No Asbestos Found

Building/Area : St Kevin's
Room/Section : Roof
Location : Slates
Description : Natural and NT
Sample No. :
Confirmation : --N\A--
Access : Full Access
Normal Use :
Recommendations :

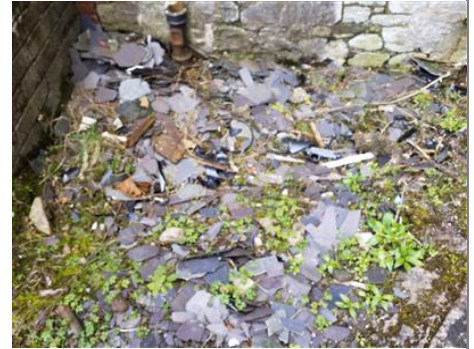
Location Details 372659 No Asbestos Found

Building/Area : St Kevin's
Room/Section : Roof
Location : Slates
Description : Natural and NT
Sample No. :
Confirmation : --N\A--
Access : Full Access
Normal Use :
Recommendations :

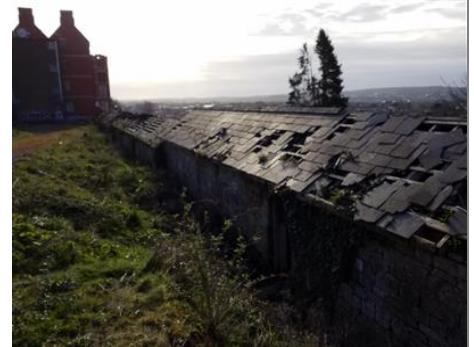
Location Details 375018 No Asbestos Found

Building/Area : Our Lady's
Room/Section : Tunnel/ Walkway
Location : Roof
Description : Natural Slates
Sample No. :
Confirmation : --N\A--
Access : Full Access
Normal Use :
Recommendations :

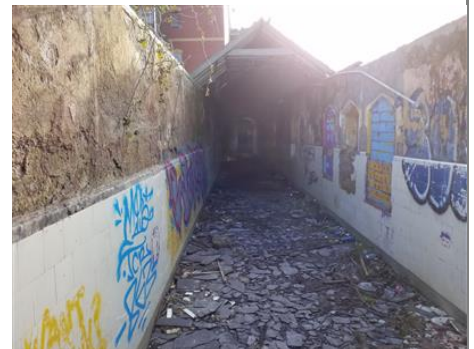
Location Details 375019 No Asbestos Found

Building/Area : Our Lady's
Room/Section : Tunnel/ Walkway
Location : Internal Walls
Description : Solid
Sample No. :
Confirmation : --N\A--
Access : Full Access
Normal Use :
Recommendations :

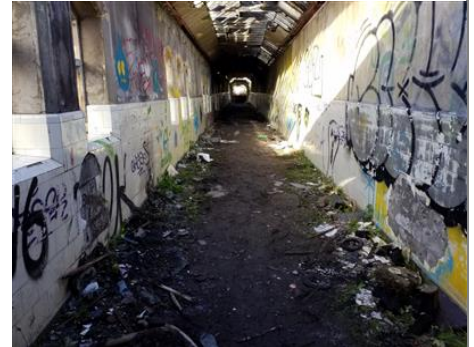
Location Details 375020 No Asbestos Found

Building/Area : Our Lady's
Room/Section : Tunnel/ Walkway
Location : Internal Walls
Description : Solid
Sample No. :
Confirmation : --N\A--
Access : Full Access
Normal Use :
Recommendations :

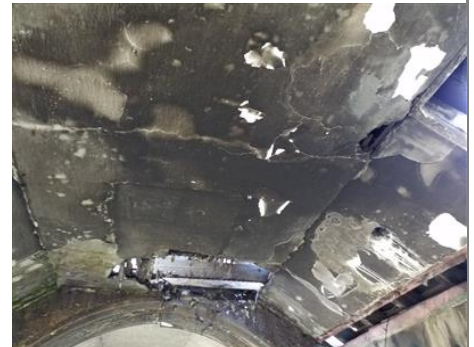
Location Details 375021 No Asbestos Found

Building/Area : Our Lady's
Room/Section : Tunnel/ Walkway
Location : Internal Ceiling
Description : lath and Plaster
Sample No. :
Confirmation : --N\A--
Access : Full Access
Normal Use :
Recommendations :

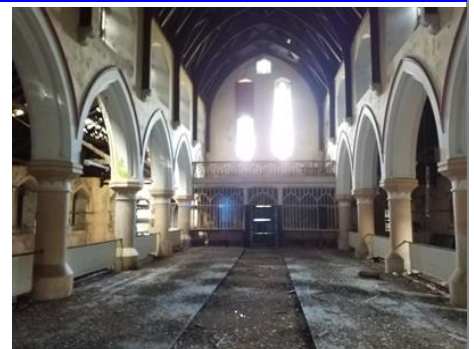
Location Details 375022 No Asbestos Found

Building/Area : Our Lady's
Room/Section : Church
Location : All Walls Floor and Ceiling
Description : Solid and Timber
Sample No. :
Confirmation : --N\A--
Access : Full Access
Normal Use :
Recommendations :

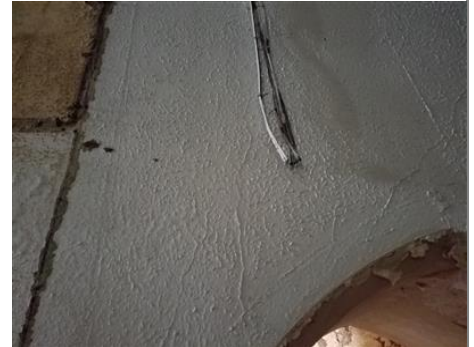
Location Details 375023 No Asbestos Found

Building/Area : Our Lady's
Room/Section : Chapel
Location : Alter
Description : Stipple
Sample No. : AMB20200319001
Confirmation : Sample Taken
Access : Full Access
Normal Use :
Recommendations :

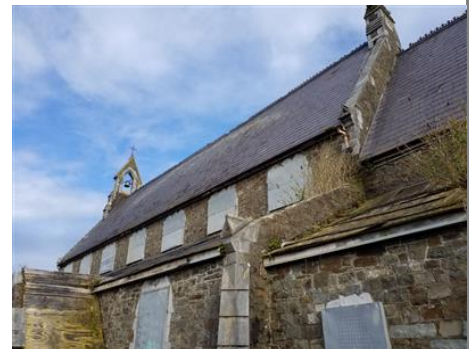
Location Details 375024 No Asbestos Found

Building/Area : Our Lady's
Room/Section : Chapel
Location : Roof
Description : Natural Slates
Sample No. :
Confirmation : --N\A--
Access : Full Access
Normal Use :
Recommendations :

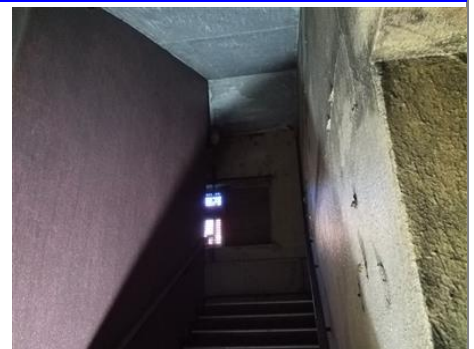
Location Details 372646 No Asbestos Found

Building/Area : St Kevin's
Room/Section : Side Entrance
Location : All Walls and Ceiling
Description : Solid
Sample No. :
Confirmation : --N\A--
Access : Full Access
Normal Use :
Recommendations :

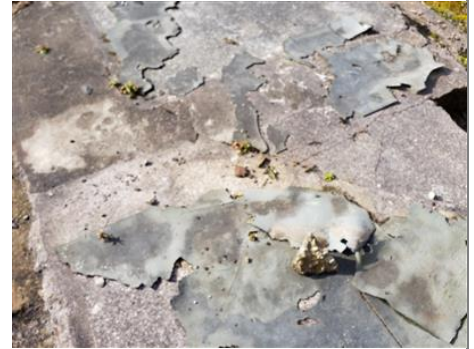
Location Details 375032 No Asbestos Found

Building/Area : Our Lady's
Room/Section : Entrance Demolished Building
Location : Floor Slab
Description : Lino on Solid
Sample No. :
Confirmation : --N\A--
Access : Full Access
Normal Use :
Recommendations :

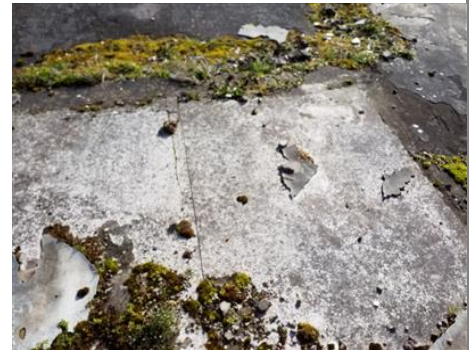
Location Details 375033 No Asbestos Found

Building/Area : Our Lady's
Room/Section : Entrance Demolished Building
Location : Floor Slab
Description : Lino on Solid
Sample No. :
Confirmation : --N\A--
Access : Full Access
Normal Use :
Recommendations :

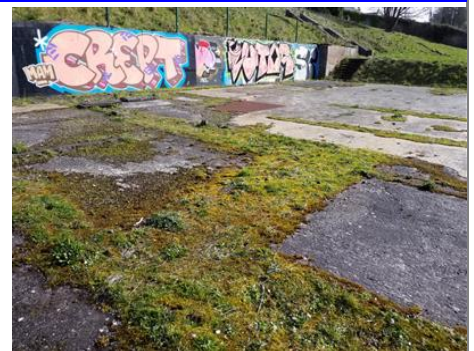
Location Details 375034 No Asbestos Found

Building/Area : Our Lady's
Room/Section : St Kevins Demolished Building
Location : Floor Slab
Description : Ceramic on Solid
Sample No. :
Confirmation : --N\A--
Access : Full Access
Normal Use :
Recommendations :

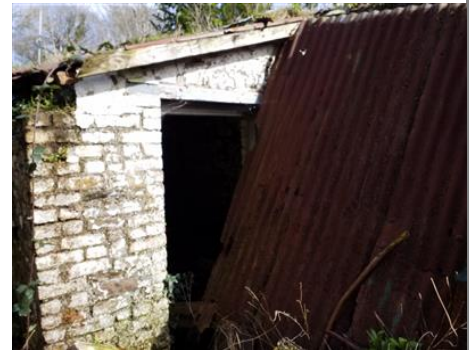
Location Details 375041 No Asbestos Found

Building/Area : Administration Block
 Room/Section : Rear Sheds
 Location : All Walls Floor and Ceiling
 Description : Solid and Metal
 Sample No. :
 Confirmation : --N\A--
 Access : Full Access
 Normal Use :
 Recommendations :
 ;

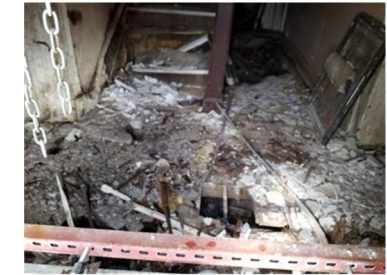
Administration Block internal
