**Architectural Heritage Impact Assessment  
(incorporating conservation survey)**

**St Kevin's Strategic Housing Development, Shanakiel, Cork City**

**December 2020**

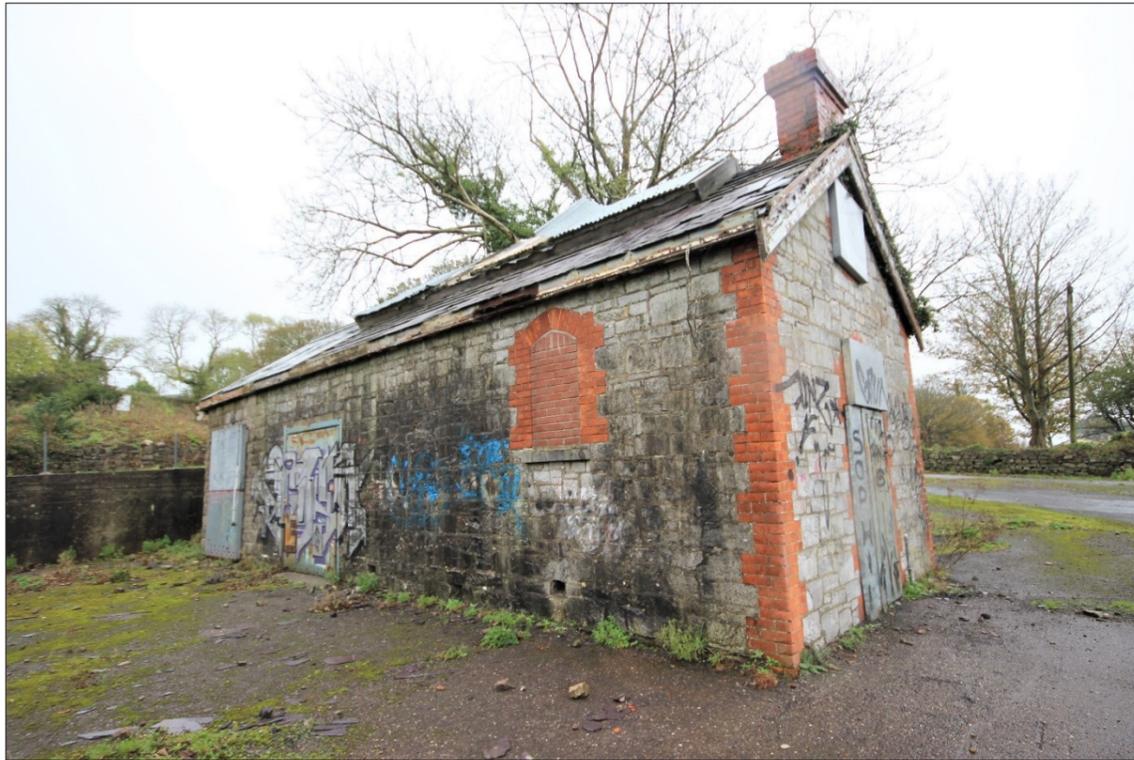
Figure 10: Former mortuary building

This consists of a derelict, small late nineteenth-century building with later extension to the northern end, overgrown with ivy on east elevation. Extensive loss of slate cladding from roof but otherwise limestone structure with brick dressings appears relatively sound. Associated buildings to west no longer extant. **The building is of limited architectural or historical interest but of some social interest.**

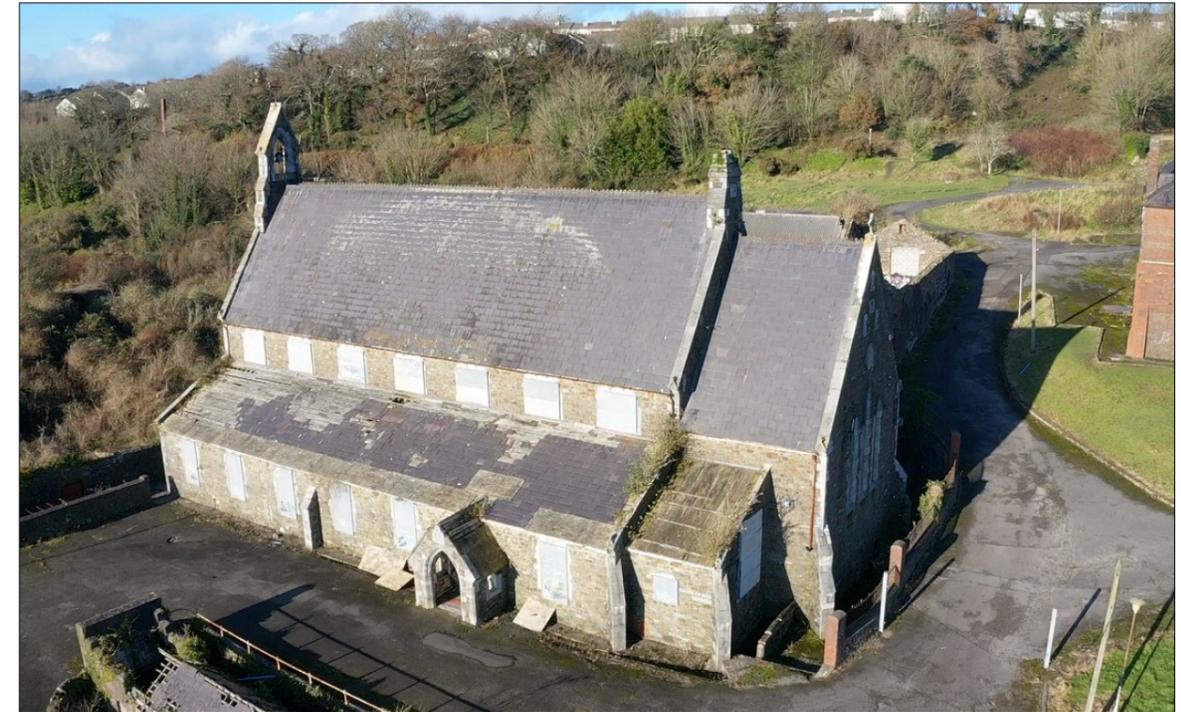
Figure 16: Recent aerial photograph of the former chapel

Rubble sandstone former chapel building with punch-finished limestone dressings and slate roofs which are generally in good condition notwithstanding extensive vegetation becoming established on structure which will accelerate its decay and dereliction unless redevelopment and refurbishment occurs in the medium term. South façade of chapel along with main St Kevin's façade forms significant feature of views from Carrigrohane roadway and O'Neill Crowley Bridge to south-east. Simple interior has plain plaster decoration and limited internal fabric of significance but appears to be of generally sound condition. **This is a building of architectural and historical significance with certain artistic and social interest.** The building is to be retained and converted to provide a new Office Enterprise Centre.

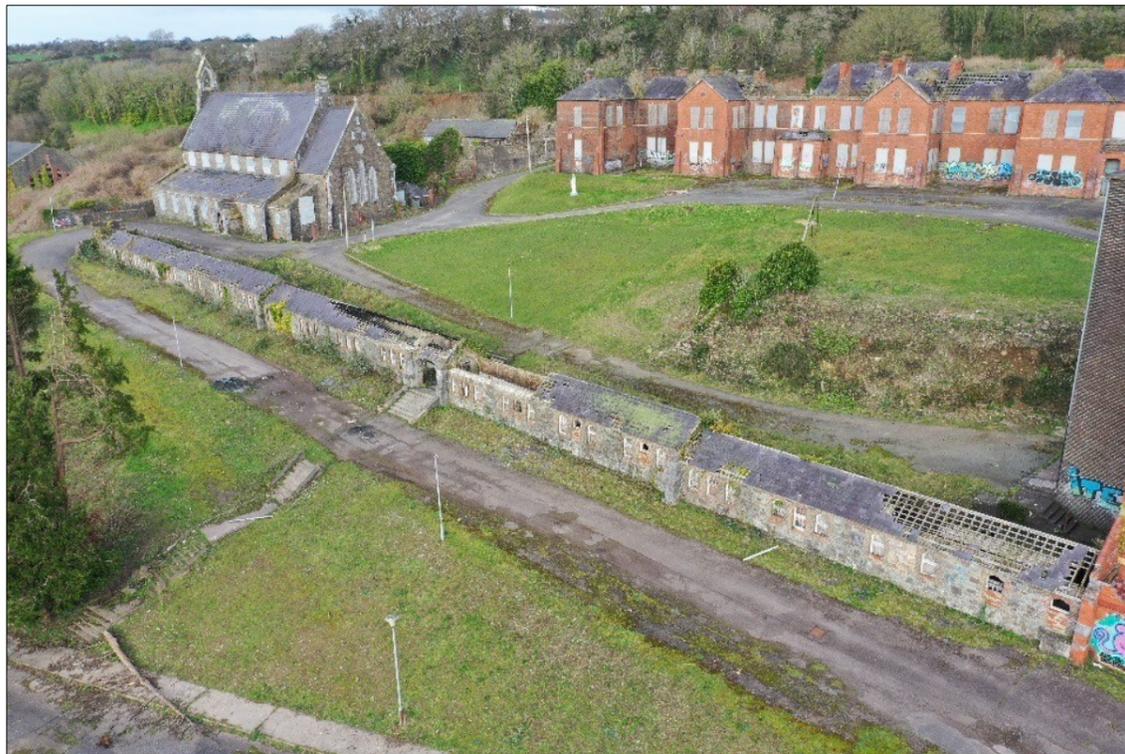
There are no features of particular note within this structure's interior and it forms a very minor part of the main façade of the site visible from areas to the south. Though recorded by the NIAH as having architectural and social interest, much of its significance has diminished due to the demolition/removal of the continuation of the corridor with the remainder of the Our Lady's campus to the west. Furthermore, the fabric and structure of the corridor within the present site has become greatly compromised in recent years. Due both to its limited plan adaptability and its deteriorated condition, it has limited scope for reuse. However, in an acknowledgement of its former function and role, the footprint of the majority of the corridor is to be retained as a landscape feature within the proposed scheme and the central archway is to be retained and reroofed.

Figure 18: Aerial view of the link corridor

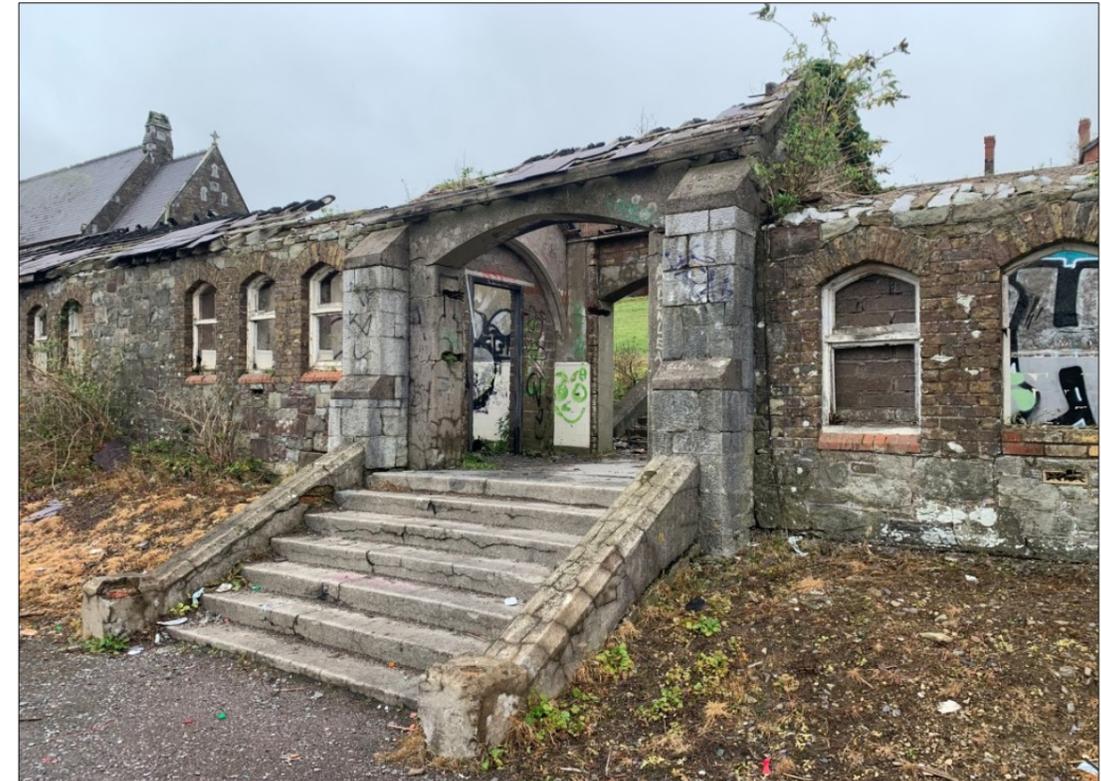
Figure 19: Central opening in the link corridor – this buttressed opening is to be retained and made good

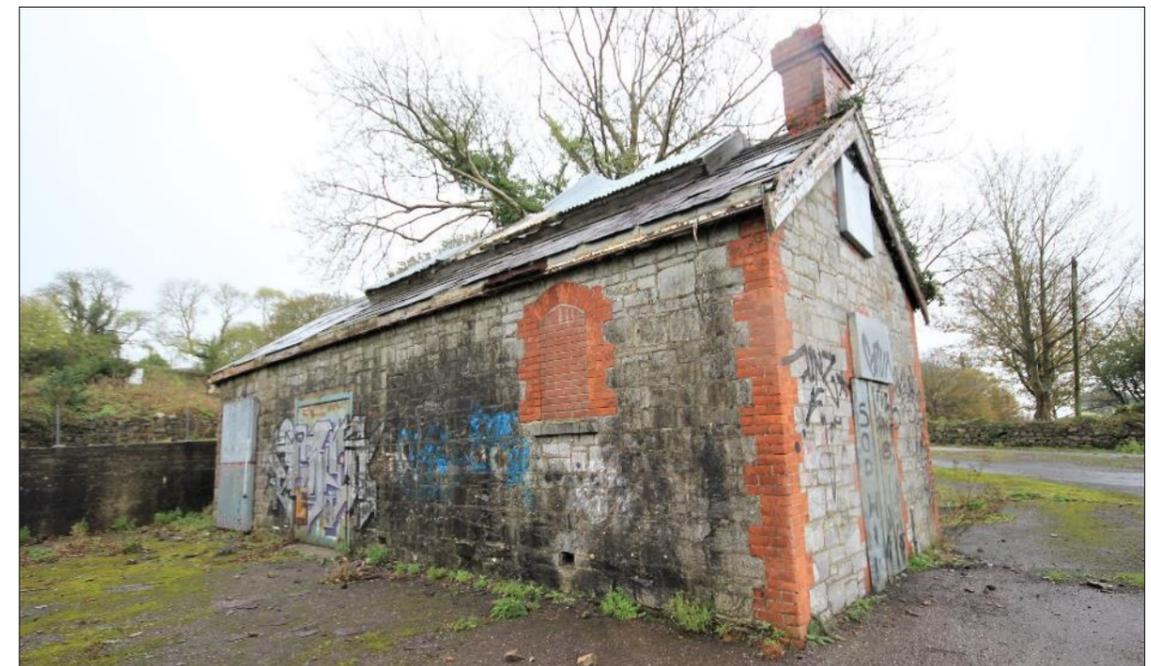
**Plate 4:** South gable and west elevation of late 1890s mortuary building with later extension to north. Entire structure proposed to be removed

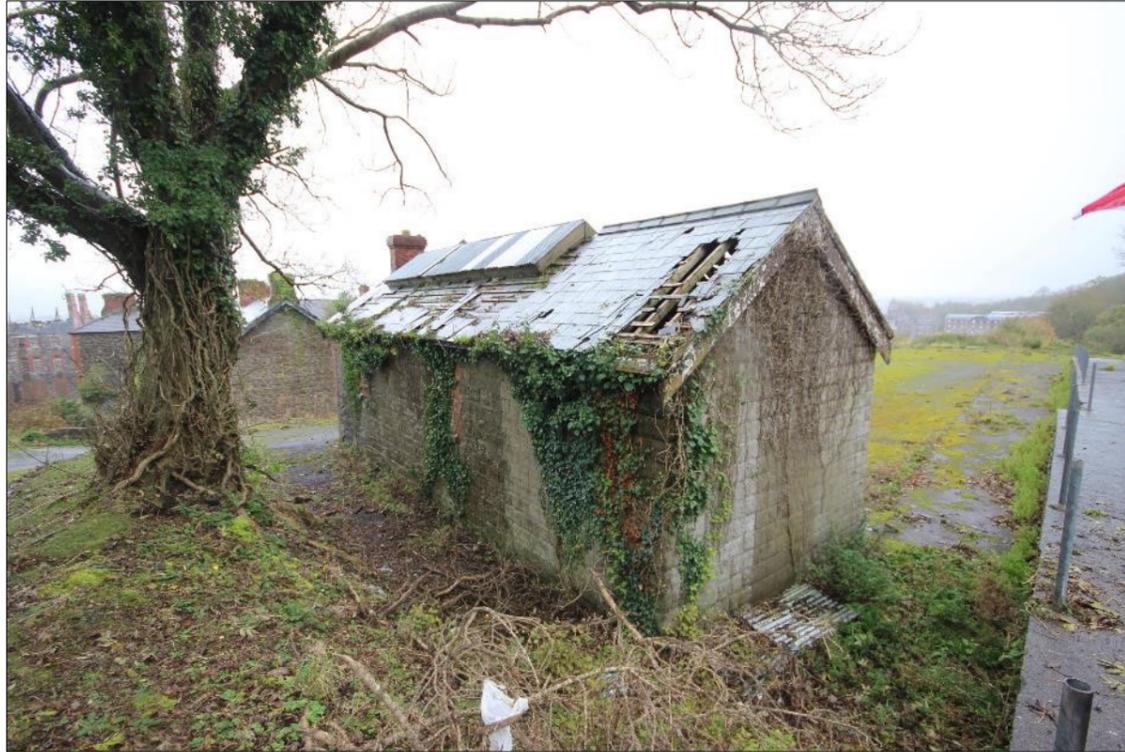
**Plate 5:** Extended north gable and east elevation of late 1890s mortuary building.

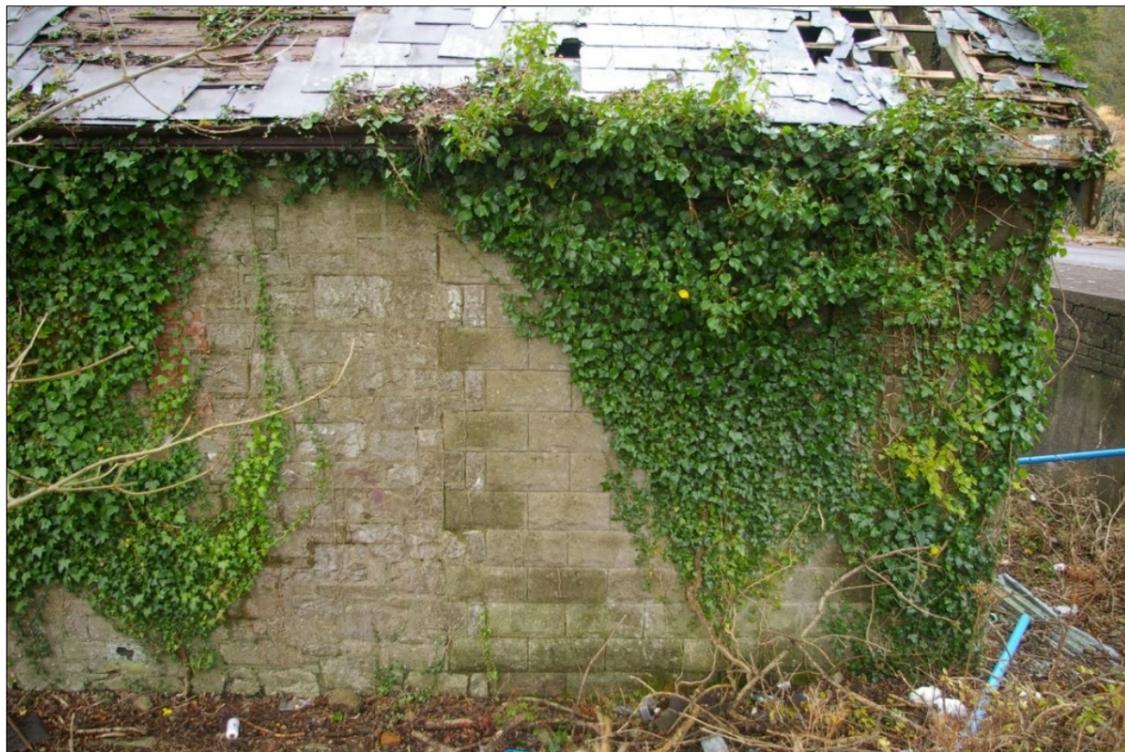
**Plate 6:** Joint between original stone building and concrete built extension to north

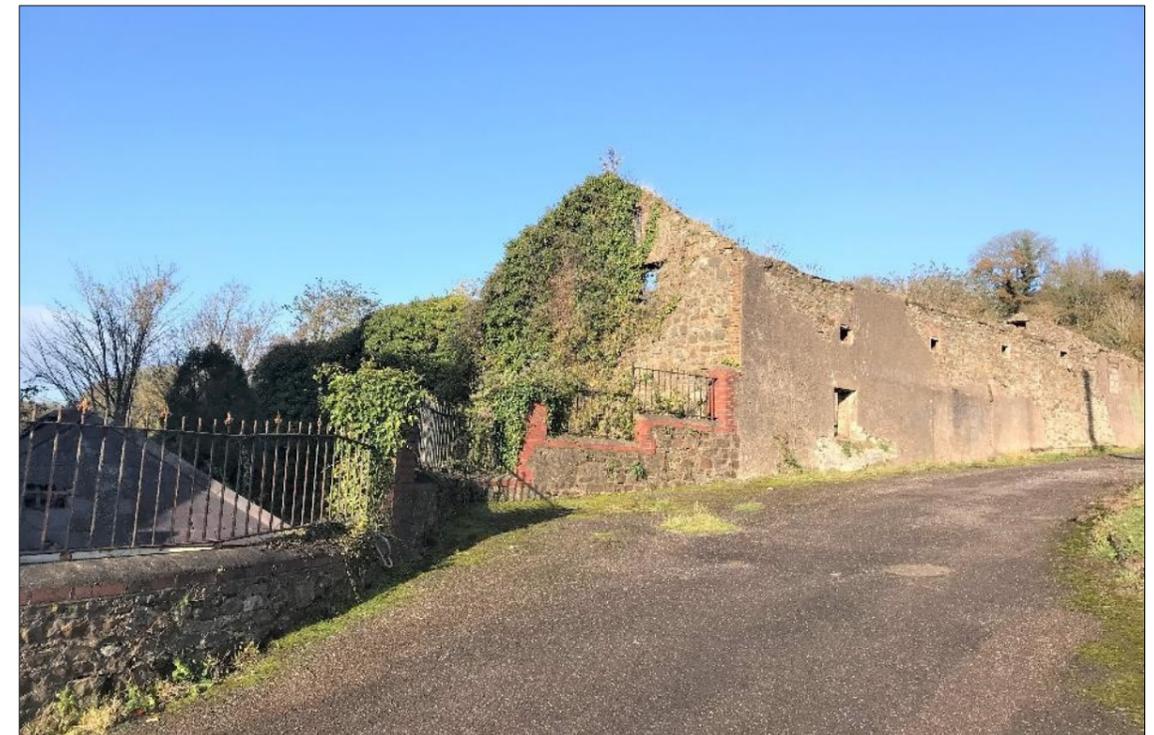
**Plate 8:** East range of group of nineteenth-century outbuildings (roofed until after 2005) with railings outside former chapel visible to left side of foreground.

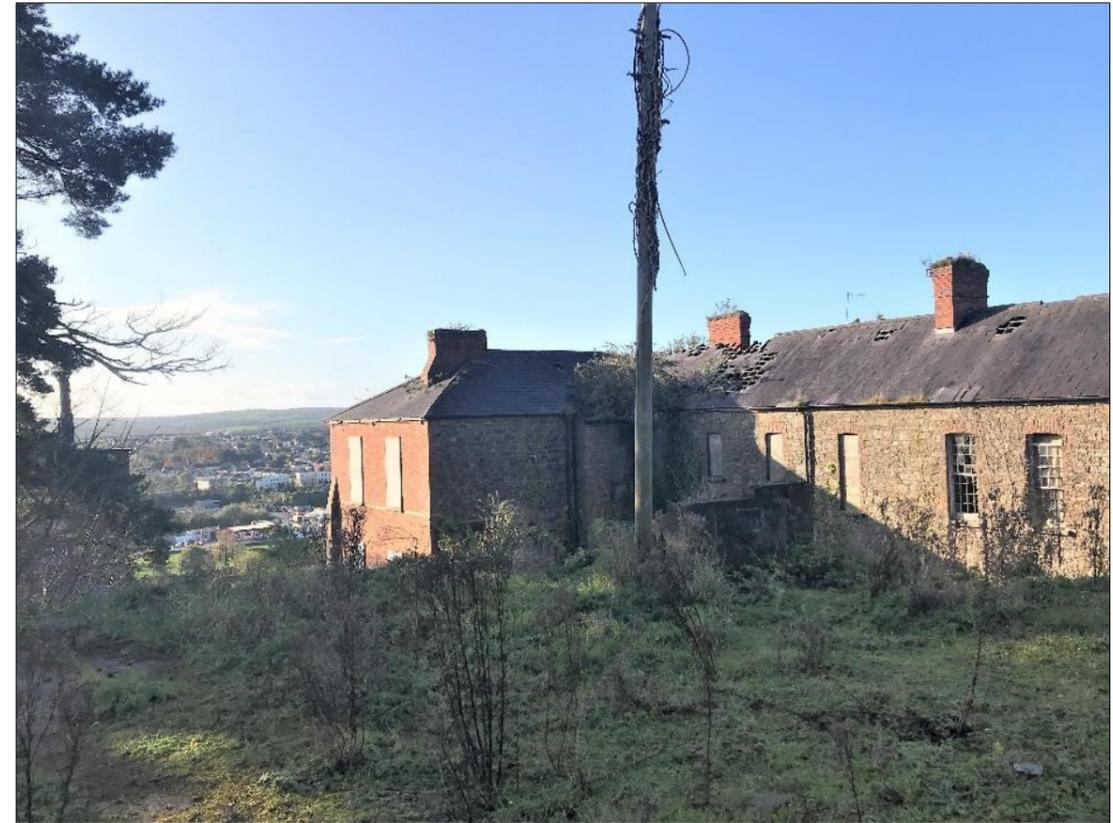
**Plate 19:** East end of brick-built front block of former St Dymphna's Hospital and east elevation of rear range

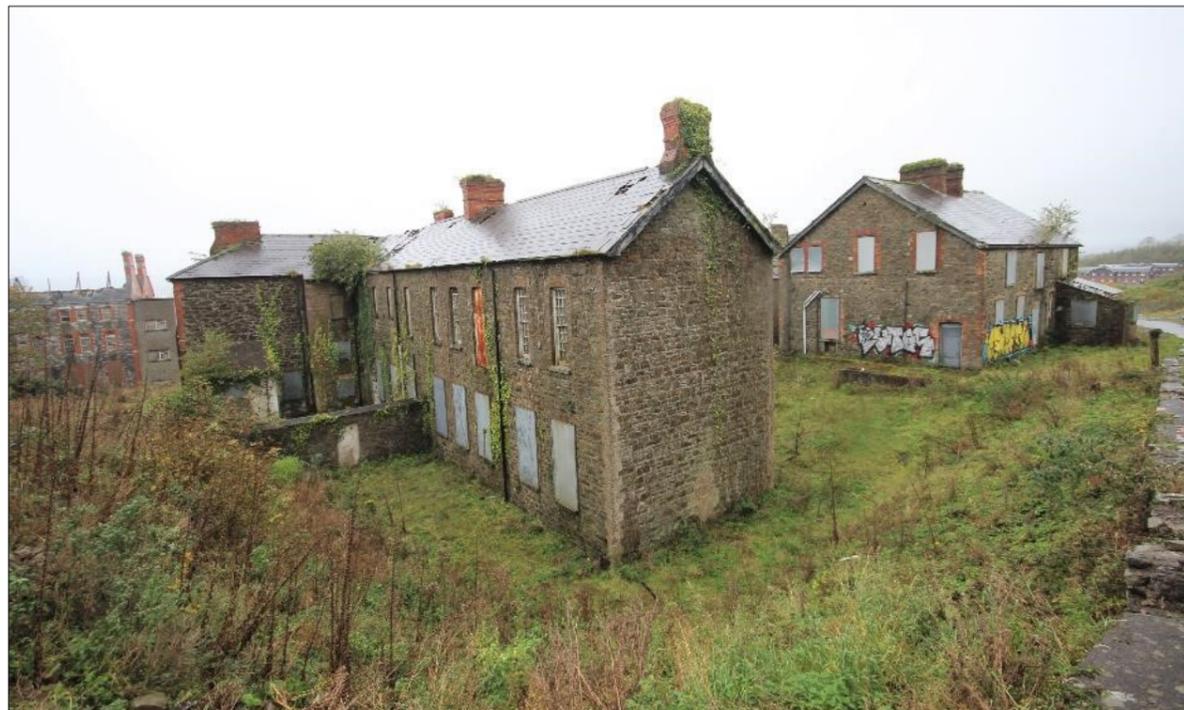
**Plate 18:** Former St Dymphna's Hospital building from north-east. Fire-damaged west end of former St Kevin's Hospital building visible in background to left side of photograph.

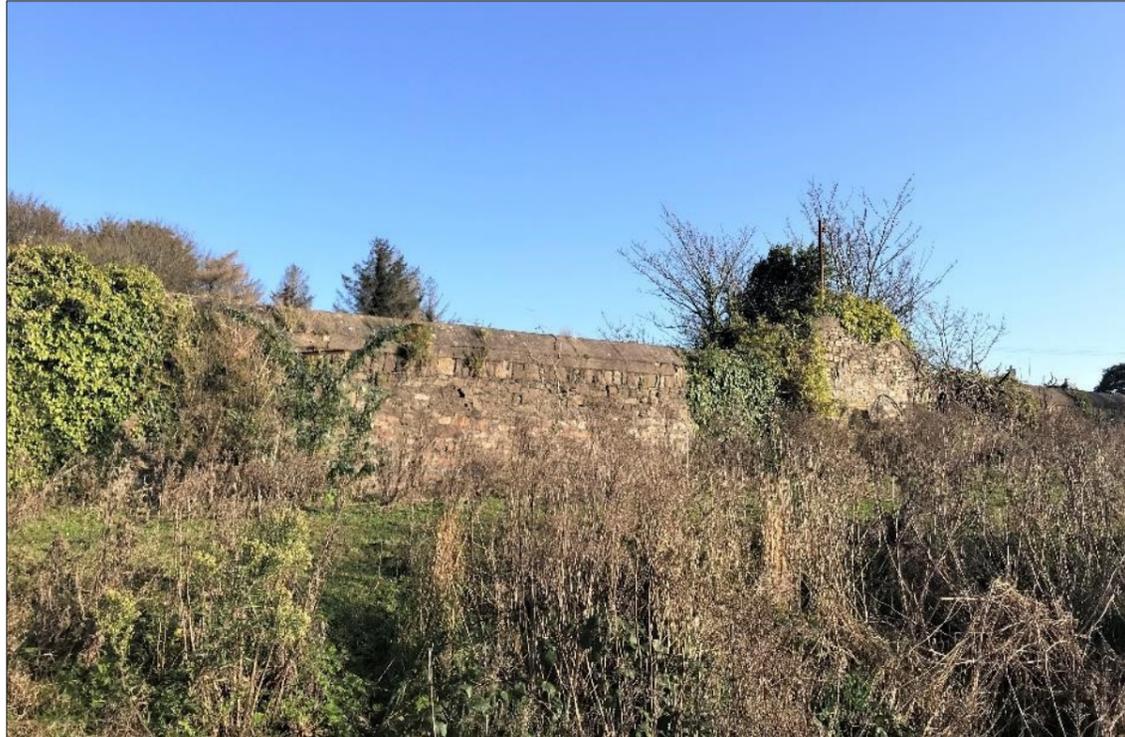
**Plate 25:** South elevation of wall around 'Lower Reservoir' forming part of proposed development site boundary. This and other upstanding masonry walls will be conserved as per appended methodology

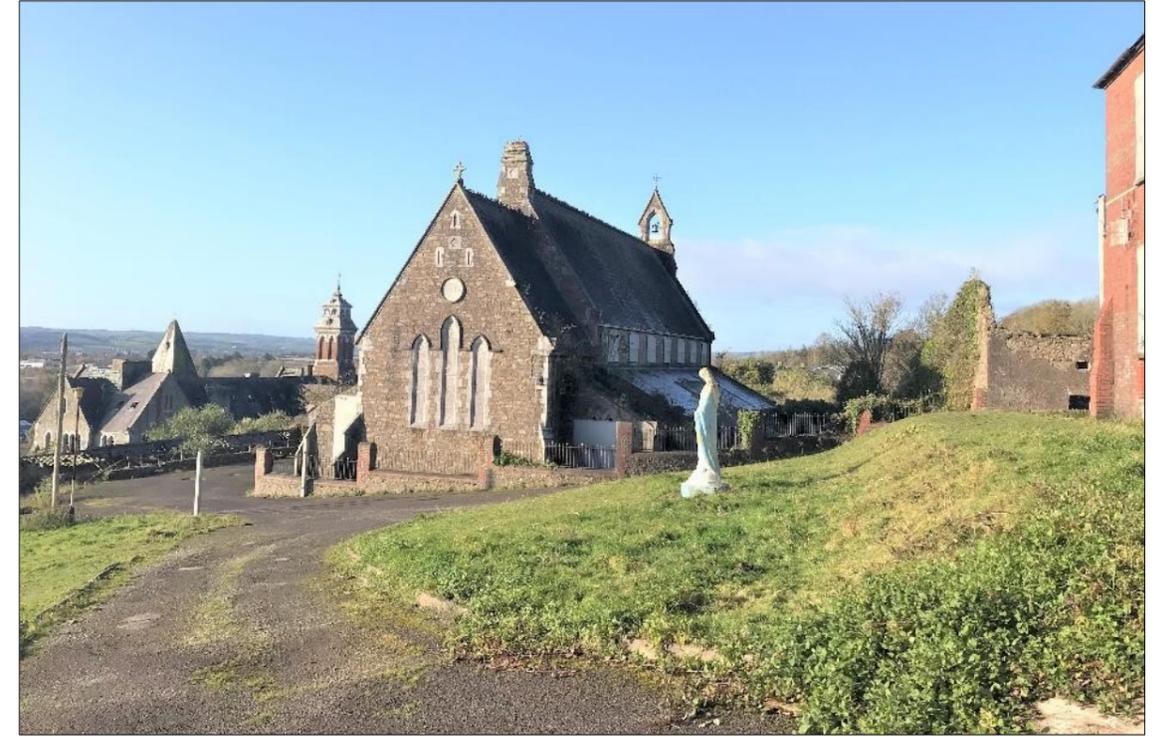
**Plate 27:** East gable and north elevation of late nineteenth-century former chapel to be retained and conserved to accommodate an office enterprise centre.

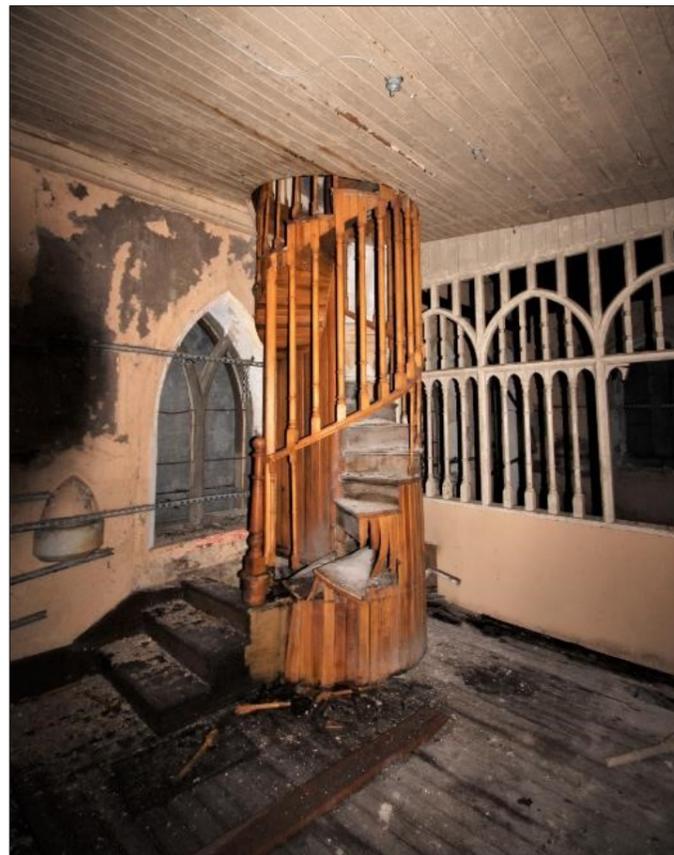
*Plate 33: Timber spiral staircase accessing mezzanine gallery to west end of former chapel nave proposed to be conserved and retained*

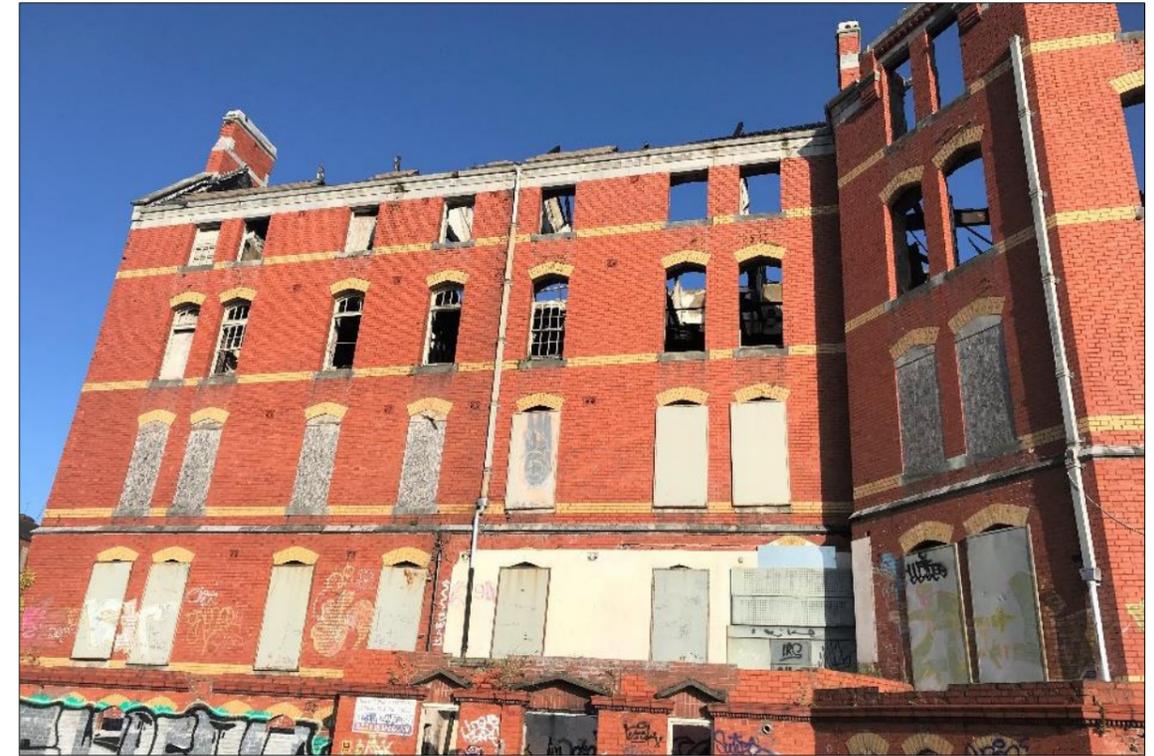
**Plate 46:** Façade detail to west side of former St Kevin's Hospital building with brick and cut limestone masonry, cast-iron rainwater goods, and timber sliding sash windows, all of which are proposed to be conserved as part of redevelopment.

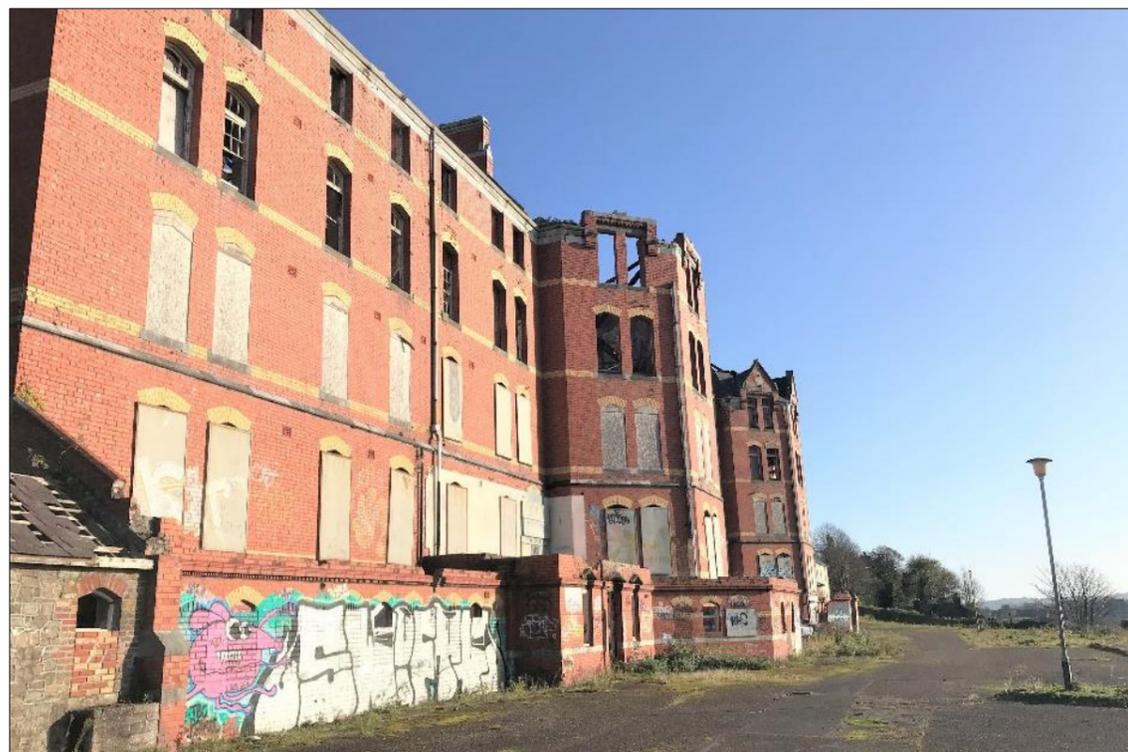
**Plate 45:** West end of southern façade of former St Kevin's Hospital proposed to be retained and refurbished to provide residential accommodation.

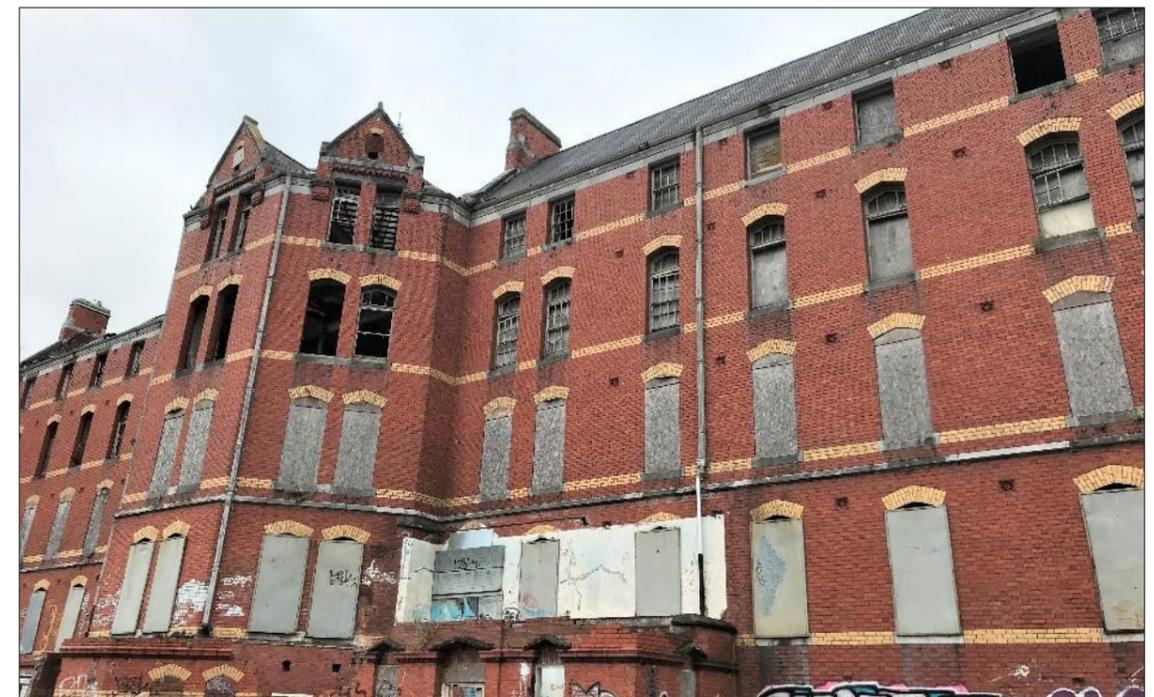
**Plate 47:** One of two canted bay projections to front façade with reinstatement of single-storey extension on outer side of both projections proposed with contemporary glazing to ground floor-level.

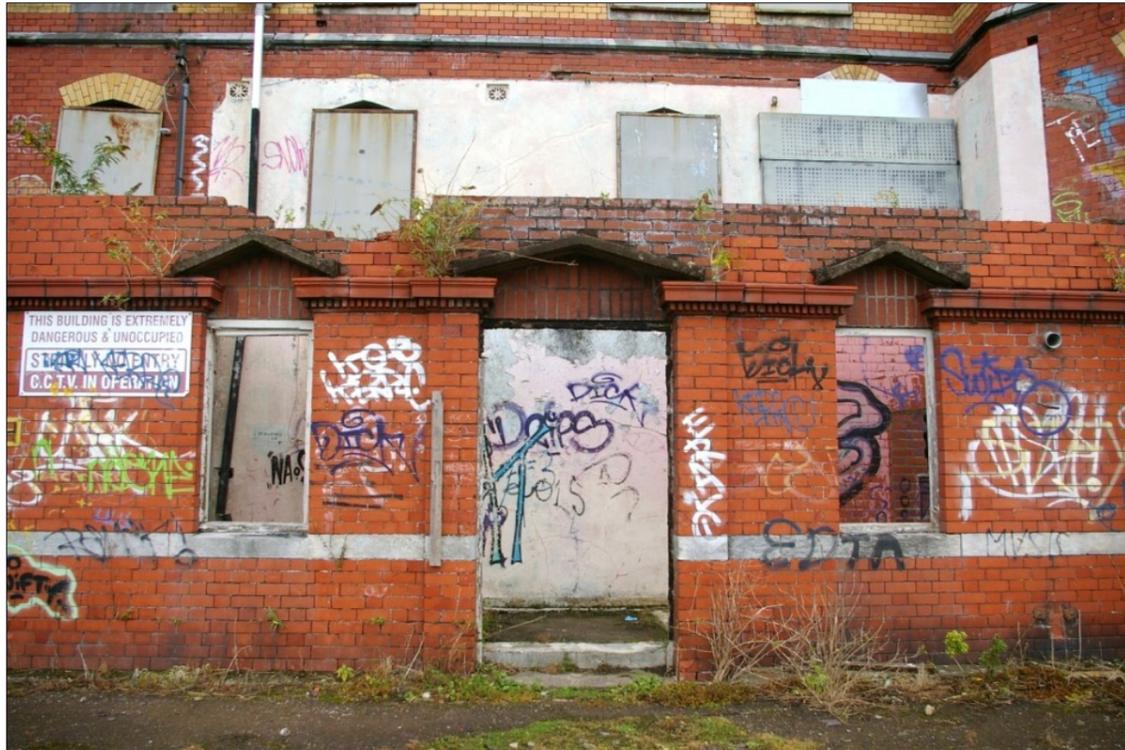
**Plate 48:** Detail of windows to southern elevation

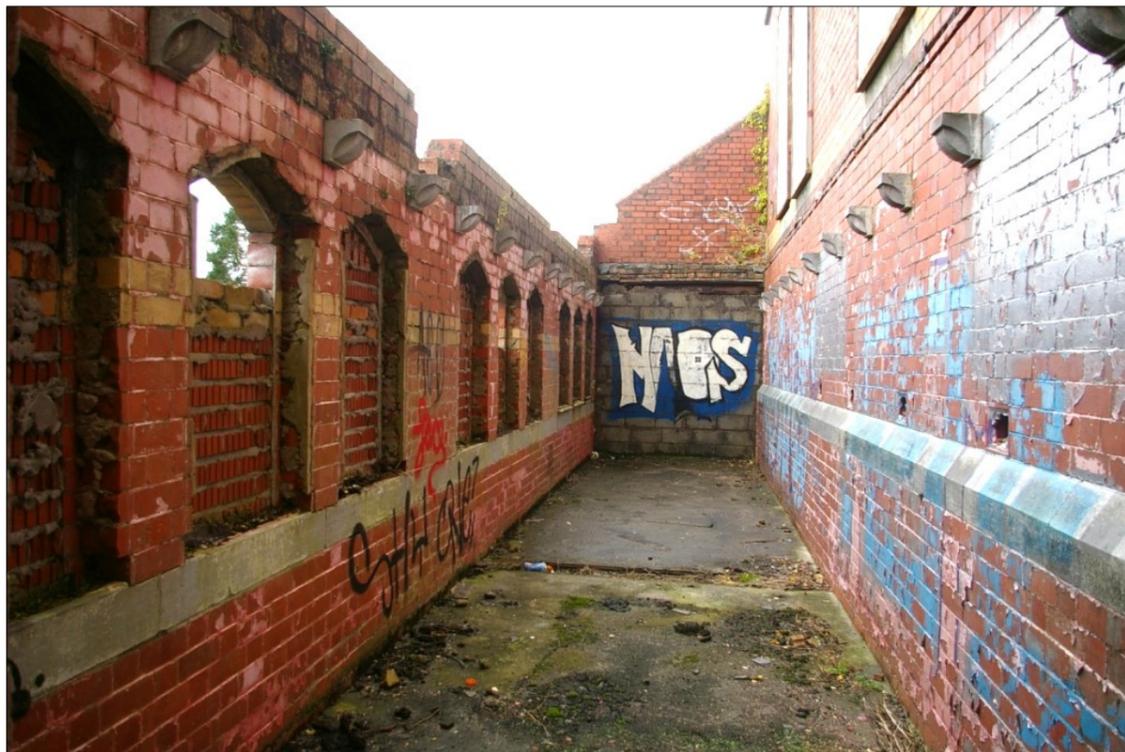
**Plate 49:** Interior of single-storey corridor to southern elevation.

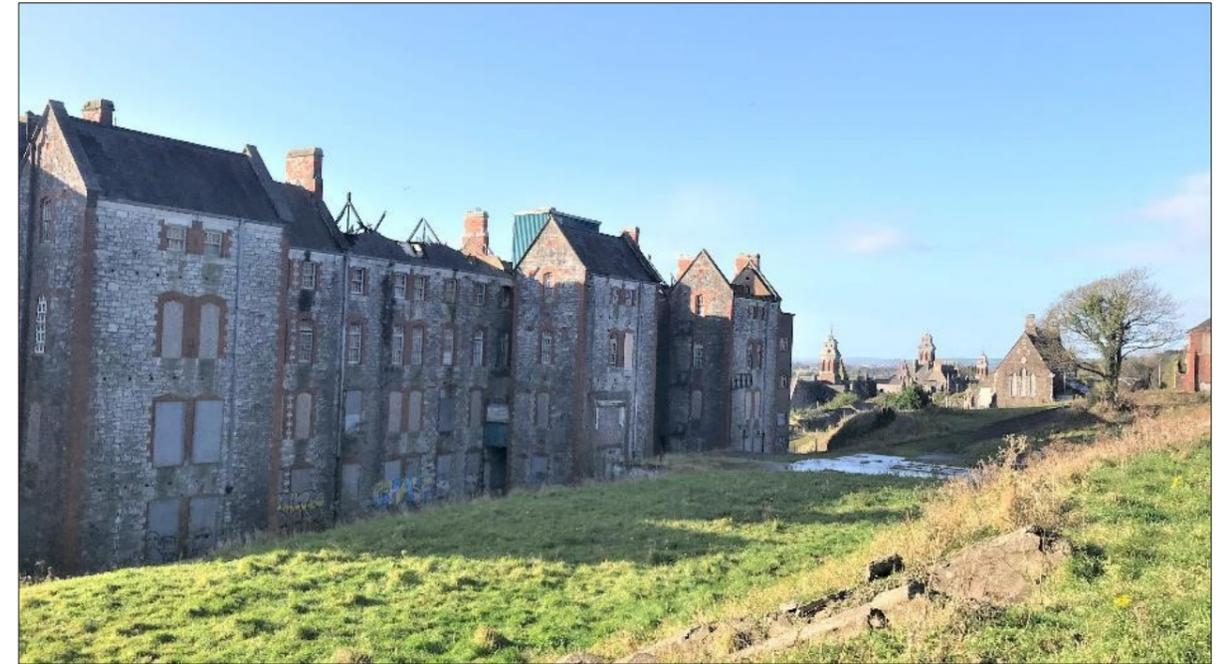
**Plate 50:** Western portion of rear north elevation of former St Kevin's Hospital. All existing rear extensions and central half of rear elevation will be removed to create modern rear extensions for apartment accommodation and balcony areas. Pedestrian bridges from raised area to middle-distance on photograph into proposed rear extensions will provide direct access to building at this level.

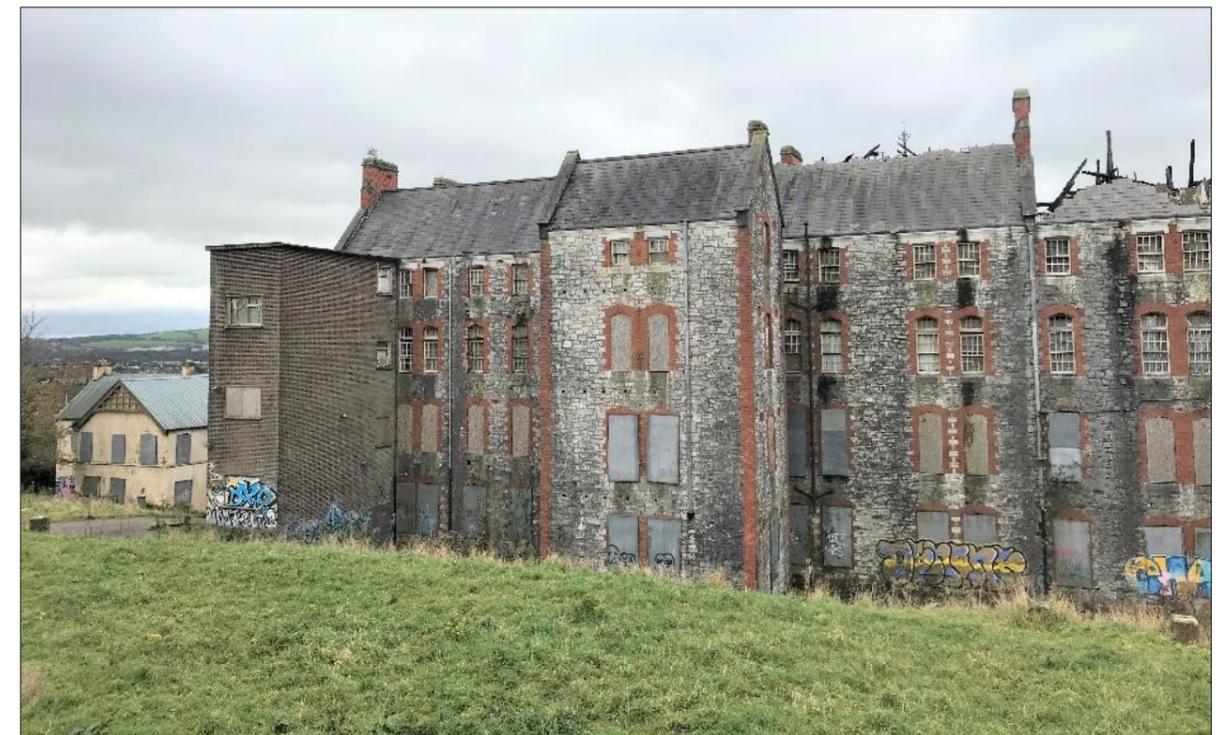
**Plate 51:** Eastern end of rear north elevation of former St Kevin's Hospital. Modern flat-roofed extension will be removed from here and end five bays of main block will be retained in situ up to where existing brick and stone extension, which is proposed to be removed, is located.

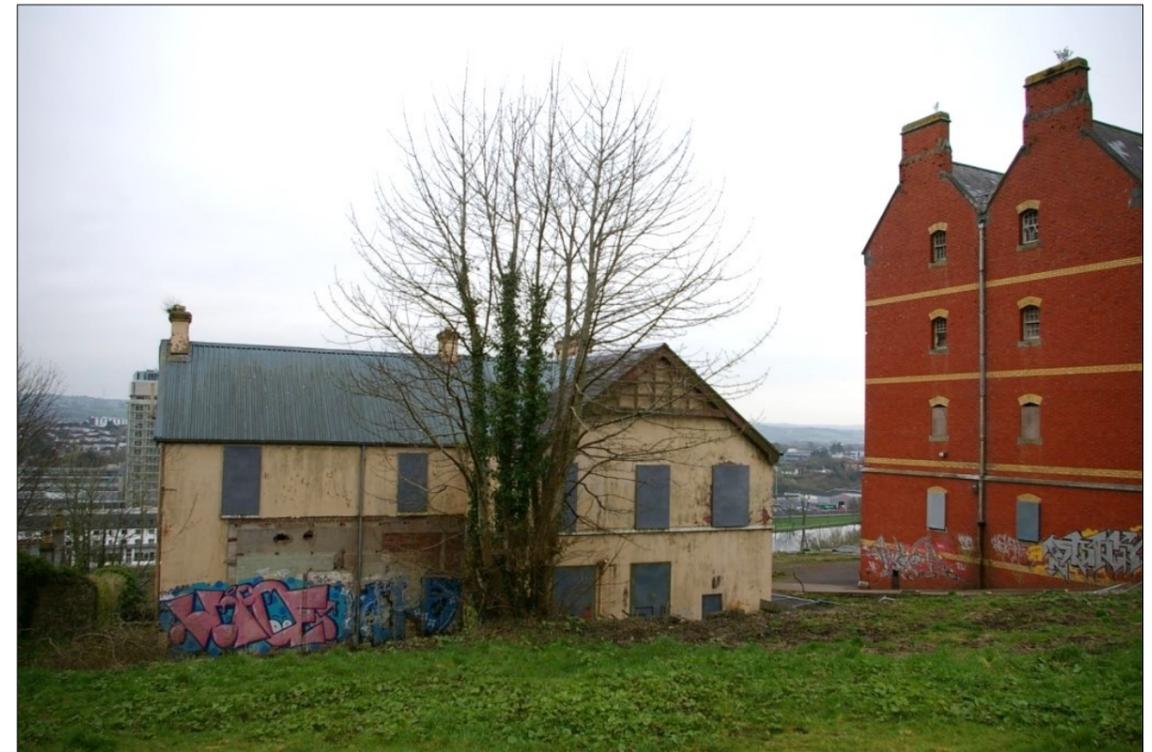
**Plate 58:** Rear elevation of former Doctors' residence with the former St. Kevin's to the right

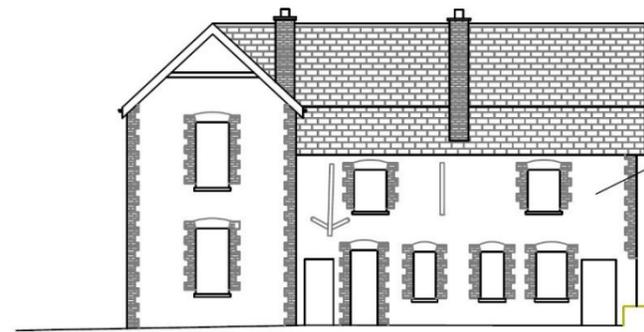
Northern elevation

Uncoursed limestone walls with brick detailing to window openings and quins

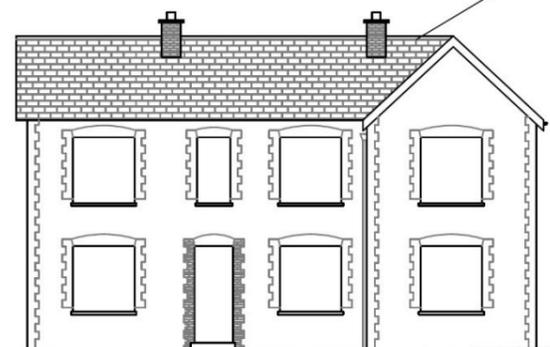
Southern elevation

Natural slate roof with brick chimneys. Heavily vegetated to rear.

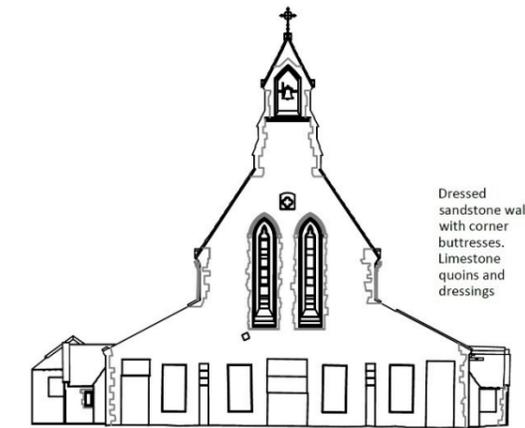
Western elevation

Dressed sandstone walls with corner buttresses. Limestone quoins and dressings

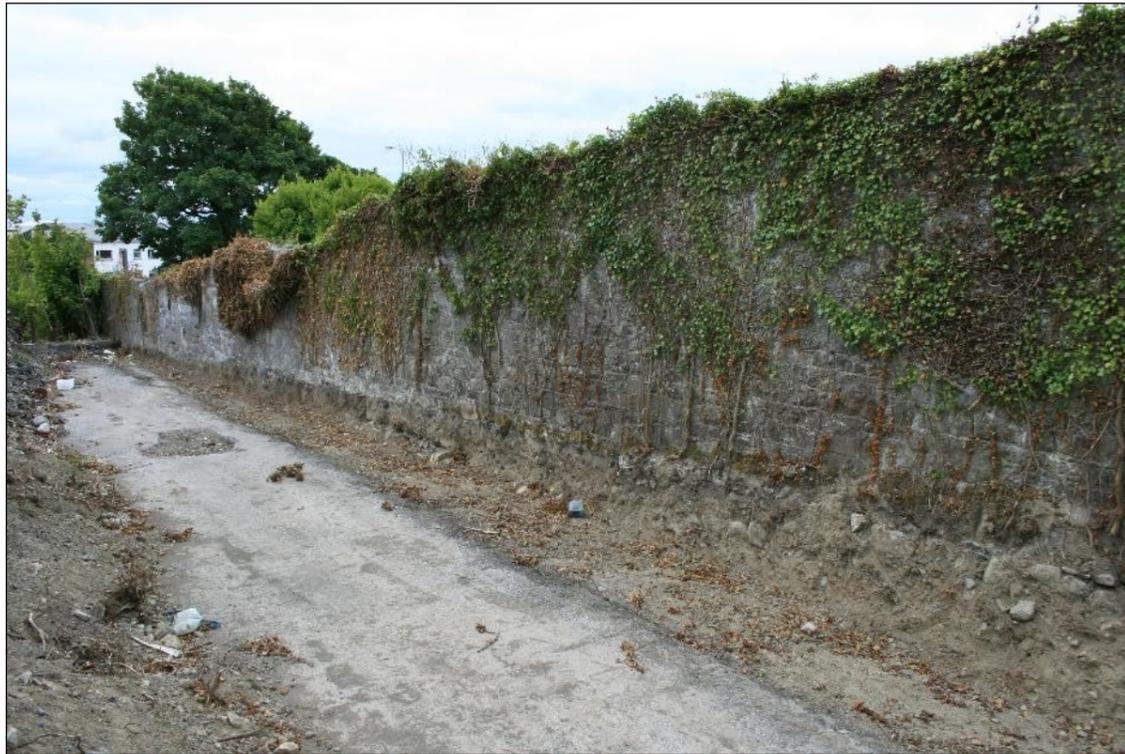
**Figure e):** Ivy on a nineteenth-century masonry wall has been trimmed back tight to masonry as part of maintenance works on the adjacent site. Vegetation removal, localised pointing and consolidation of the wall top is required to conserve and sustain this wall's survival in the medium term.

Trimming-back of vegetation should take place as part of regular maintenance of a masonry wall but complete removal of ivy needs to take place as part of masonry consolidation works carried out by suitably-experienced contractors using appropriate lime mortar to re-construct and point stone-work to match the style and finish of existing historic masonry. When the undertaking of specialist masonry works on the site has been secured, ground-rooted stems of ivy growing on walls should be cut through with a section removed to make cuts obvious. This should **not** be done unless masonry works by an appropriate specialist conservation contractor to an agreed methodology are imminent as to cut main stems of ivy before overgrowth on the wall is trimmed back to the masonry surface or before the contractor and resources are in place to carry out the masonry repair works would risk the ivy developing more damaging root systems on the structure itself, thereby exacerbating the decay of the wall.
