PROJECT: ST KEVIN'S STRATEGIC HOUSING DEVELOPMENT
AT THE FORMER ST. KEVIN'S HOSPITAL AND GROUNDS
SHANAKIEL
CORK

DOCUMENT TITLE: STRUCTURAL REPORT ON SOUTH RETAINING WALL
DOCUMENT NO: 19.305 – SR – 01

ST KEVIN'S STRATEGIC HOUSING DEVELOPMENT
AT THE FORMER ST. KEVIN'S HOSPITAL AND GROUNDS
SHANAKIEL
CORK
STRUCTURAL REPORT ON
SOUTH RETAINING WALL

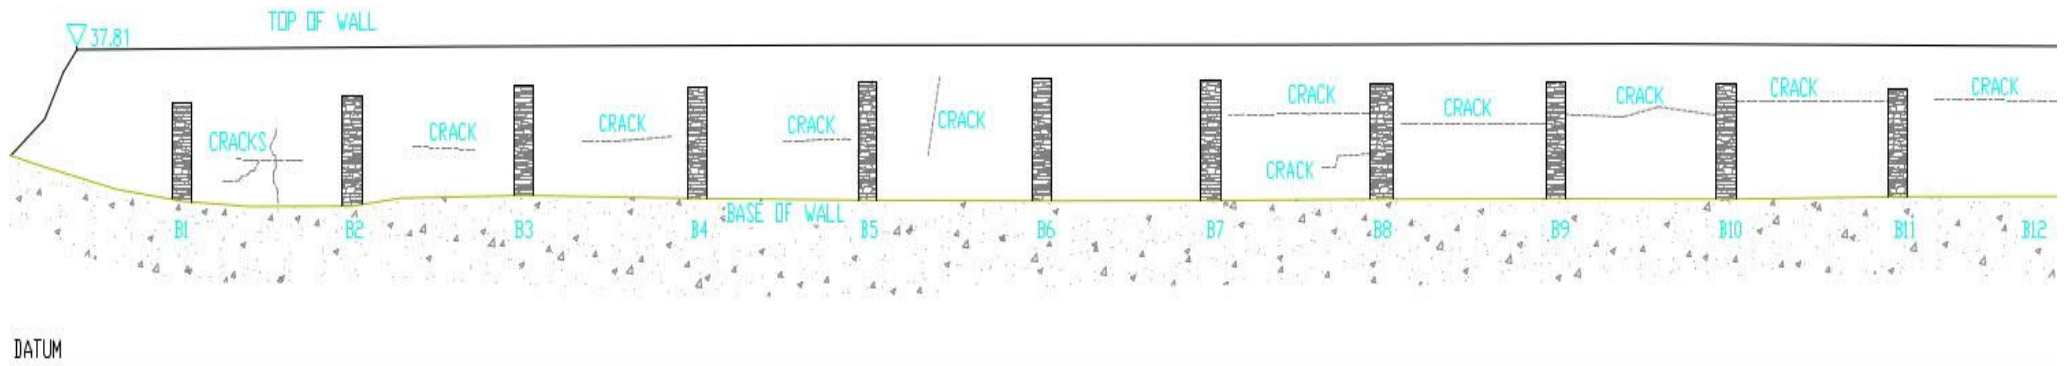
Wall elevation B1 to B11

Location	Photo Ref	Description of Defect
Buttresses 1-2	1	Significant horizontal crack approx. 1m from lower level. Small cracks emanating from this crack.
Buttresses 2-3	2	Significant horizontal crack approx. 1m from lower level. Open joints in buttress 3.
Buttresses 3-4	3	Overgrown with ivy. Some minor horizontal cracks..
Buttresses 4-5	4	Horizontal crack visible where not overgrown.
Buttresses 5-6	5	Buttresses need to be repointed. Minor diagonal crack.
Buttresses 6-7	6	Open joints in buttresses & Buddleia growth in buttress 6.
Buttresses 7-8	7	Open joints in buttresses. Minor Horizontal cracks
Buttresses 8-9	8	Significant horizontal crack approx. 1.5m from lower level. Open joints in buttress.
Buttresses 9-10	9	Collapsed section at top of buttress 9. Significant horizontal cracking.
Buttresses 10-11	10	Significant horizontal crack approx. 1.5m from lower level.
Buttresses 11-12	11	Buttress 12 has largely been removed- wall significantly weakened. Horizontal cracking.

Buttresses 12-13	12	As above - Buttress 12 has largely been removed- wall significantly weakened.
Buttresses 13-14	13	Vertical & horizontal cracking.
Buttresses 14-15	14	Top section of buttress 15 has fallen away.
Buttresses 15-16	15	Significant horizontal cracking approx. 1.5m from lower level.
Buttresses 16-17	16	Open joints in buttress 16
Buttresses 17-18	17	Top section of buttress 17 has fallen away.
Buttresses 18-19	18	Major failure of wall between buttresses with body of wall fallen away and earth behind wall exposed and coming through to lower level. Horizontal cracking on remaining section of wall.

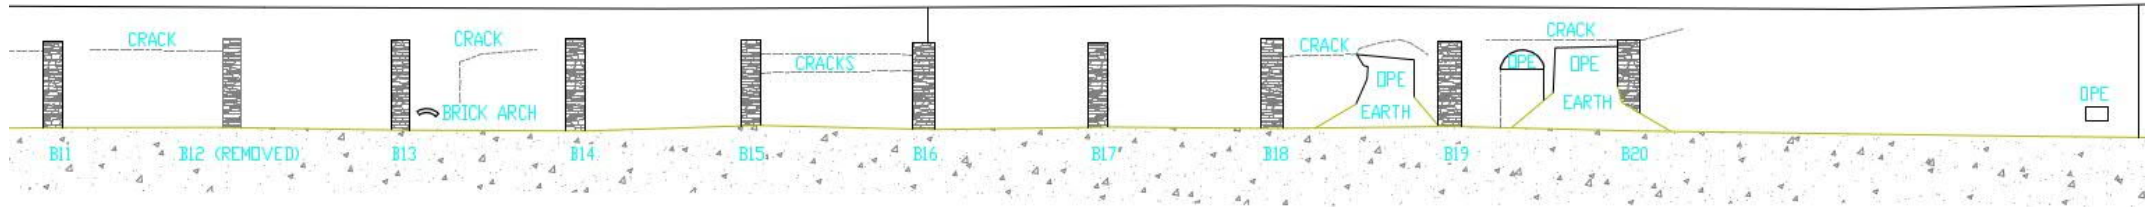
Wall Elevation B 11 to B20

Buttresses 19-20	19	Similar but more extensive failure of wall between buttresses with body of wall fallen away and earth behind wall exposed and coming through to lower level. Old formed opening in wall to left of collapsed section.
Buttresses 20	20	Diagonal crack near buttress 20. No other significant defects.
Buttresses 21	21	opes in wall to left hand side of buttress 21
Buttresses 21-22	22	Largely overgrown with ivy. No significant defects evident.
Buttresses 22-23	23	Two cavities visible where stone has fallen away.
Buttresses 23-24	24	Section of top of wall has fallen away over buttress 24
Buttresses 24-25	25	Same comment as for photo 24
Buttresses 25-26	26	Wall completely overgrown with ivy and mature tree adjacent to this section of wall.

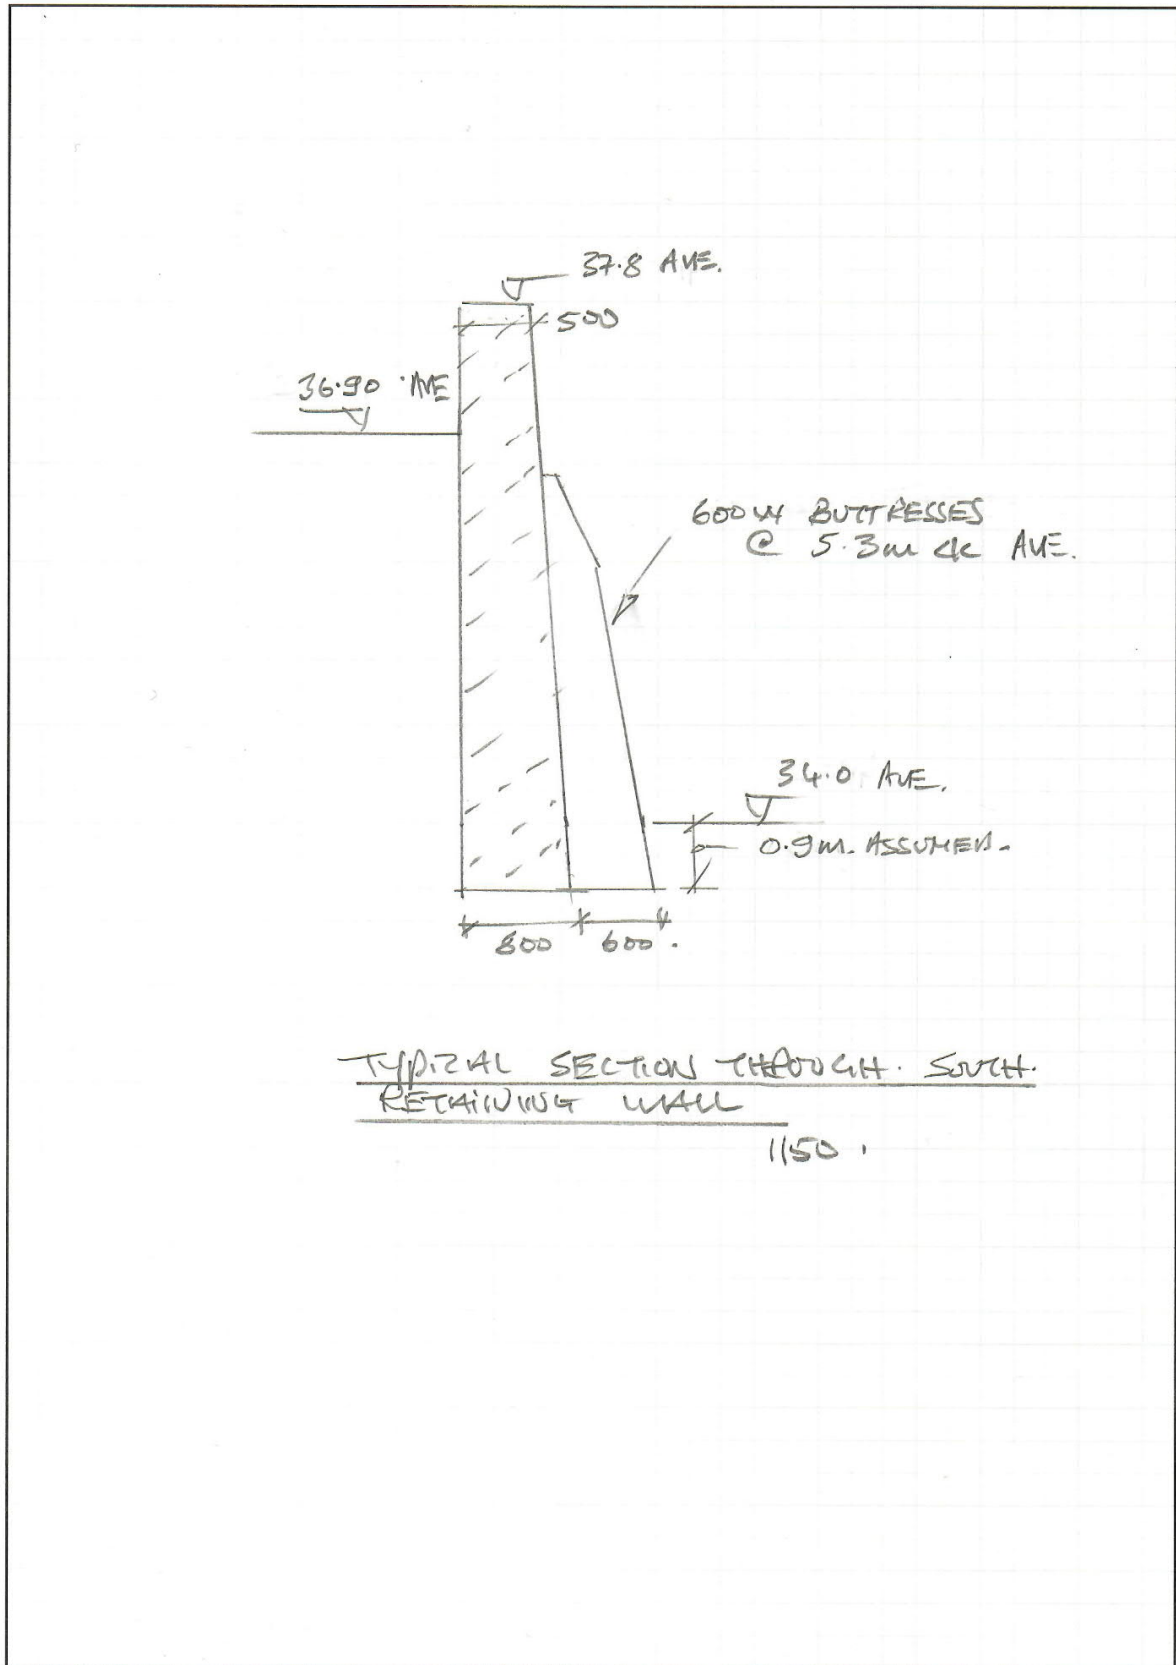
TYPICAL SECTION THROUGH SOUTH RETAINING WALL

In summary the stability of the wall cannot be verified by calculation as adequate. These deficiencies are evidenced by systemic horizontal cracking and sections where complete collapse has occurred -see section 2.2. The fact that more extensive collapse has not occurred suggests that the buttresses, in places, are effective in enhancing stability (albeit with inadequate factor of safety) and that the coefficient of friction mobilised to resist sliding is, in places, greater than the standard value of 0.4 used in the check calculation.

Given the inherent deficiencies in the wall and the history of sectional collapse it is the recommendation of this report that the wall should be demolished. There is, however, enough space to bank back the earth from the lower level at a safe slope of 1 vertical to 3 horizontal which is generally available. This removes the requirement for a retaining wall and provides a much more sustainable approach to the landscaping. It is the recommendation of this report, therefore, that the wall is demolished and the retained side is banked back at a safe angle so that no new retaining structure is required.
